# Arboricultural Report

Job No. 35419

**Prepared by:** David Spencer – Consultant Arborist

**Re:** Application to relocate the Museum St Oak Tree

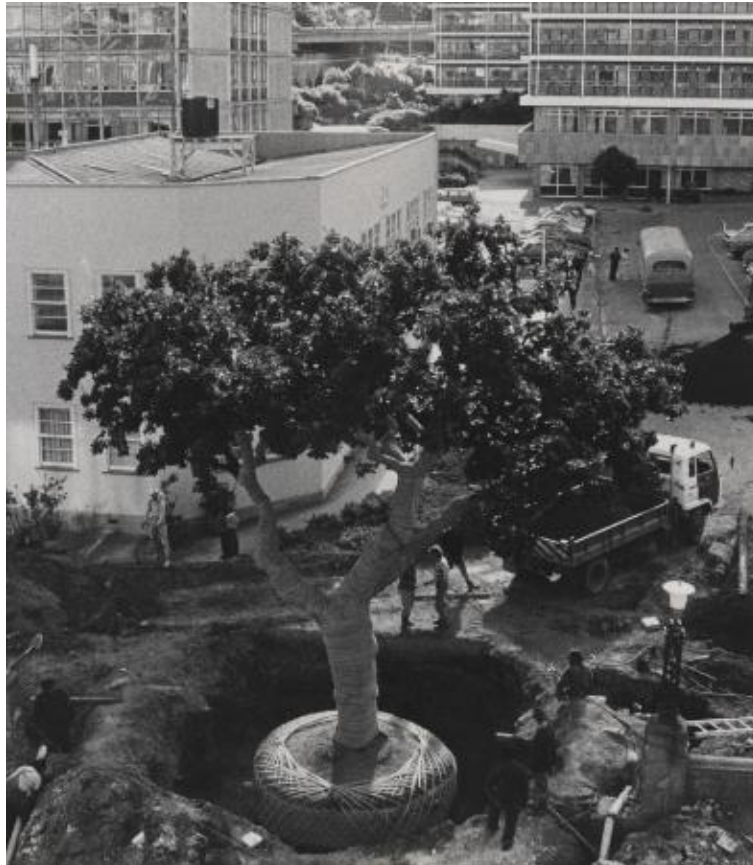
- 9.1 In 1986-7 the tree was previously prepared for relocation. At this time significant pruning of both the canopy and root system were carried out. This can be seen in the following photograph 3.

**Photograph 3. Tree in preparation for relocation (1986-7)**

- 9.2 The root pruning and removal at this time will have affected root architecture of the tree.
- 9.3 On site investigations have shown the tree's root system is compact and dense and generally contained within the current planting area. In addition, the soil that was used to back fill the hole created in 1986-7 was of good quality and combined with the regular application of mulch and existing irrigation system has led to a healthy root mass within the planter area.
- 9.4 The root system is deeper than expected and continues to be healthy and dense to approximately 1.6m in depth.

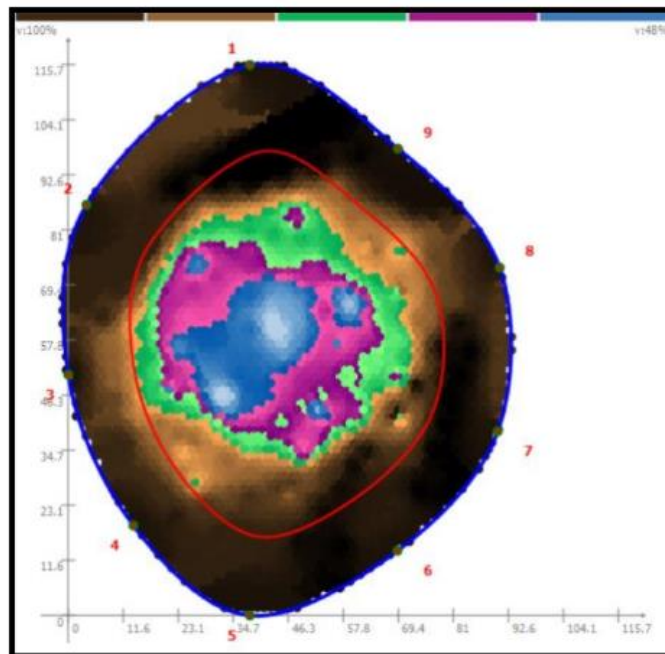
Figure 4. Tomogram at 300mm.

- 11.4 In September 2019 the cavity at the base of the tree and its lower trunk were assessed using sonic tomography. The tomograms were taken at 300mm from ground level, just above the cavity and at 1800mm from ground level. They can be seen in Figures 4 and 5 respectively.

11.5 The tomographs undertaken indicate that while there is decay at the base of the trees main stem it should not be sufficient to affect the integrity of the stem during the transplant. There are no causes for concern with this amount of decay on a tree of this age. It is in fact, expected to find decay on trees of this age and size.

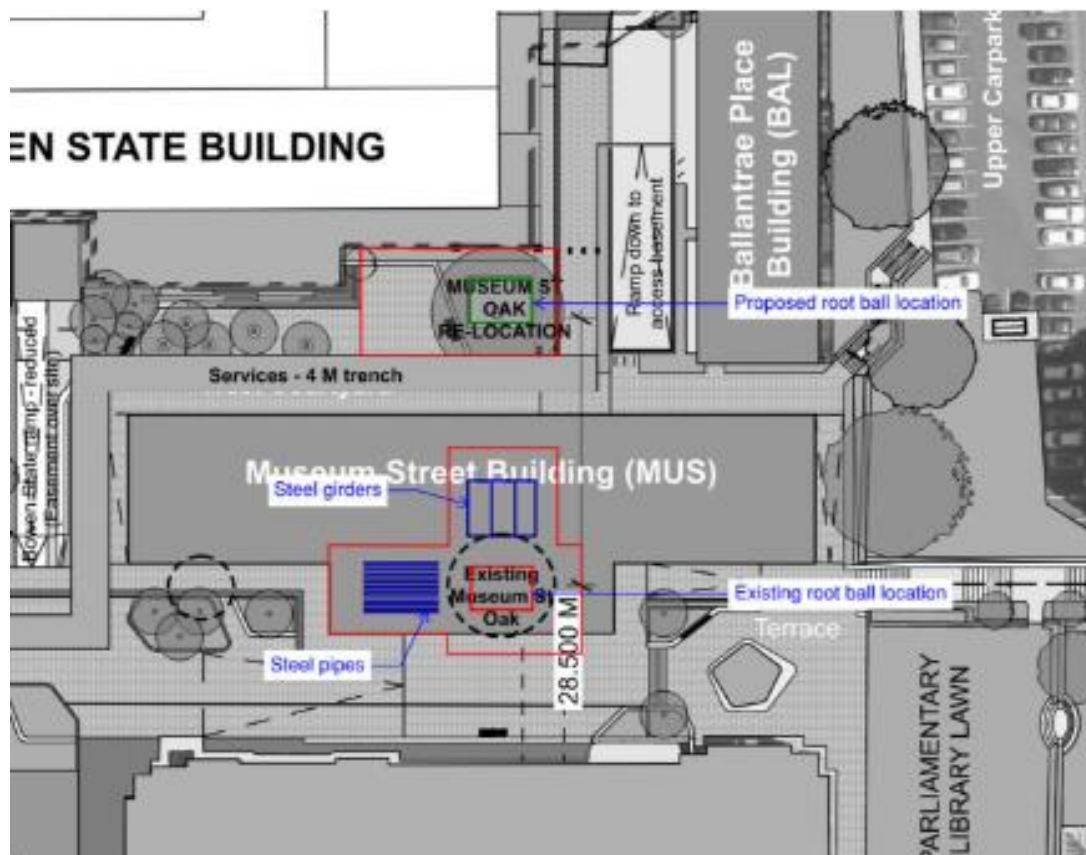
- 14.6 This is likely to require a work area of 10m to the west side of the tree and 12m to the southern side of the tree. The work area will need to be excavated to a similar depth(2m) to install the steel frames under the tree root ball.

- 14.7 To ensure a large enough root ball can be excavated and steel frames thrust underneath as described above, a large working area is required. This area should be sufficient to allow the pipes to be thrust under the root ball from the south and the girders from the west. The following aerial image Figure 6 indicates the required work area in red.

Figure 6. Likely excavation requirements.

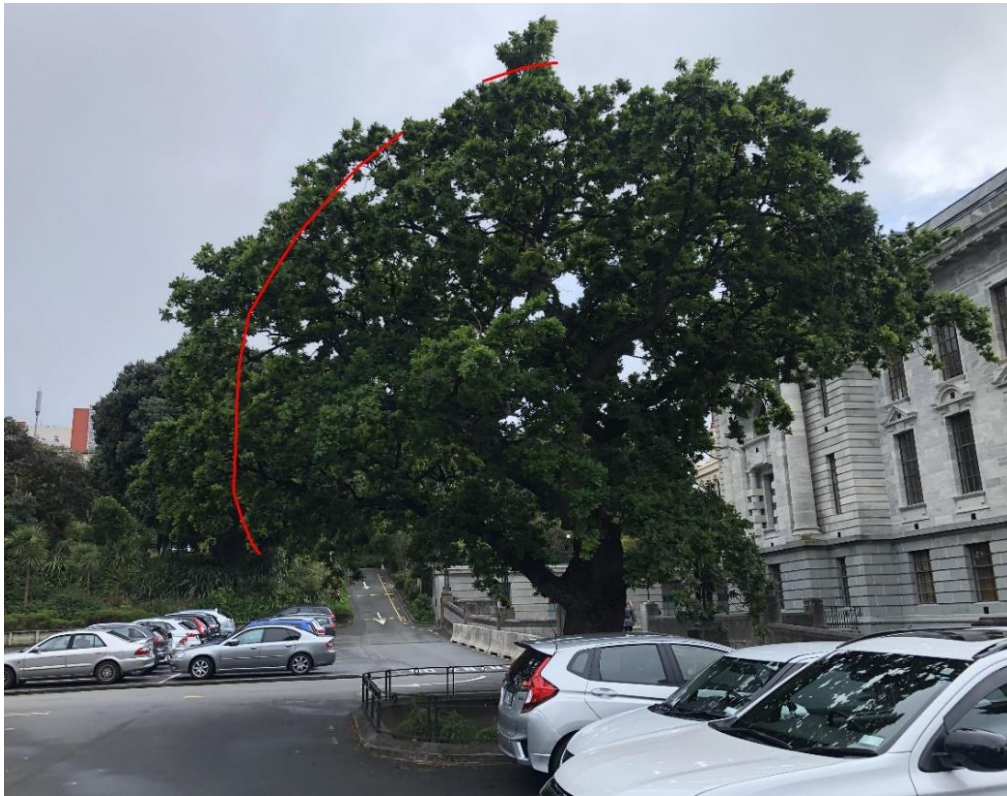
18.13 To further mitigate the wind load changes it is proposed to carry out some selective reduction of branches on the western side and top of the tree. The following photograph 5 shows the proposed reduction work.

**Photograph 5. Proposed canopy reduction on western side and top of the museum oak.**

18.14 The proposed reduction work will reduce the load on the branches and therefore lessen the likelihood of failure due to changes in wind loading.

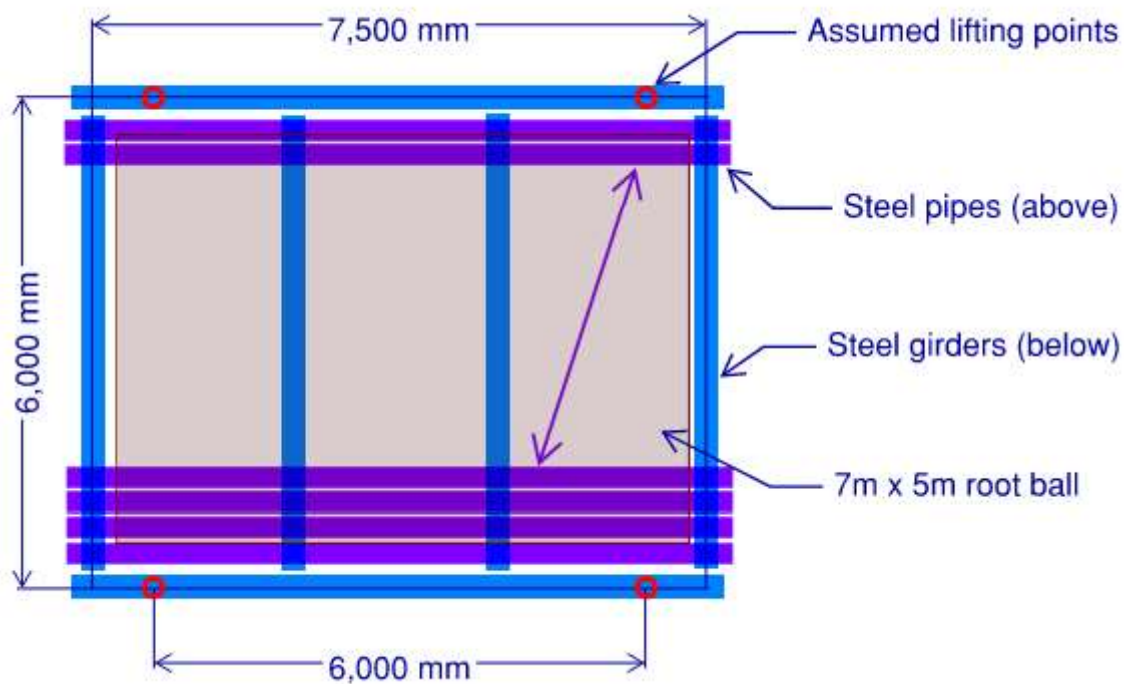
We have investigated the steel member sizes for the lifting frame geometry shown in Figure 2. There are many ways the frame can be iterated with member size, layout and spacing, so the initial geometry is informed by the parameters discussed during the workshop. A cross section of the frame is also shown in Figure 3.

- 220CHS tubes at 275mm crs in the n-s direction.
- 4x girders in the e-w direction, spaced at 2.5m crs.
- 2x edge girders in the n-s direction, connected to the perpendicular girders.
- 4x crane lifting points at 6m x 6m spacing.

Figure 2: Initial geometry of the structural lifting frame.

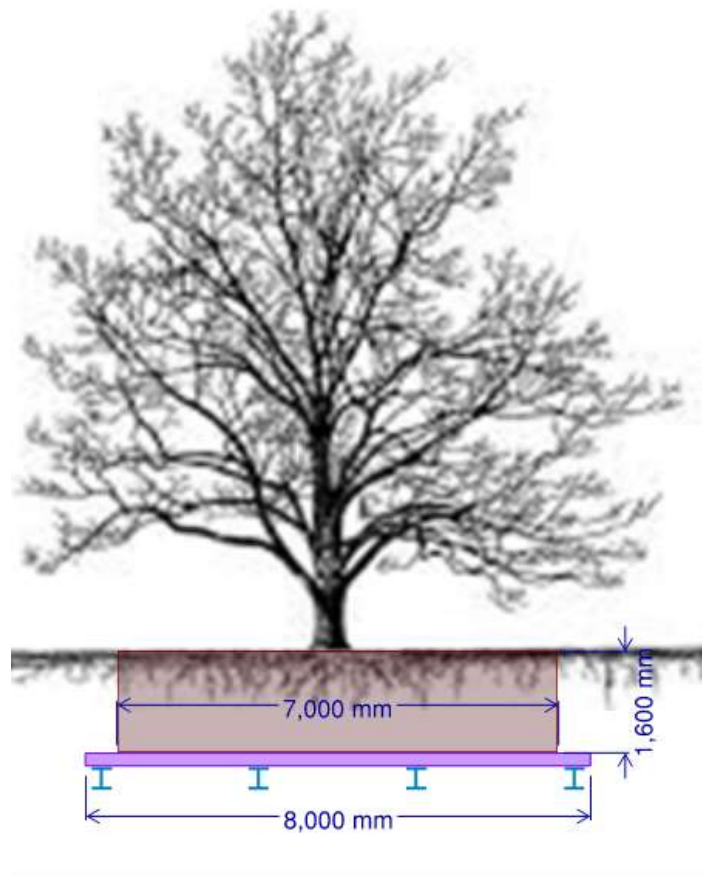
Figure 3: Cross section of the structural frame below the tree and root ball.

The proposed lifting strategy was found to require a structural frame formed by a grillage of 220mm diameter CHS tubes, supported on a 350-400mm deep structural frame. The frame would be supported the four corners (lifted by crane).

Following confirmation of this relocation strategy, we recommend a detailed structural design of the cradle system is undertaken in collaboration with the arborist and feedback from a crane operator.

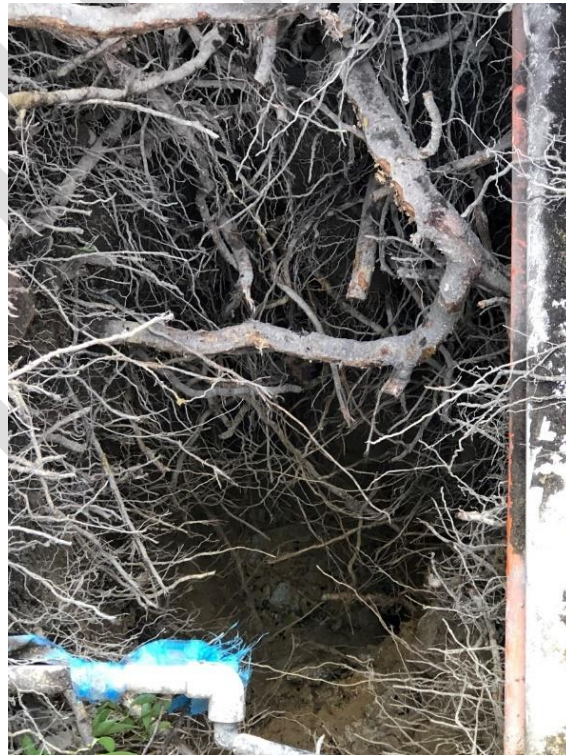
**Photograph 1. Southeast corner of root zone depth to 1.8m**

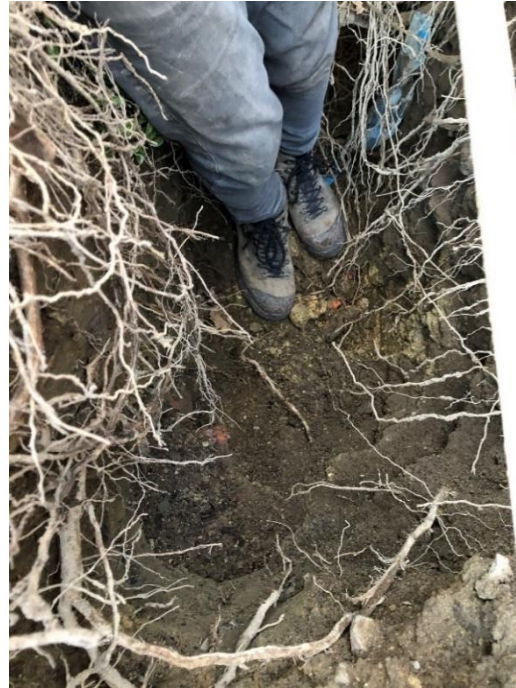
**Figure 1: Typical soil profile and root development**

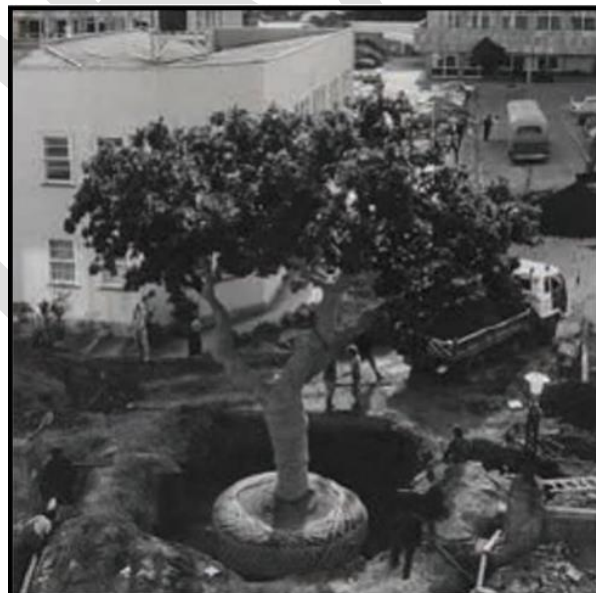
- 6.6 Information has been supplied in the form of photos that clearly show the tree was previously excavated around when the tree was prepared for relocation in 1986-1987 and roots were severed around the circumference of the tree. This strongly indicated the majority of roots were pruned approximately 1.5m from the tree base. We have not been able to confirm if the roots were severed below the tree. Photograph 3 shows the tree when previously prepared for relocating.

**Photograph 3. Museum Oak, 1986 relocation preparations (severe crown reduction and root prune).**

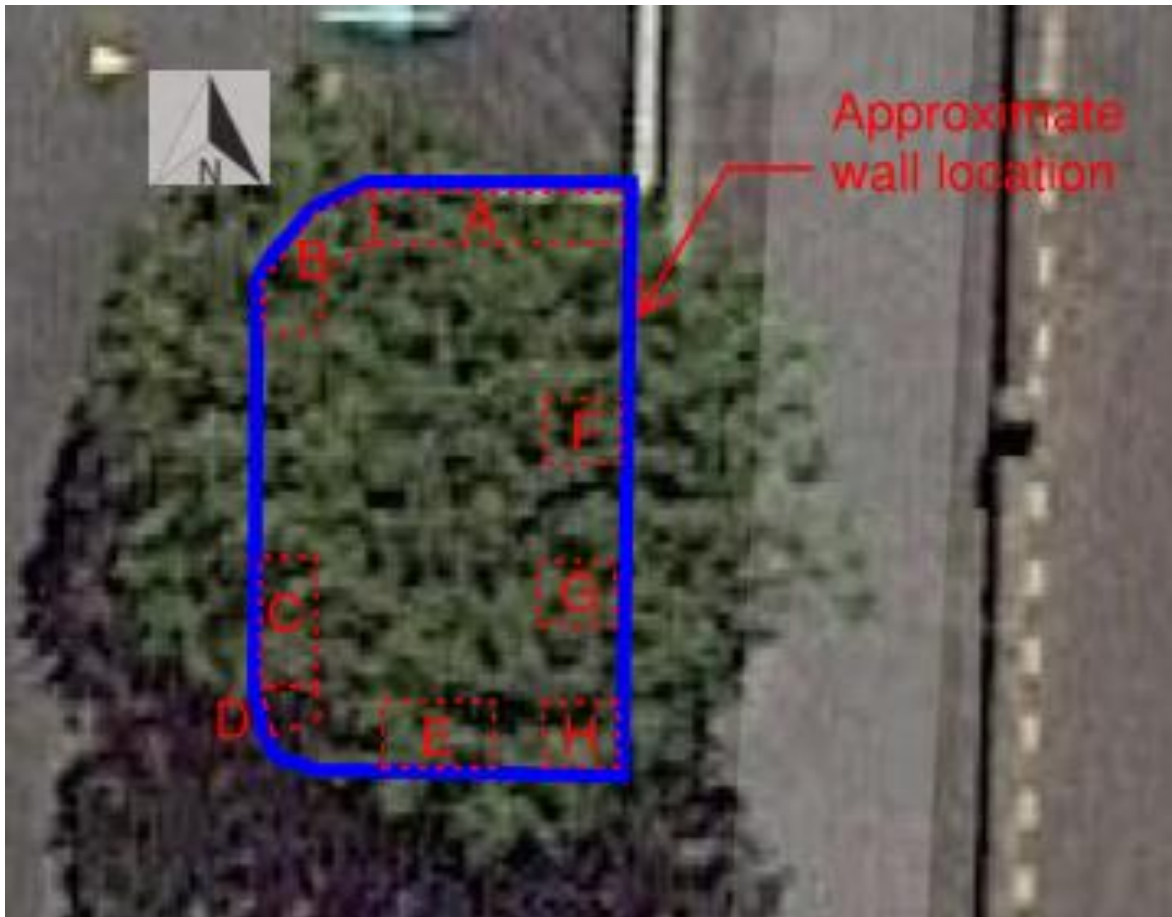
Excavation Location	Root Depth	Notes
A	500mm	Hard compacted material
B	1.4m	Roots consistently found to 1.2m
C	1.2m	Roots consistently found. One root 50mm diameter growing under wall
D	600mm	Roots consistently found. Bricks and broken pottery found. Stopped excavation.
E	1.4m	80 roots at 2-2.5mm in 1m section. Clay at 1.4 to 1.5m
F	600mm	Dense clusters of roots in top 500mm, Watermain and power at 1.6m
G	1.6m	Extensive roots. One 50mm root. Roots down to 1.5m from 1mm to 30mm. Clay changed at 1.5m.
H	600mm	Mass of roots.
