# Arboricultural Completion Memorandum

Job No. 35419

**Date:** August 2022

**Re:** Preparatory root pruning for proposed tree relocation completion memo

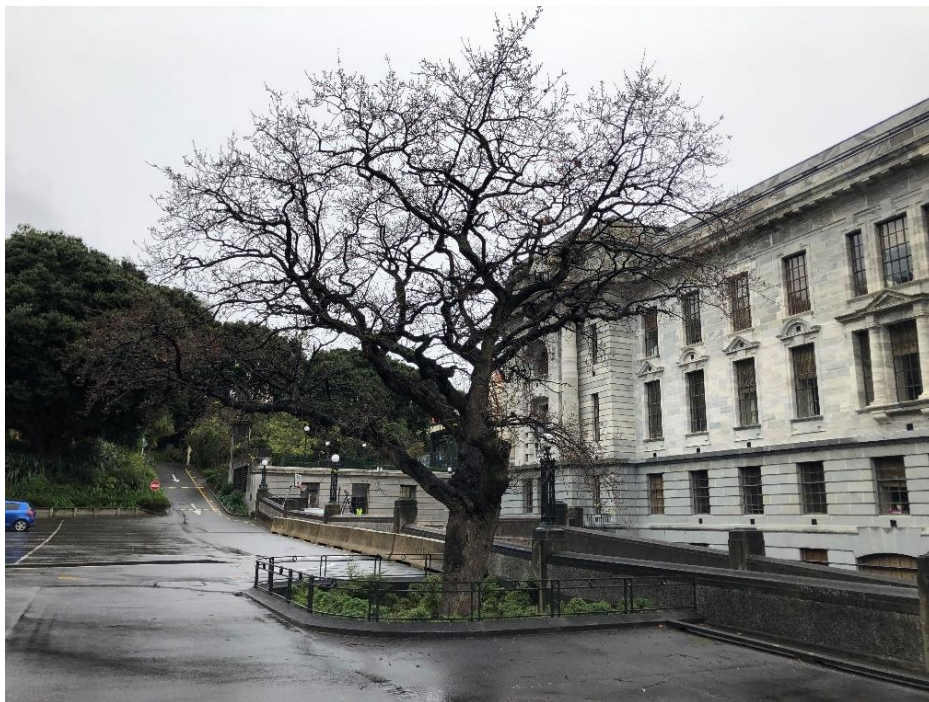
**Photograph 2: Museum Street Oak Tree in June 2021.**

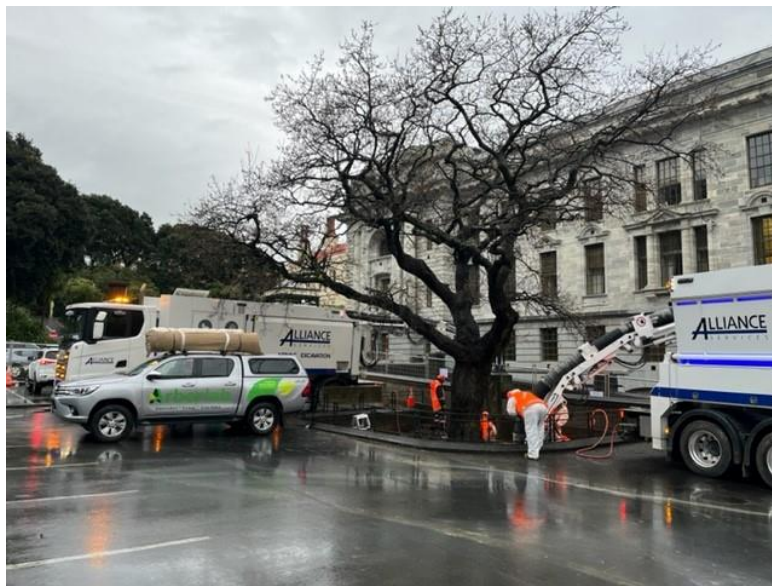
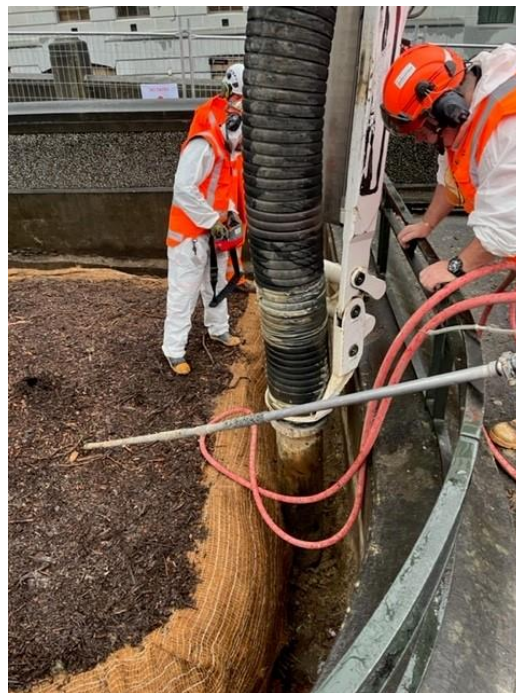
- 9.4 The preparatory work and minor root pruning was carried out at the edge of the tree's root zone i.e., just inside the planter bed and at the edge of any proposed relocation root ball.
- 9.5 Air specialist air vacuum machine was used to expose the roots. The trench was approximately 1.2m deep and 500mm wide. To minimise the root loss, the exposed roots were pruned at the outer edge of the trench and where practicable folded back against the root ball before it was wrapped.
- 9.6 The following photographs 3 and 4 show the excavation work in progress.

**Photographs 3 and 4. The excavation work in progress.**

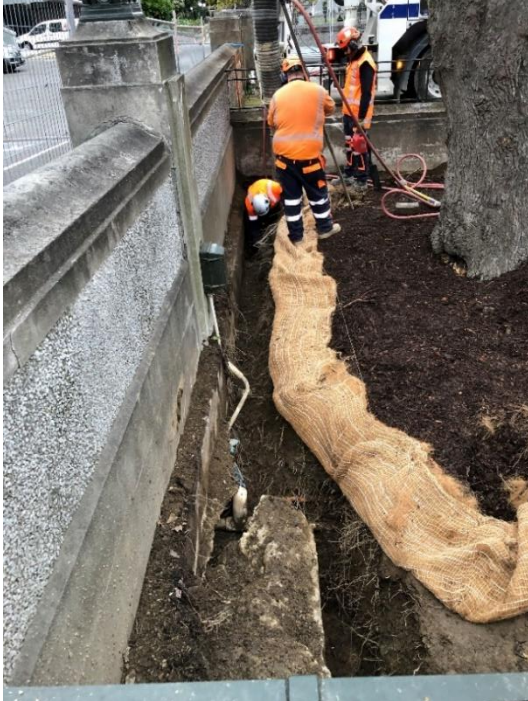
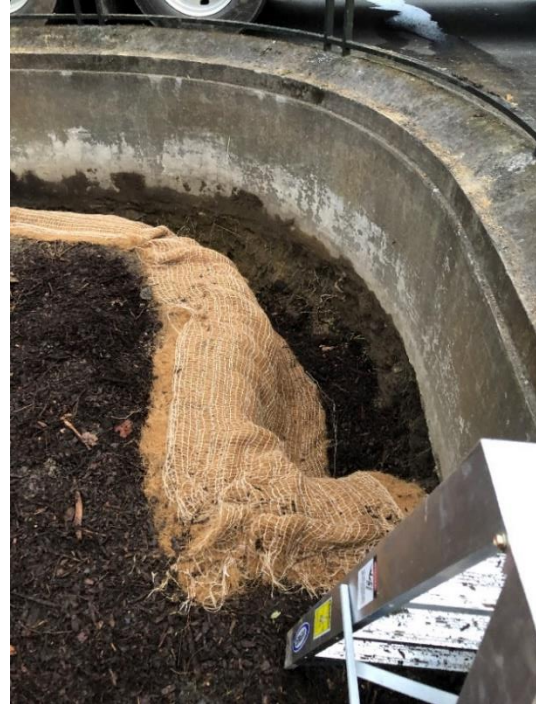
9.7 All excavations were carried out in such a way as to minimise any root loss within the proposed root ball area. As the excavations progressed the roots were covered with coconut matting to prevent desiccation and damage. The following photographs 1 to 4, show the exposed trench and roots at the edge of the root ball.

**Photographs 1 and 2. Exposed roots protected during air excavation**

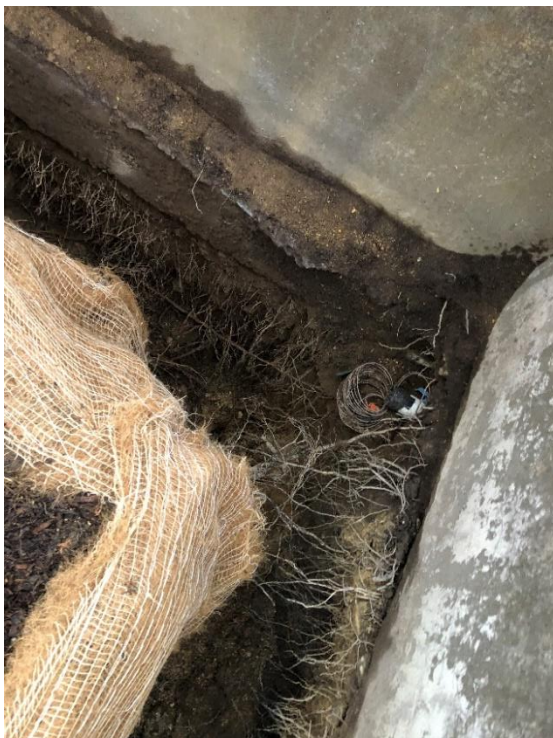
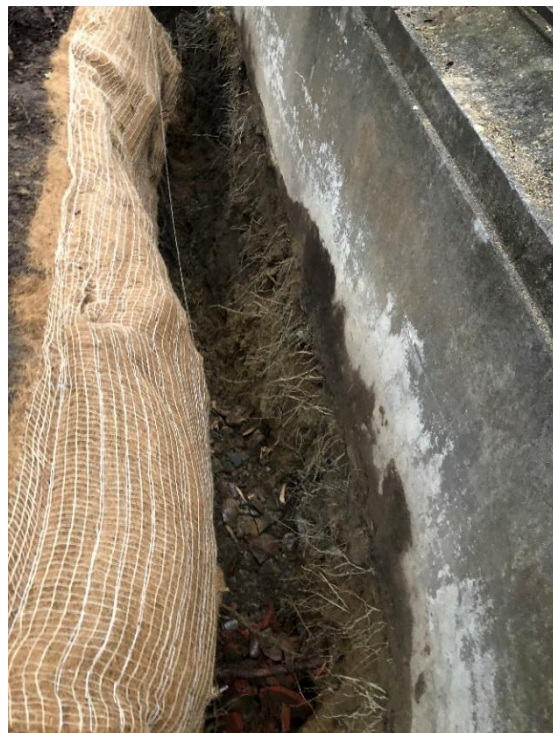
**Photographs 3 and 4. Roots covered with coconut matting at the end of day 1.**

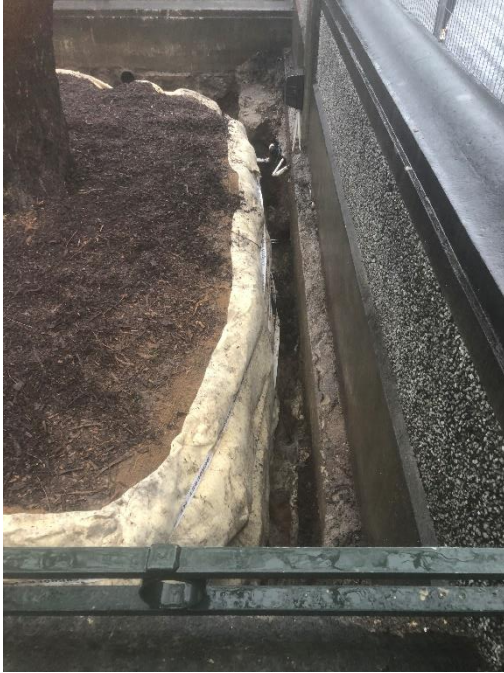
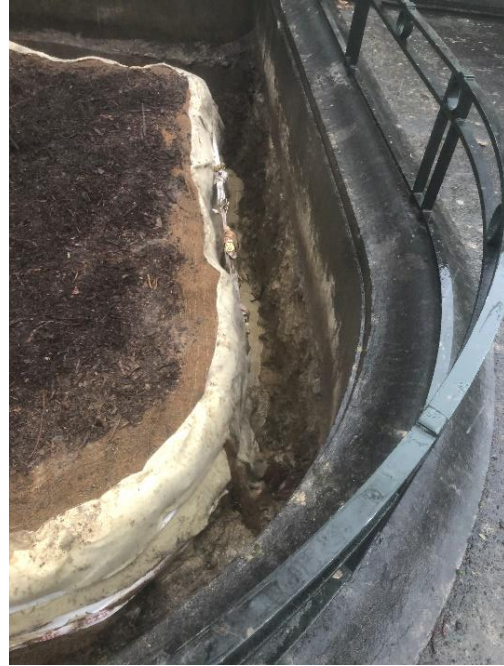
- 9.8 After the excavation work was completed and minor root pruning has been carried out the exposed roots were protected and partly prepared for the proposed relocation. To further minimise any soil loss and drying of the root ball was wrapped in a protective cloth (Hessian or Wool mulch). This was pinned back into the root ball, to hold it in place. The following photographs 5 to 8 show the root ball wrapped in coconut matting and wool mulch.

**Photographs 5 and 6. Eastern and Northern sides of wrapped root ball respectively.**

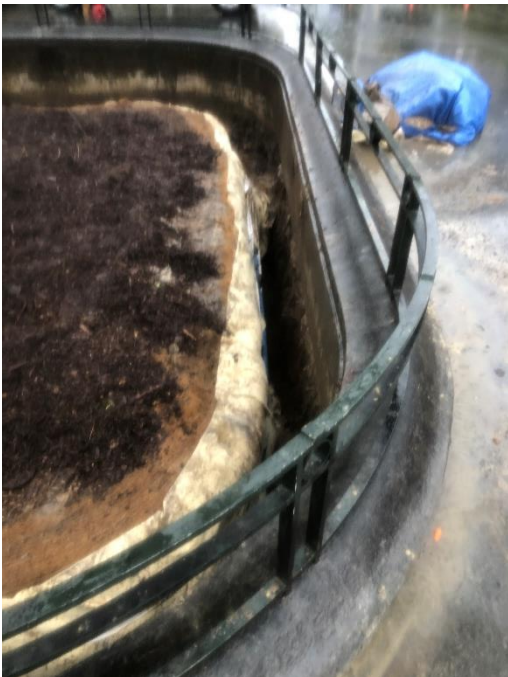
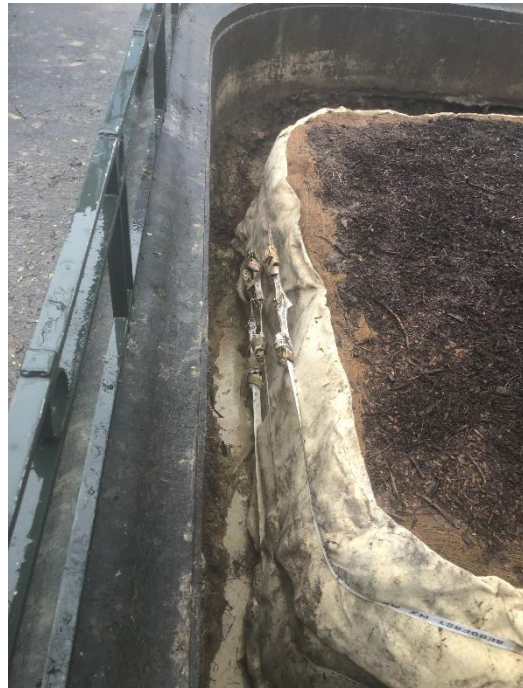
**Photographs 7 and 8. Western and Southern sides of wrapped root ball respectively.**

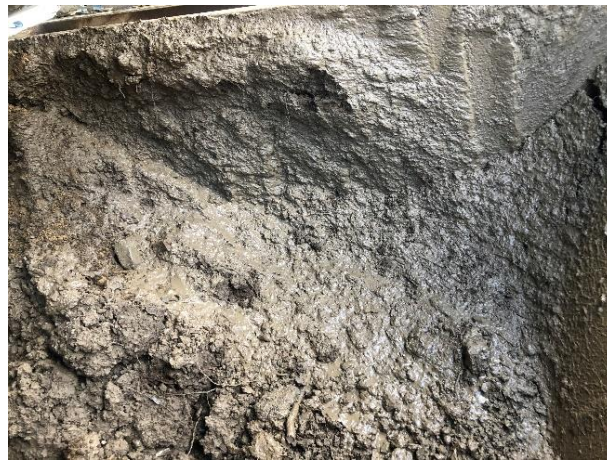
9.10 Once the excavations were complete and the root ball wrapped the hole was back filled with the excavated soil, except for a section along the southern and eastern sides which were backfilled with topsoil and excavated material. Topsoil was used here as the excavated material had become so wet it had turned to a slurry and was therefore not suitable for root growth, The following photograph 9 shows the slurry that was not used to back fill the holes.

**Photograph 9. Slurry not suitable for root growth.**

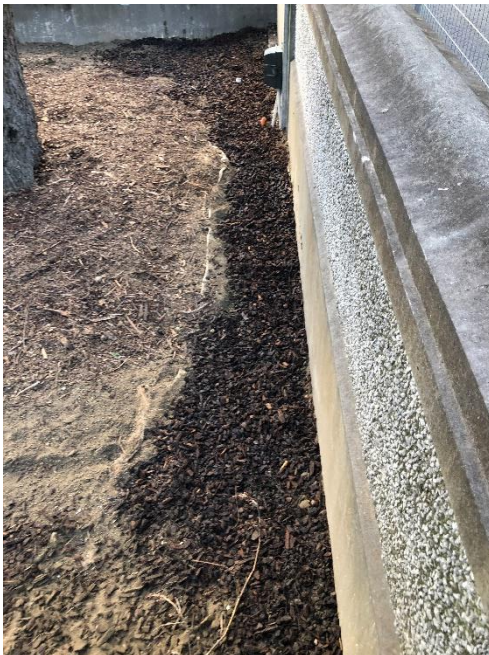
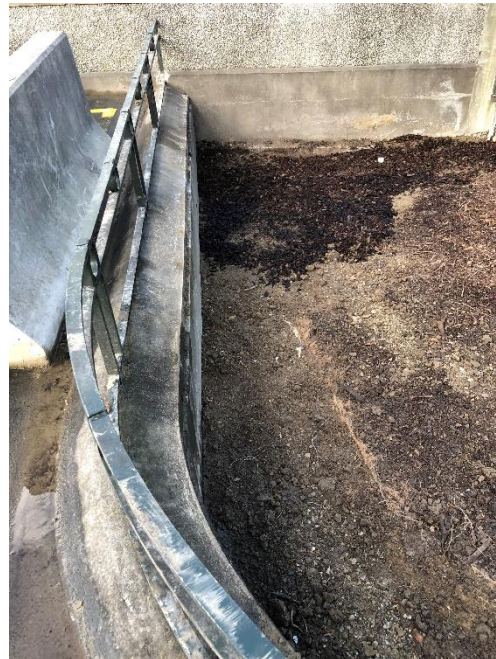
**Photographs 10 and 11. Back filled excavations on the Eastern and Northern sides respectively.**

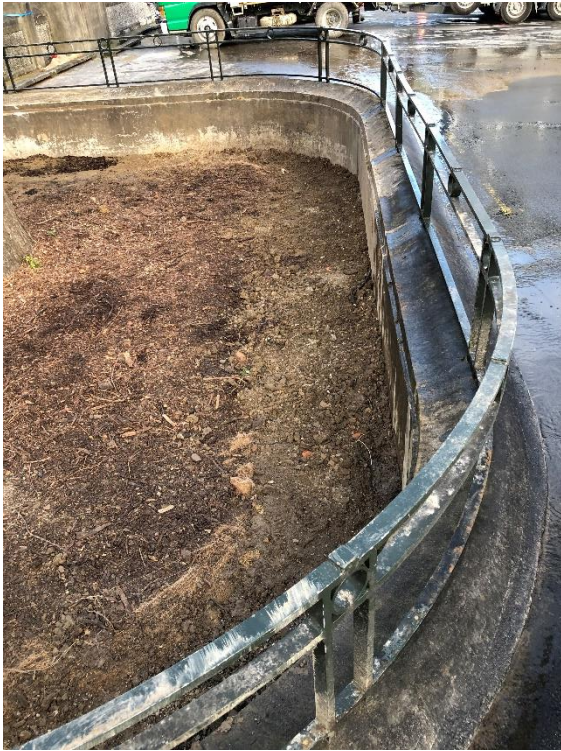
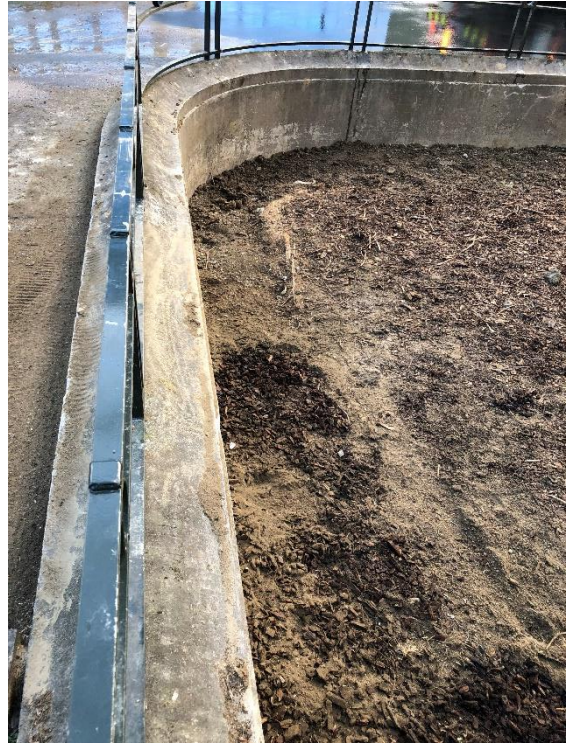
**Photographs 12 and 13. Back filled excavations on the Western and Southern sides respectively.**

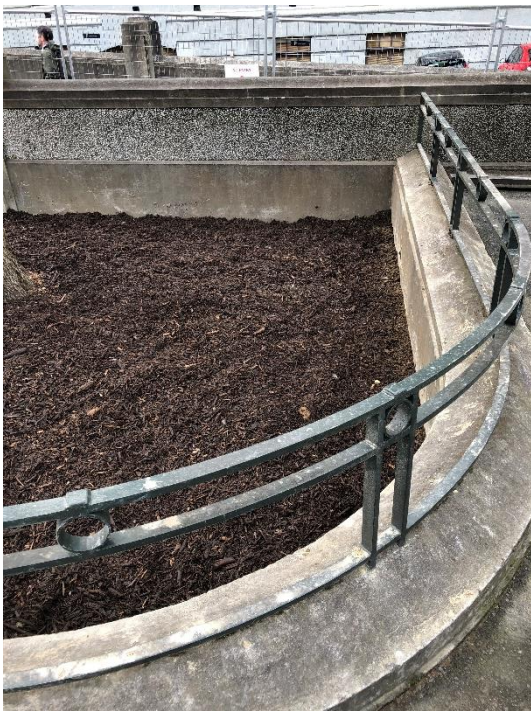
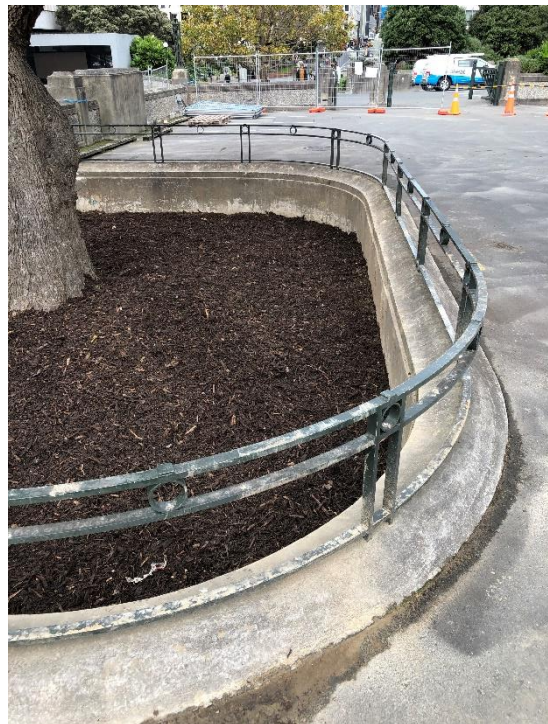
9.12 Finally, the entire root ball was mulched with aged weed free mulch to suppress any weed growth, keep the soil moist and provide nutrients to encourage further root development. The following photographs 14 and 15 show the mulch in place.

**Photographs 14 and 15. The mulch in place.**
