Defining the Wellington Fault within the Urban area of Wellington City

Client Report
2002/151

March
2003

**Institute of Geological & Nuclear Sciences client report 2002/151
Project Number: 430W0510**

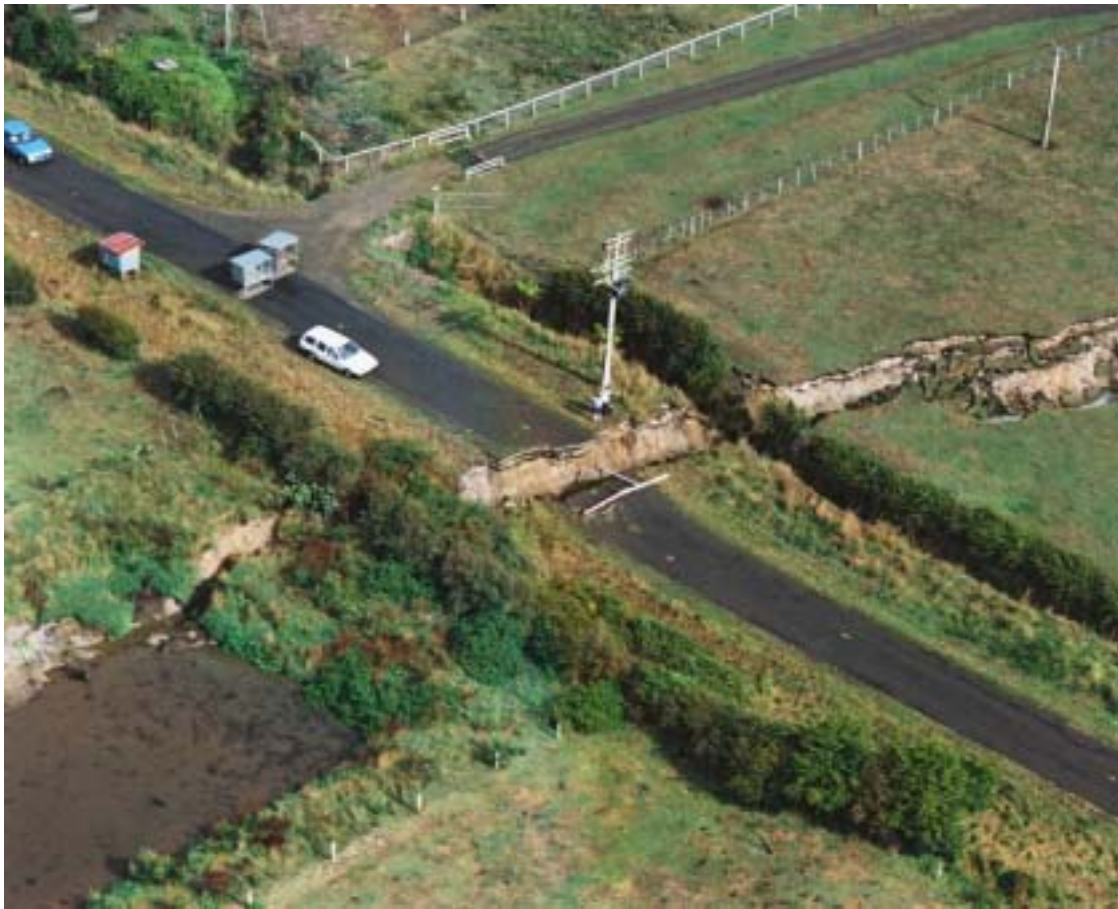
Figure 3 The 1987 fault rupture of the Edgcumbe fault at McCracken Road (Photo: D.L. Homer, GNS GNS10115-37).

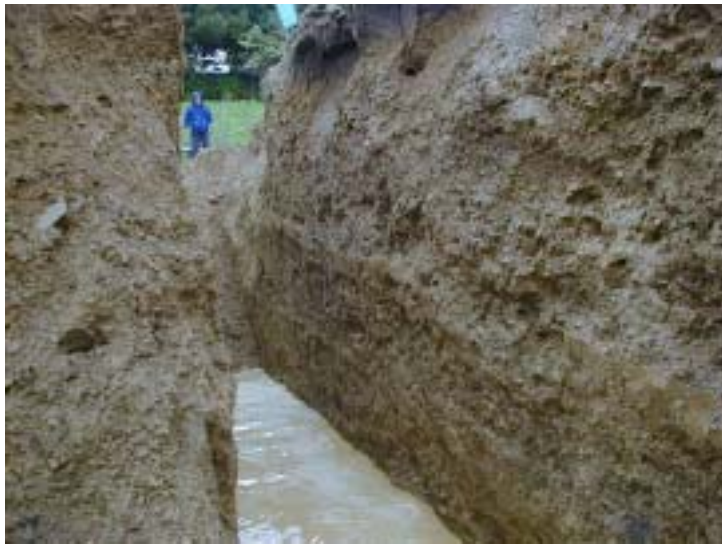
The fault has been observed from both a Ground Penetrating Radar survey and a fault investigation trench that was excavated some 6 metres deep at the former Thorndon Bowling Club site, Goring Street (locations 19-23). The trench (excavated in 2001 by Ian R Brown Associates Ltd) showed, at location 20, faulted fan gravels overlain by unfaulted gravels (Figure 5 - Figure 7). The zone of inferred faults appeared to be not more than about 4 m wide.

Figure 5 Fault investigation trench at former Thorndon Bowling Club site Goring Street. Photos: N.D. Perrin, 19 July 2001, courtesy of Ian R Brown Associates Ltd.

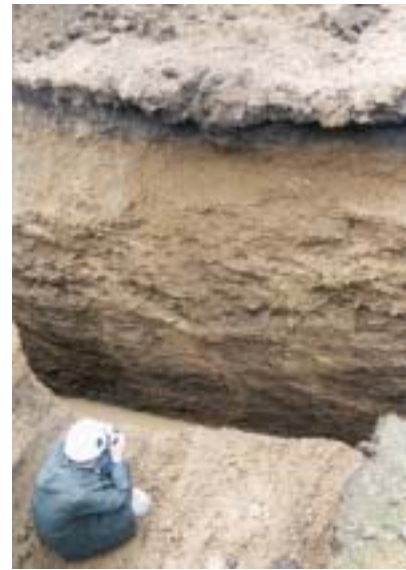
Figure 6 Fault location in trench. Photos: N.D. Perrin, 19 July 2001, courtesy of Ian R Brown Associates Ltd.

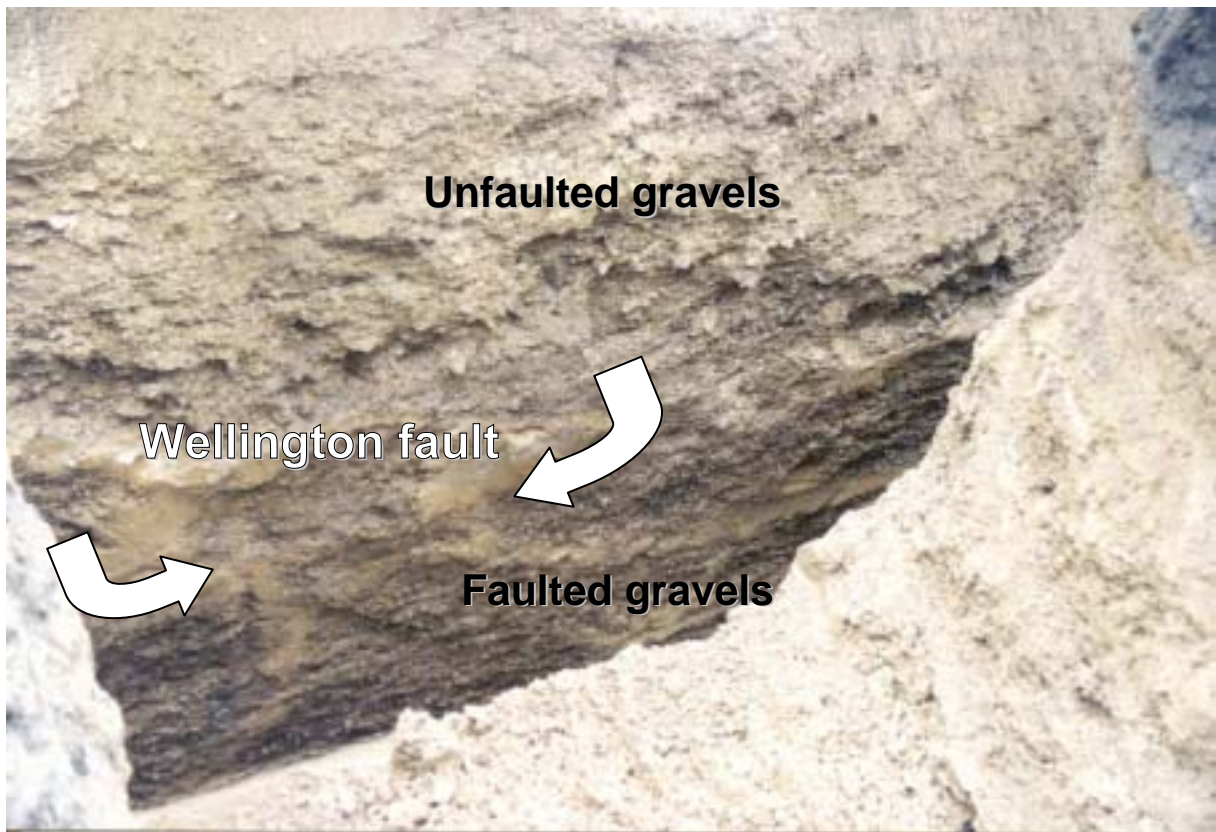
Figure 7 Inferred fault location indicated by disruption of a silt layer indicative of predominately horizontal fault rupture. There is a single, gently dipping layer to the left (west) of the photo (seen in Fig 5). It is contorted and disrupted where the “Wellington fault” is indicated. The upper gravel appears unfaulted and post-dates the last fault rupture event. Photos: N.D. Perrin, 19 July 2001, courtesy of Ian R Brown Associates Ltd.

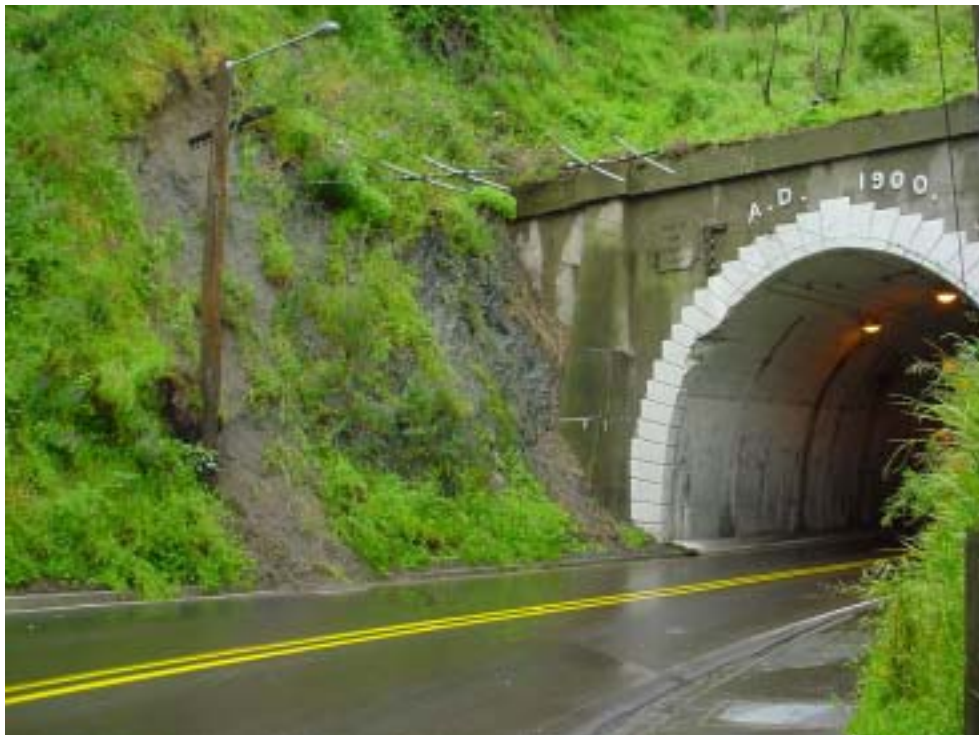
At the east portal of the Karori Tunnel (Figure 8) an exposure of rock (location 66), a crush zone (location 67), and a record by Ota *et al.* (1981) of a fault trace with gouge (at location 443), all constrain the fault location within 20 m.

Figure 8 Crushed rock of the Wellington fault is exposed, at power pole, at the eastern portal of Karori tunnel (Photo: N.D. Perrin, Dec 2001).
