Asbestos in Soils – Sampling Report

Shelly Bay - South
On behalf, of

Wellington City Council

Reference: WS-00112

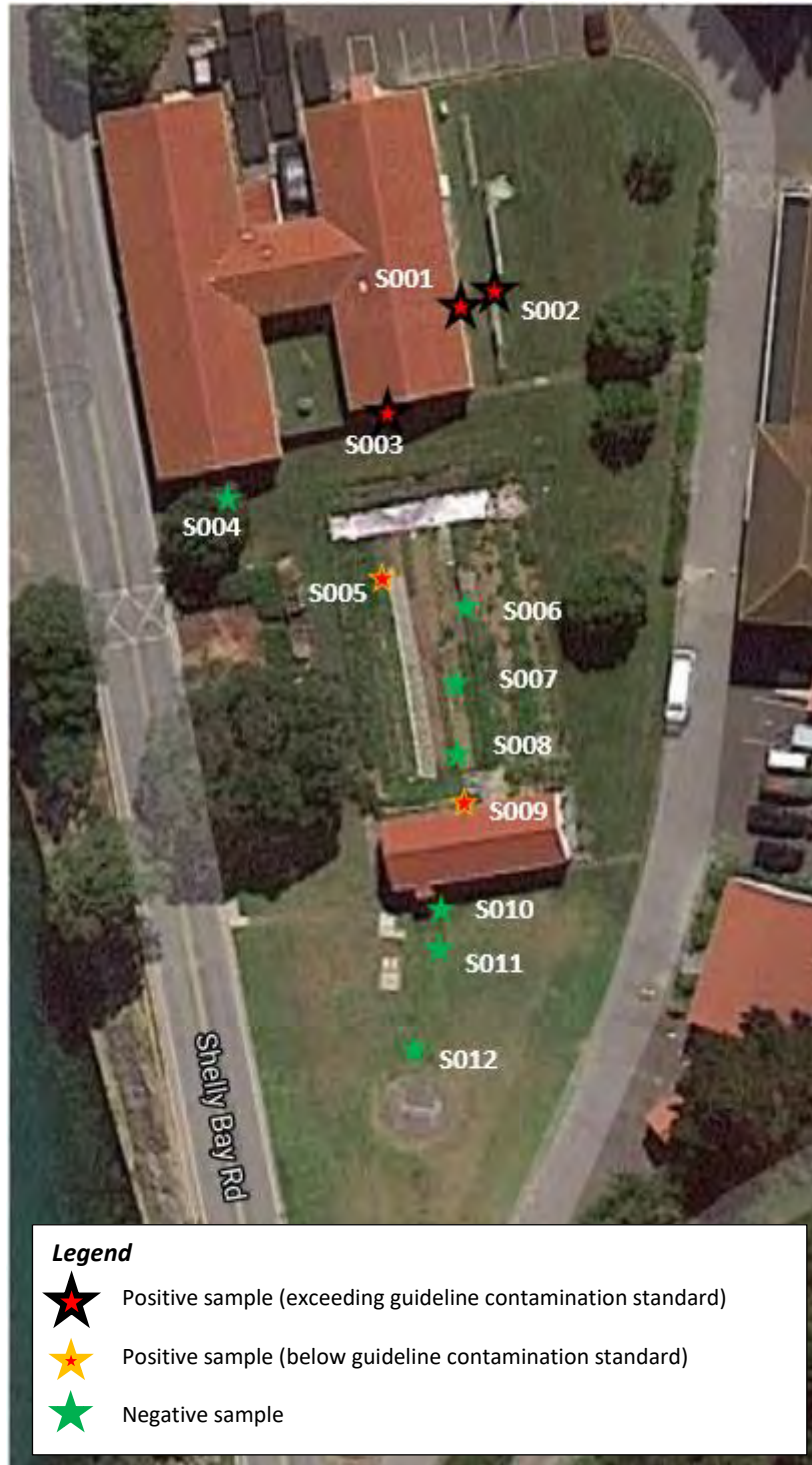
Fig 1. Sample locations

Sampling locations were selected in consultation with the client, with the aim being to assess risk to site occupants based on current site activity. Twelve surface soil samples (0-100mm depth) of 500ml were obtained in at each sampling location using a clean trowel. Samples were analysed in accordance with the New Zealand Guidelines for Assessing and Managing Asbestos in Soil (BRANZ, 2017).

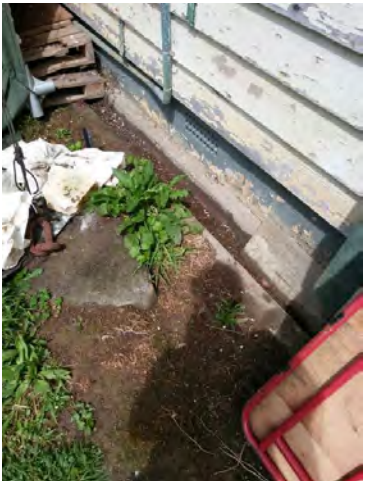
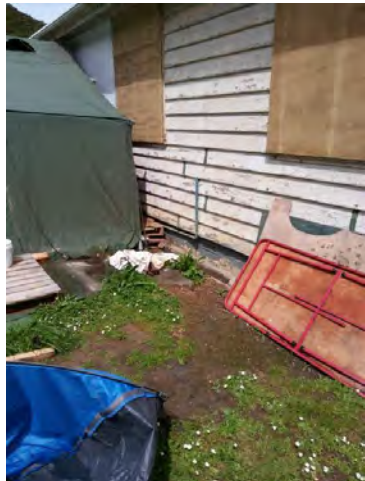
Location	Shelly Bay Complex, External, 001, H Block East Drip Line		Sample Number	1 (S)

All three of these samples were taken in the vicinity of the H block building. The positive results for asbestos are likely the result of the ineffective drainage systems of the building, with rain water run-off from the deteriorating asbestos cement roof discharging directly to blocked ground level perimeter gutters and the surrounding ground. The sample showing the highest asbestos content (sample S003) was taken from the floor level gutter itself, where soil and organic matter has accumulated.

Item / Position	Soil – H building east wall drip line	
		Asbestos Type	Chrysotile (Loose fibres)	
		ACM (% w/w)	< 0.001	
		FA + AF (% w/w)	0.002	
		FA (% w/w)	< 0.001	
		AF (% w/w)	0.002	
		Comments:

The results and site observations indicate that run-off from the asbestos cement roof of the H building is likely to be the primary cause of asbestos contamination of site soil. No assessment has been made of site surface drainage patterns, and although surface soil samples taken from the wider site have returned either negative or low-level results for asbestos, a precautionary approach should be taken with access restricted to the immediate perimeter of the H building at a distance of at least two meters, and to all surrounding areas that may be affected by surface run-off from the H building during rain.

Access should remain restricted until remediation can be undertaken to address the contaminated soil and deteriorating building systems.

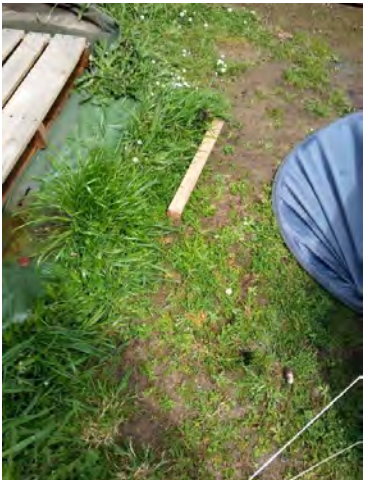
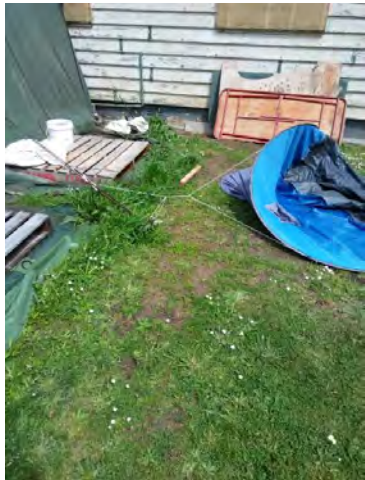
Location	Shelly Bay Complex, External, 002, H Block East Drip Line +2m		Sample Number	2 (S)

Item / Position	Soil – 2m step out from drip line	
		Asbestos Type	Chrysotile (Loose fibres)	
		ACM (% w/w)	< 0.001	
		FA + AF (% w/w)	0.002	
		FA (% w/w)	< 0.001	
		AF (% w/w)	0.002	
		Comments:

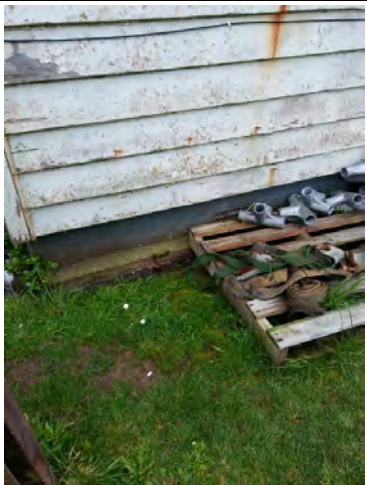
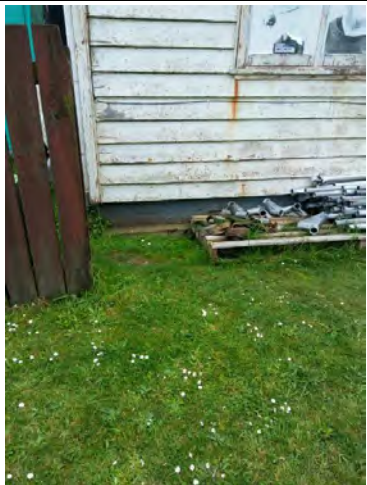
Location	Shelly Bay Complex, External, 002, H Block Drip Line South Gutter		Sample Number	3 (S)

Item / Position	Soil – H building drip line South Gutter	
		Asbestos Type	Chrysotile (ACM Debris & Loose fibres)	
		ACM (% w/w)	< 0.001	
		FA + AF (% w/w)	0.004	
		FA (% w/w)	< 0.001	
		AF (% w/w)	0.004	
		Comments:

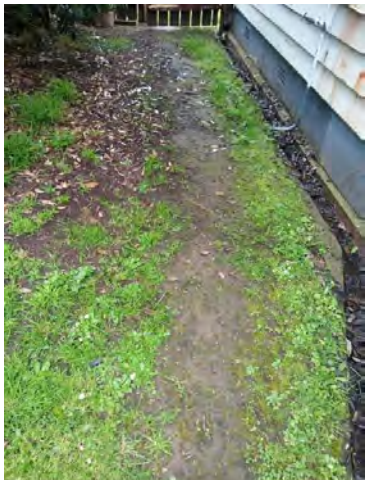
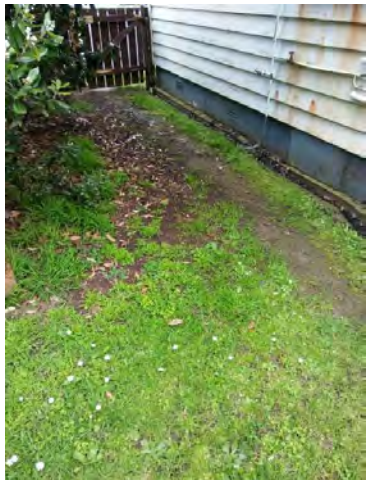
Location	Shelly Bay Complex, External, 002, H Block South Path		Sample Number	4 (S)

Item / Position	Soil - H Block South Path	
		Asbestos Type	No Asbestos Detected	
		ACM (% w/w)	< 0.001	
		FA + AF (% w/w)	< 0.001	
		FA (% w/w)	< 0.001	
		AF (% w/w)	< 0.001	
		Comments:

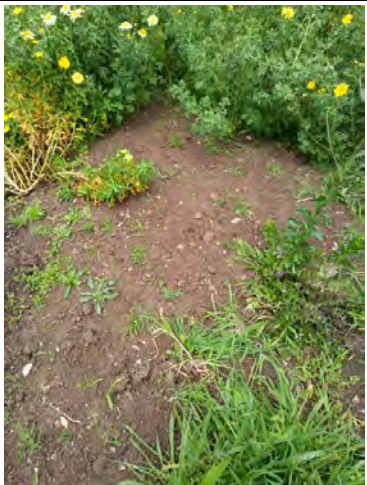
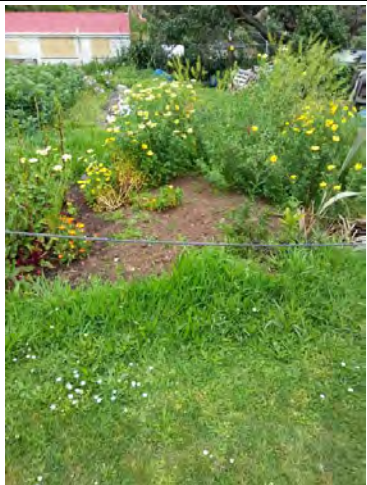
Location	Shelly Bay Complex, External, 005, Central Garden North		Sample Number	5 (S)

Of the remaining two positive samples, one was taken several meters south of the H block building in a garden area being used for the growth of produce. Although other sources cannot be ruled out, this positive result may also be due to ground run-off patterns from the H-block building. However, three negative samples also taken in the garden area provide good evidence that contamination in this area is unlikely to be widespread.

Item / Position	Soil – Central Garden North	
		Asbestos Type	Chrysotile (Loose fibres)	
		ACM (% w/w)	< 0.001	
		FA + AF (% w/w)	< 0.001	
		FA (% w/w)	< 0.001	
		AF (% w/w)	< 0.001	
		Comments:

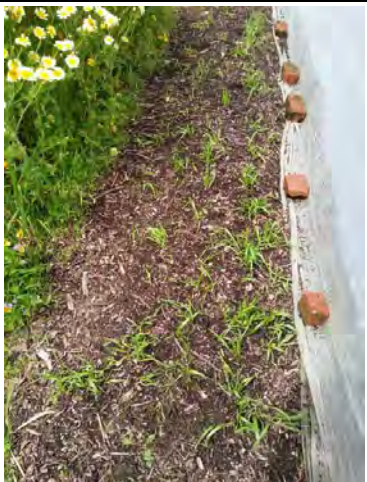
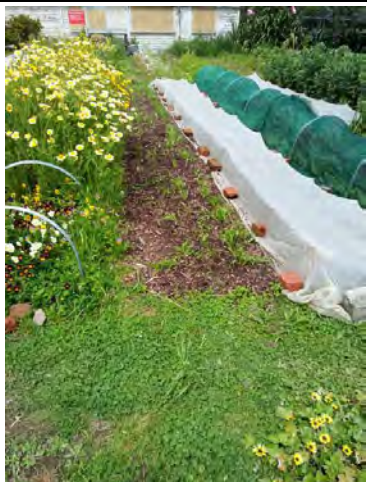
Location	Shelly Bay Complex, External, 005, Central Garden		Sample Number	6 (S)

vvvvvvvvvv	Soil – Central Garden	
		Asbestos Type	No Asbestos Detected	
		ACM (% w/w)	< 0.001	
		FA + AF (% w/w)	< 0.001	
		FA (% w/w)	< 0.001	
		AF (% w/w)	< 0.001	
		Comments:

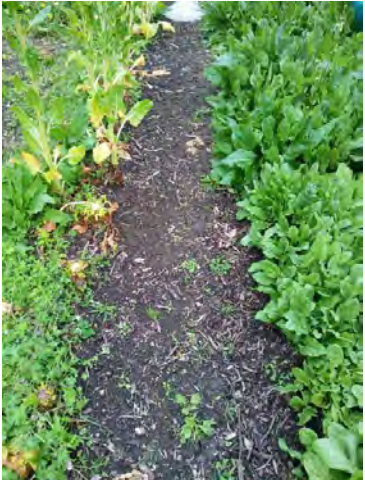
Location	Shelly Bay Complex, External, 005, Central Garden		Sample Number	7 (S)

vvvvvv	Soil – Central Garden	
		Asbestos Type	No Asbestos Detected	
		ACM (% w/w)	< 0.001	
		FA + AF (% w/w)	< 0.001	
		FA (% w/w)	< 0.001	
		AF (% w/w)	< 0.001	
		Comments:

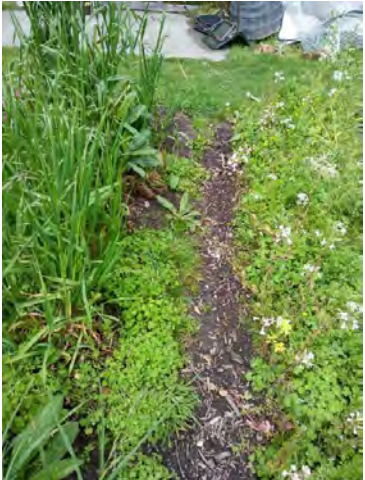
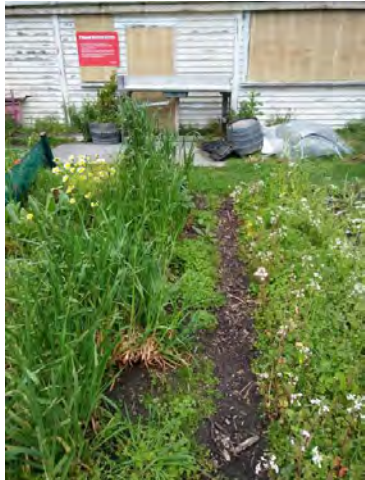
Location	Shelly Bay Complex, External, 005, Central Garden South		Sample Number	8 (S)

Item / Position	Soil – Central Garden South	
		Asbestos Type	No Asbestos Detected	
		ACM (% w/w)	< 0.001	
		FA + AF (% w/w)	< 0.001	
		FA (% w/w)	< 0.001	
		AF (% w/w)	< 0.001	
		Comments:

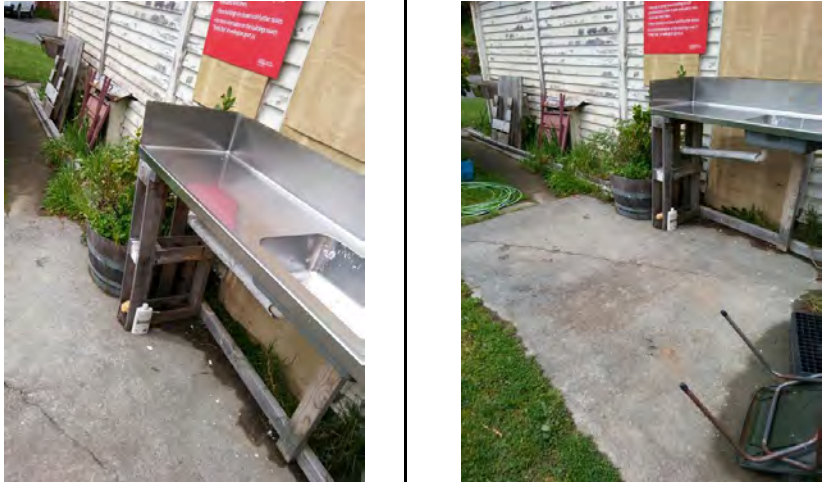
Location	Shelly Bay Complex, External, 005, Laundry North	Sample Number	9 (S)

The final remaining positive sample was taken at the northern perimeter of the southern 'laundry' building, with the low-level detection of asbestos likely associated with products present in this building, and unrelated to the other positive results seen to the north.

Item / Position	Soil – Laundry North
		Asbestos Type	Chrysotile (Loose fibres)
		ACM (% w/w)	< 0.001
		FA + AF (% w/w)	< 0.001
		FA (% w/w)	< 0.001
		AF (% w/w)	< 0.001
		Comments:	Composite of soil along drip line

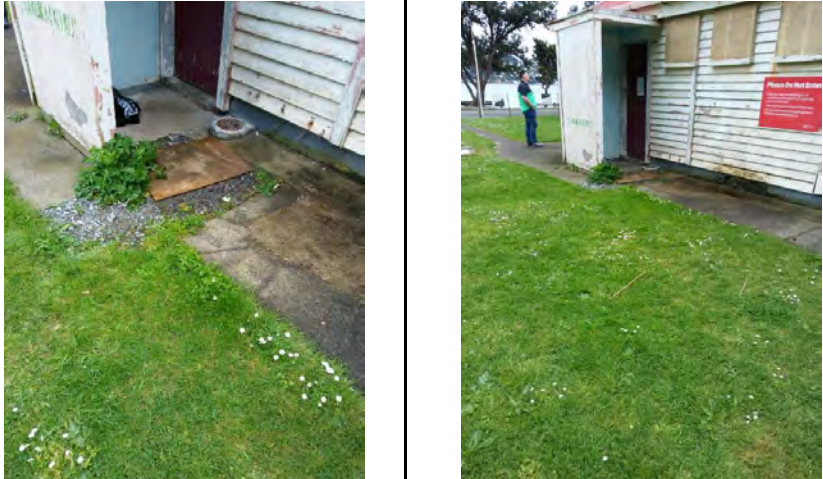
Location	Shelly Bay Complex, External, 006, Laundry South	Sample Number	10 (S)

Item / Position	Soil – Laundry South
		Asbestos Type	No Asbestos Detected
		ACM (% w/w)	< 0.001
		FA + AF (% w/w)	< 0.001
		FA (% w/w)	< 0.001
		AF (% w/w)	< 0.001
		Comments:

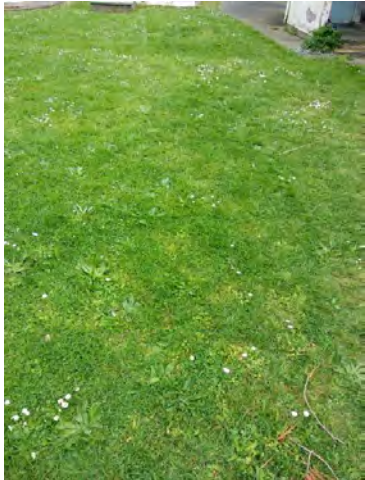
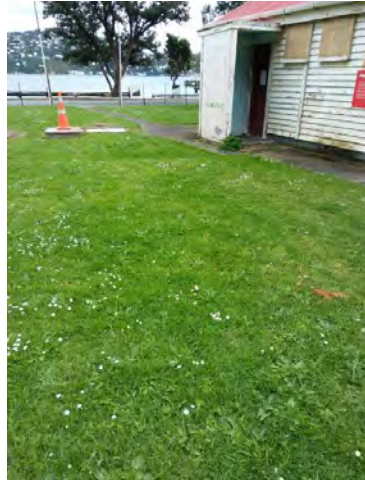
Location		Shelly Bay Complex, External, 006, Laundry South		Sample Number	11 (S)

Item / Position	Soil – Laundry South		
		Asbestos Type	No Asbestos Detected		
		ACM (% w/w)	< 0.001		
		FA + AF (% w/w)	< 0.001		
		FA (% w/w)	< 0.001		
		AF (% w/w)	< 0.001		
		Comments:	Stepped back 3m

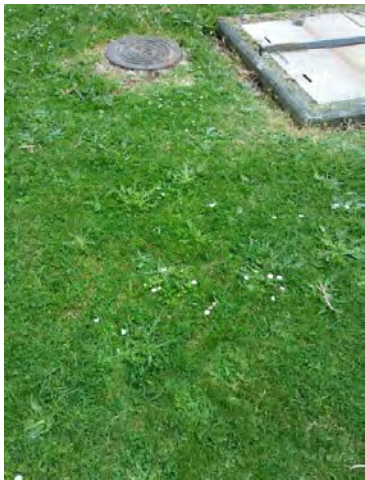
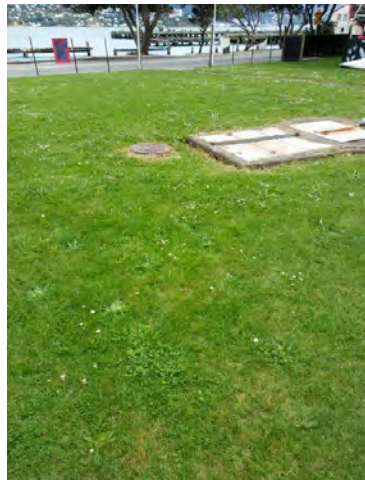
Location		Shelly Bay Complex, External, 006, Laundry South		Sample Number	12 (S)

Item / Position	Soil – Laundry South		
		Asbestos Type	No Asbestos Detected		
		ACM (% w/w)	< 0.001		
		FA + AF (% w/w)	< 0.001		
		FA (% w/w)	< 0.001		
		AF (% w/w)	< 0.001		
		Comments:
