# Seismic Capacity and Strengthening Review

TRAMWAY HOTEL

114 ADELAIDE ROAD, WELLINGTON

IPG CORPORATION LIMITED

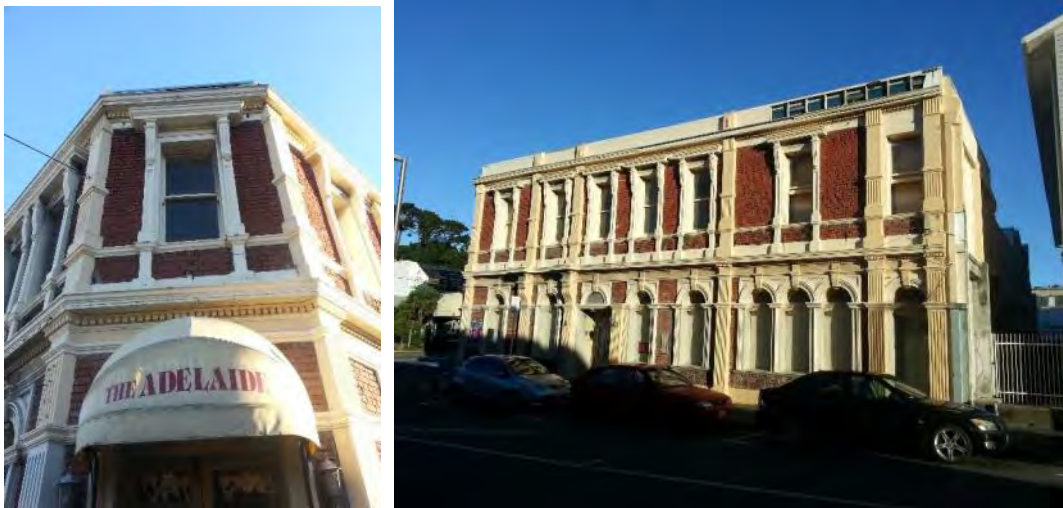
The original part of the existing URM Building at 114 Adelaide Road was constructed in 1899. There have been some additions made mainly on the south side of the original structure and some alterations made to the existing structure to allow connectivity to these additions. The additions to the existing structure have not been considered in this report.

The structure of the existing original building is as follows:

- Roof- corrugated steel on timber framing,
- First floor- timber framed support of URM and timber framed walls below,
- Ground floor- timber framed supported off timber piles and URM walls,
- Walls and parapets- URM.
- Foundations- concrete strips under URM walls and timber piles.

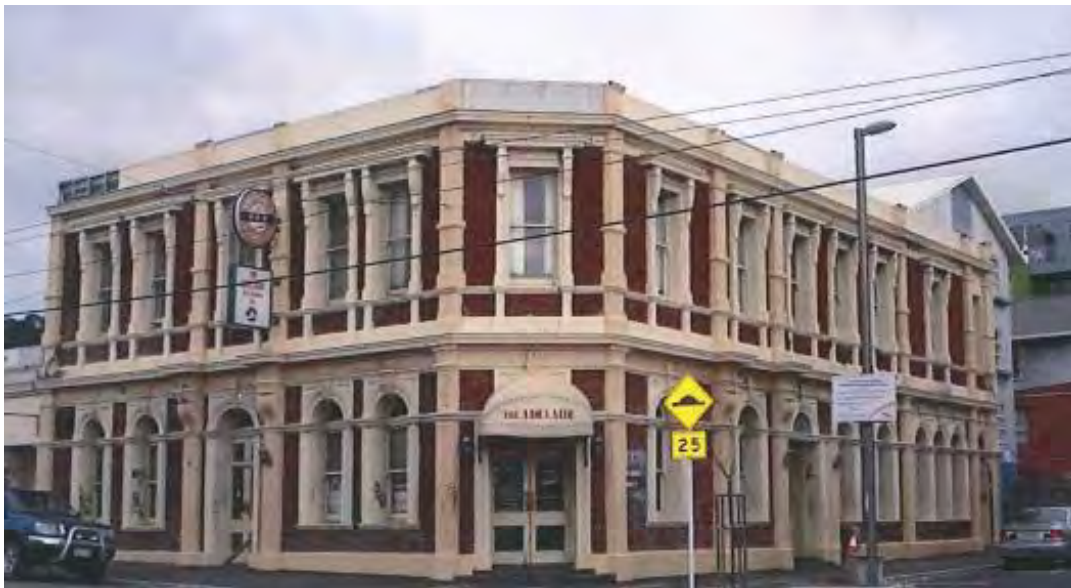
In 2018 façade securing works were carried out that involved tying the URM parapet facades at roof level back to the timber frame roof structure.

The works meet the legal URM parapet and façade securing requirements but did not address the seismic capacity of the primary structure. The strengthening also did not address the out-of-plane capacity of URM walls on connection of URM walls at first floor and ground levels.

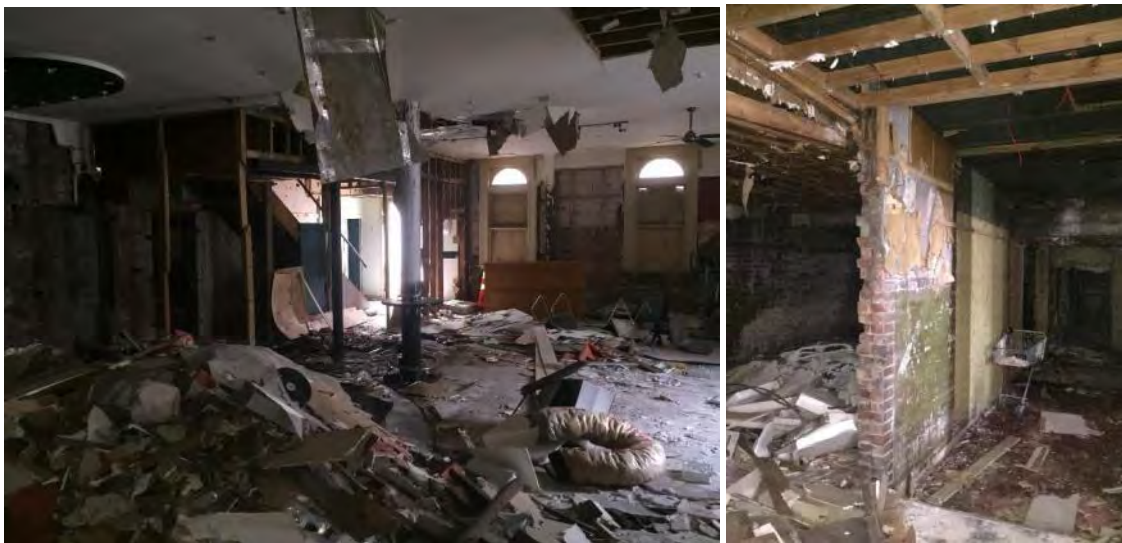
The existing building has not had any remedial work carried out to address these conditions. The main deterioration issue is timber decay. Decay of timber members will have worsened since 2017. This will reduce the seismic capacity of the building.

To remedy the timber decay issue, affected members would need to be removed and replaced including timber piled foundations. This would be a very involved process, propping of the facade would likely be required to allow for the replacement of damaged timber structure in the first floor.

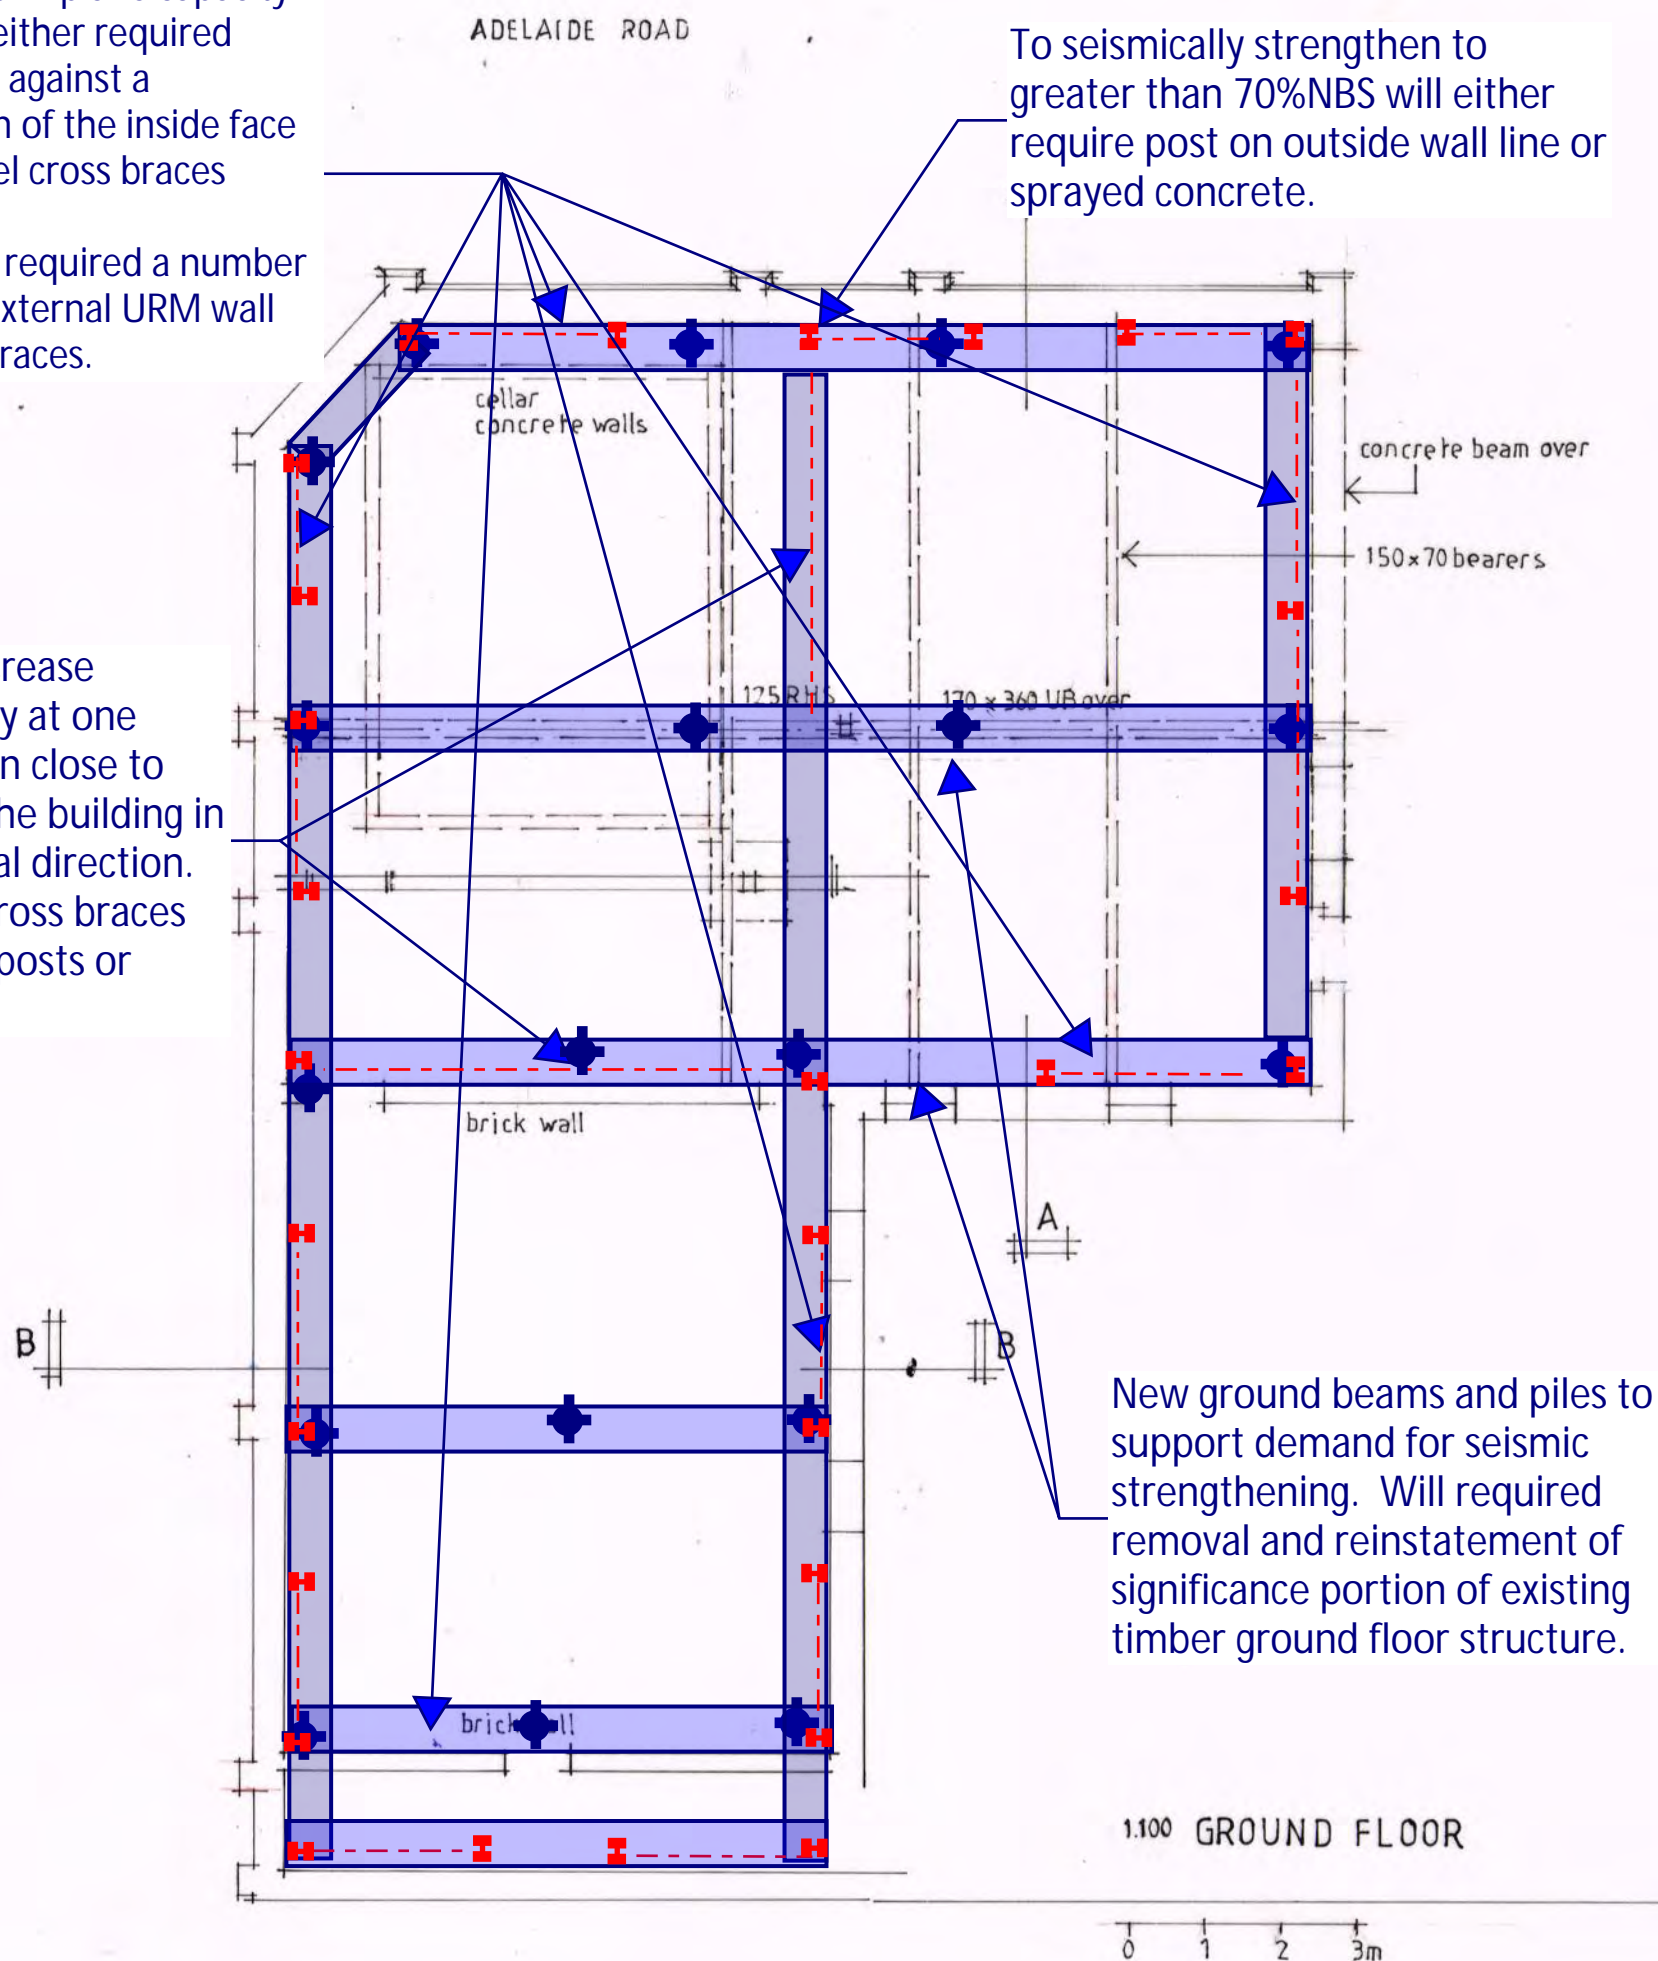
JOB # 21614 DRAWING # 2020-2-5-SK1

To strengthen the in-plane capacity of URM wall will either required sprayed concrete against a significant portion of the inside face of the wall or steel cross braces between post.

If cross bracing is required a number of bays on each external URM wall line will require braces.

Will require increase bracing capacity at one internal location close to the middle of the building in each orthogonal direction. This could be cross braces between steel posts or concrete walls.

To seismically strengthen to greater than 70%NBS will either require post on outside wall line or sprayed concrete.

COMMENTS: PLAN- Ground floor level- marked up to show concept seismic strengthening works.

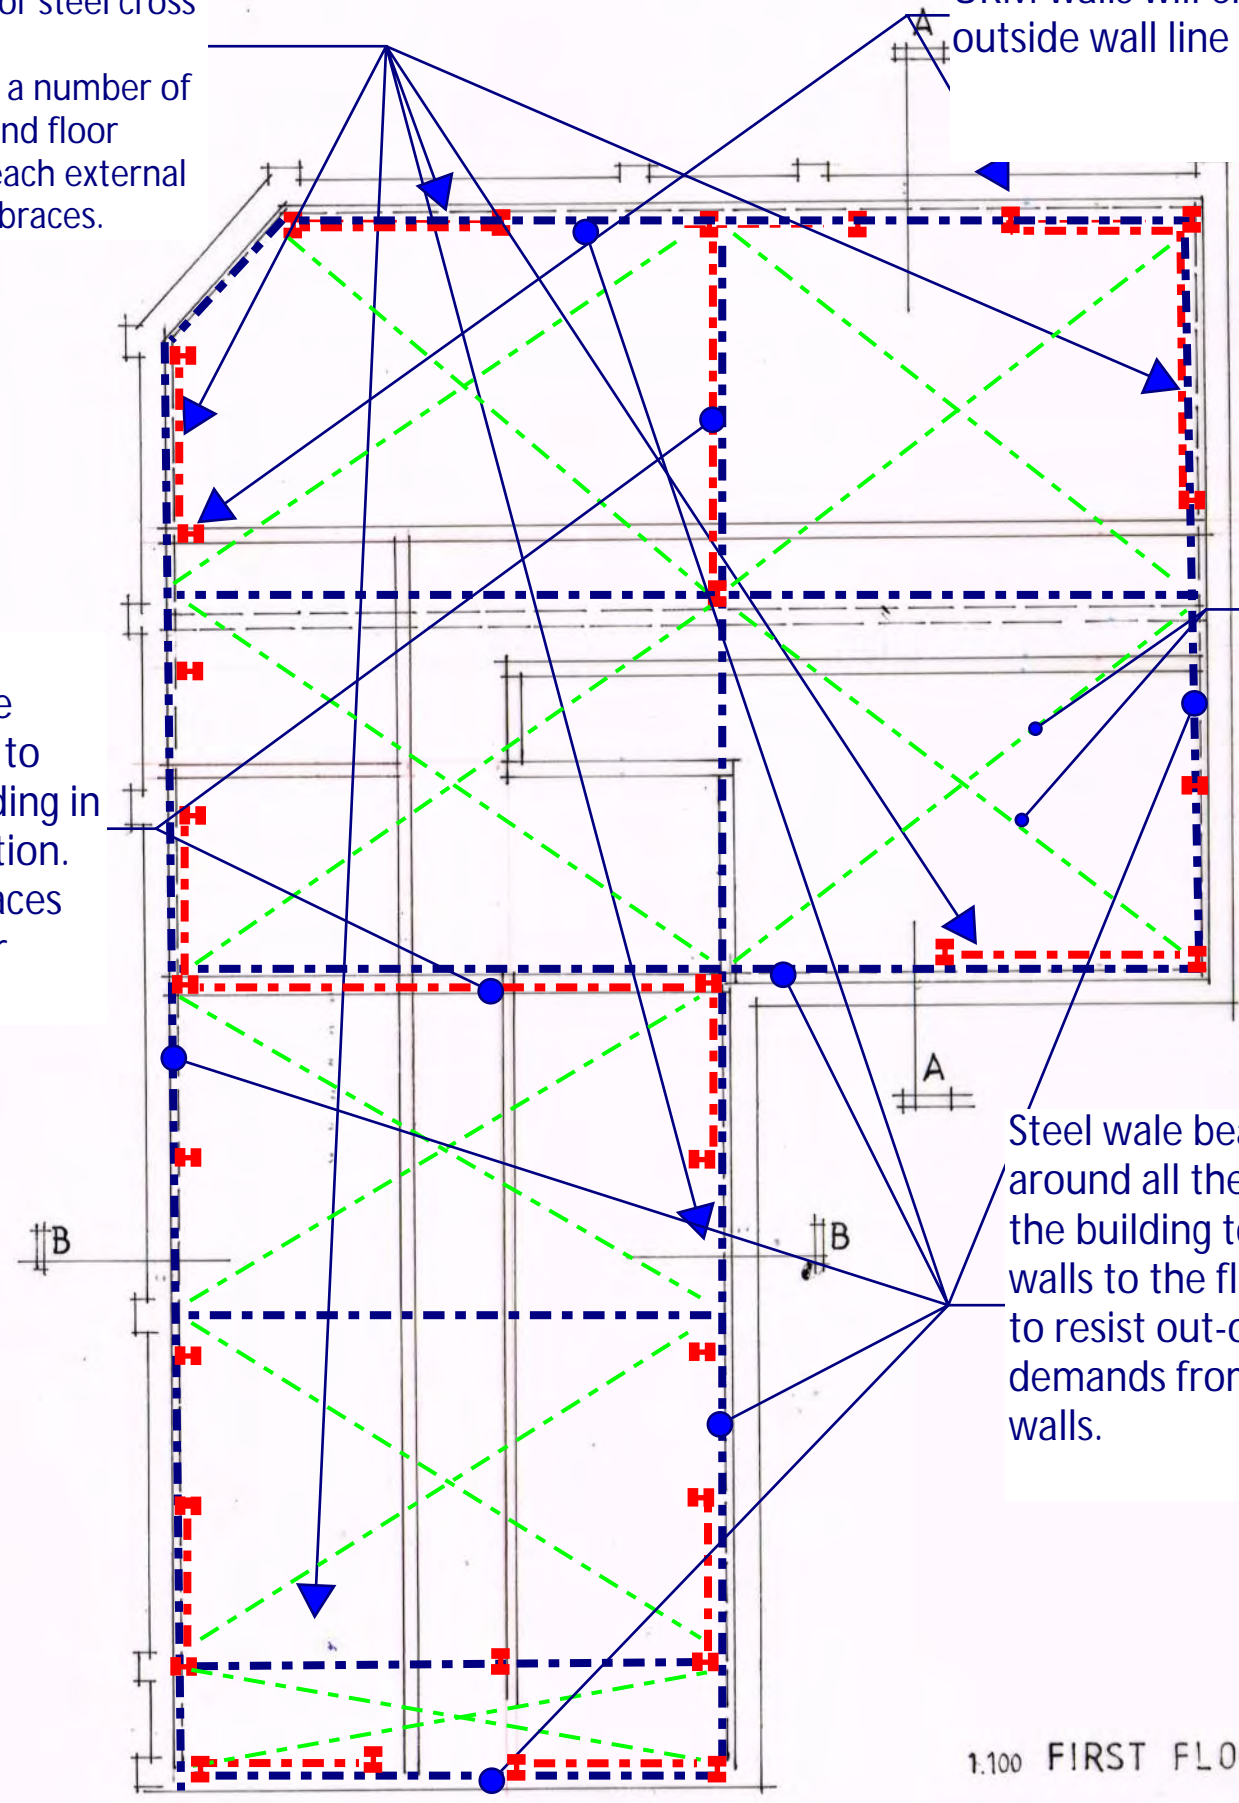
To strengthen the in-plane capacity of URM wall will either required sprayed concrete against a significant portion of the inside face of the wall or steel cross braces between post.  
 If cross bracing is required a number of bays (but less than at ground floor level) will be required on each external URM wall line will require braces.

To seismically strengthen to greater than 70%NBS against out-of-plane demands on URM walls will either require post on outside wall line or sprayed concrete.

Will require increase bracing capacity at one internal location close to the middle of the building in each orthogonal direction. This could be cross braces between steel posts or concrete walls.

Steel cross braces in or under the plane of the floor structure to increase the diaphragm capacity at first floor level.

Steel wale beam required around all the perimeter of the building to tie the URM walls to the floor diaphragm to resist out-of-plane demands from the URM walls.

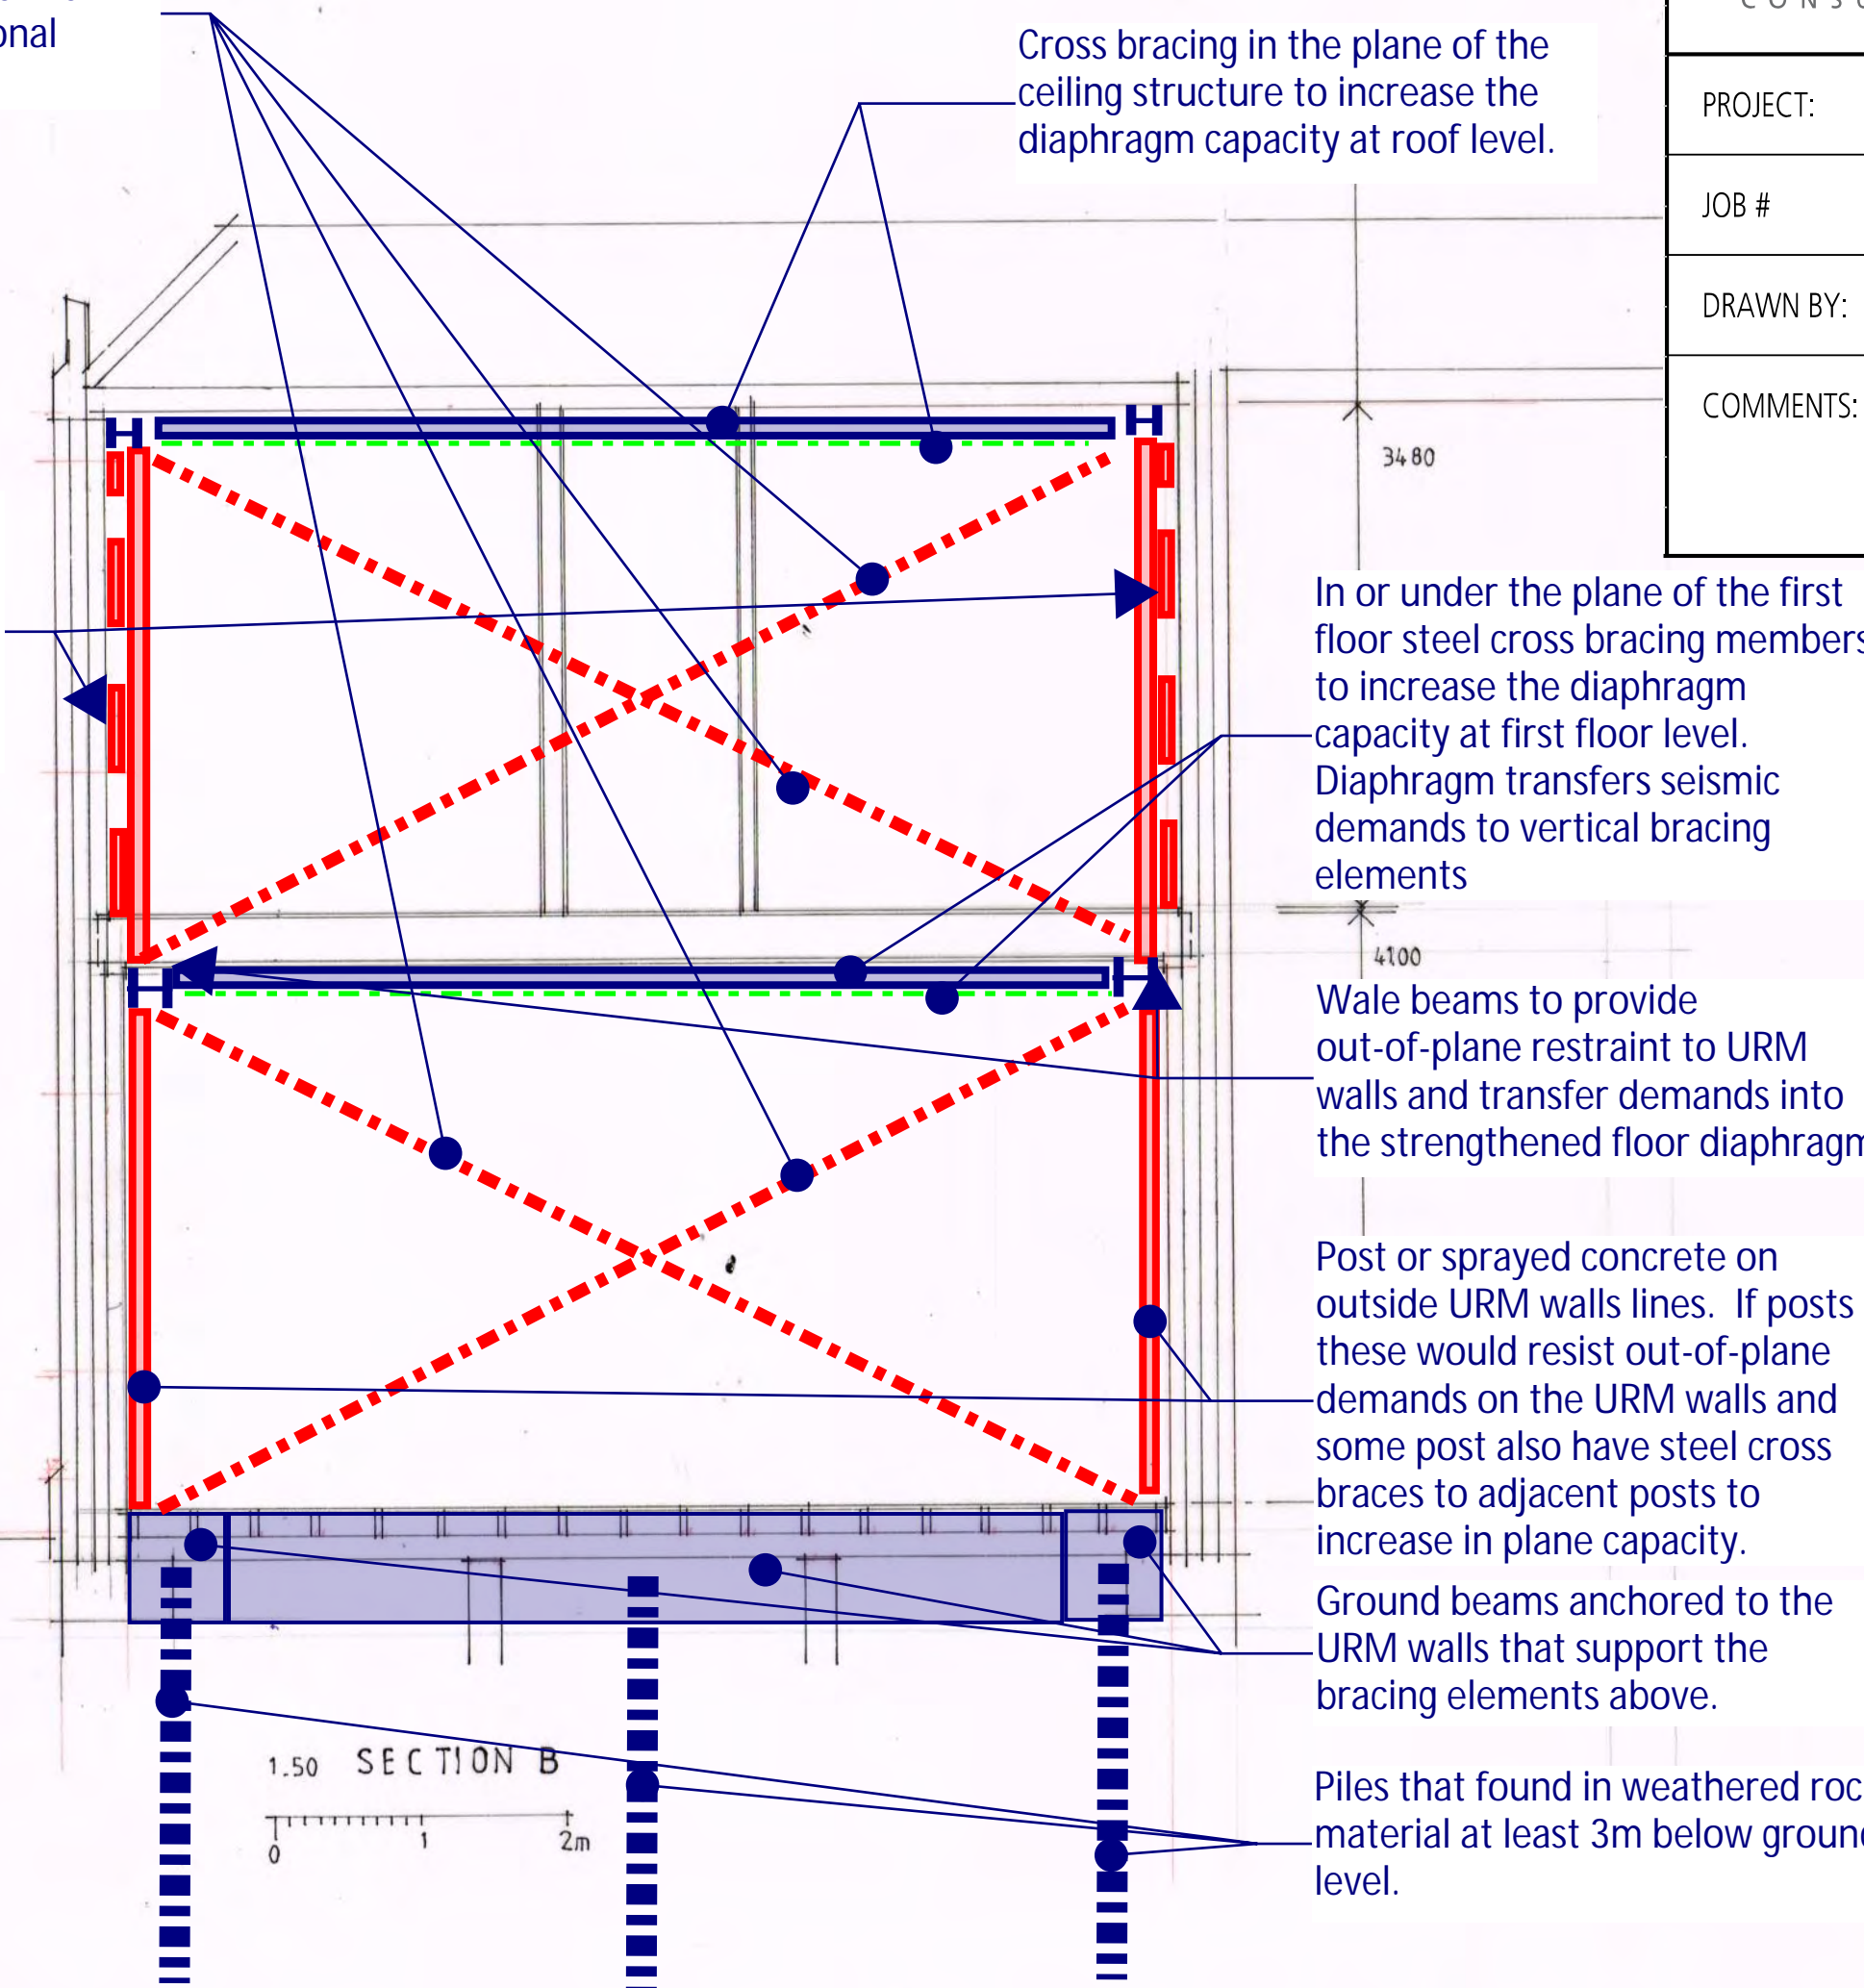
1.50 SECTION B  
 0 1 2m

COMMENTS: SECTION- marked up to show concept seismic strengthening works.

Internal cross bracing or concrete shear walls on two internal wall lines, one in each orthogonal direction.

Cross bracing in the plane of the ceiling structure to increase the diaphragm capacity at roof level.

If posts used will required packers at first floor level to allow for the reduction in wall thickness at first floor level.

In or under the plane of the first floor steel cross bracing members to increase the diaphragm capacity at first floor level. Diaphragm transfers seismic demands to vertical bracing elements

Wale beams to provide out-of-plane restraint to URM walls and transfer demands into the strengthened floor diaphragm.

Ground beams anchored to the URM walls that support the bracing elements above.

Piles that found in weathered rock material at least 3m below ground level.

Post or sprayed concrete on outside URM walls lines. If posts these would resist out-of-plane demands on the URM walls and some post also have steel cross braces to adjacent posts to increase in plane capacity.
