APPENDIX B

Responses to Further Information
Request – Tonkin & Taylor

**Responses to Further Information Request by Wellington City Council
Service Request Number 471670, WGN 210104
Redevelopment of 26 Donald Street and 37 Campbell Street, Karori, Wellington**

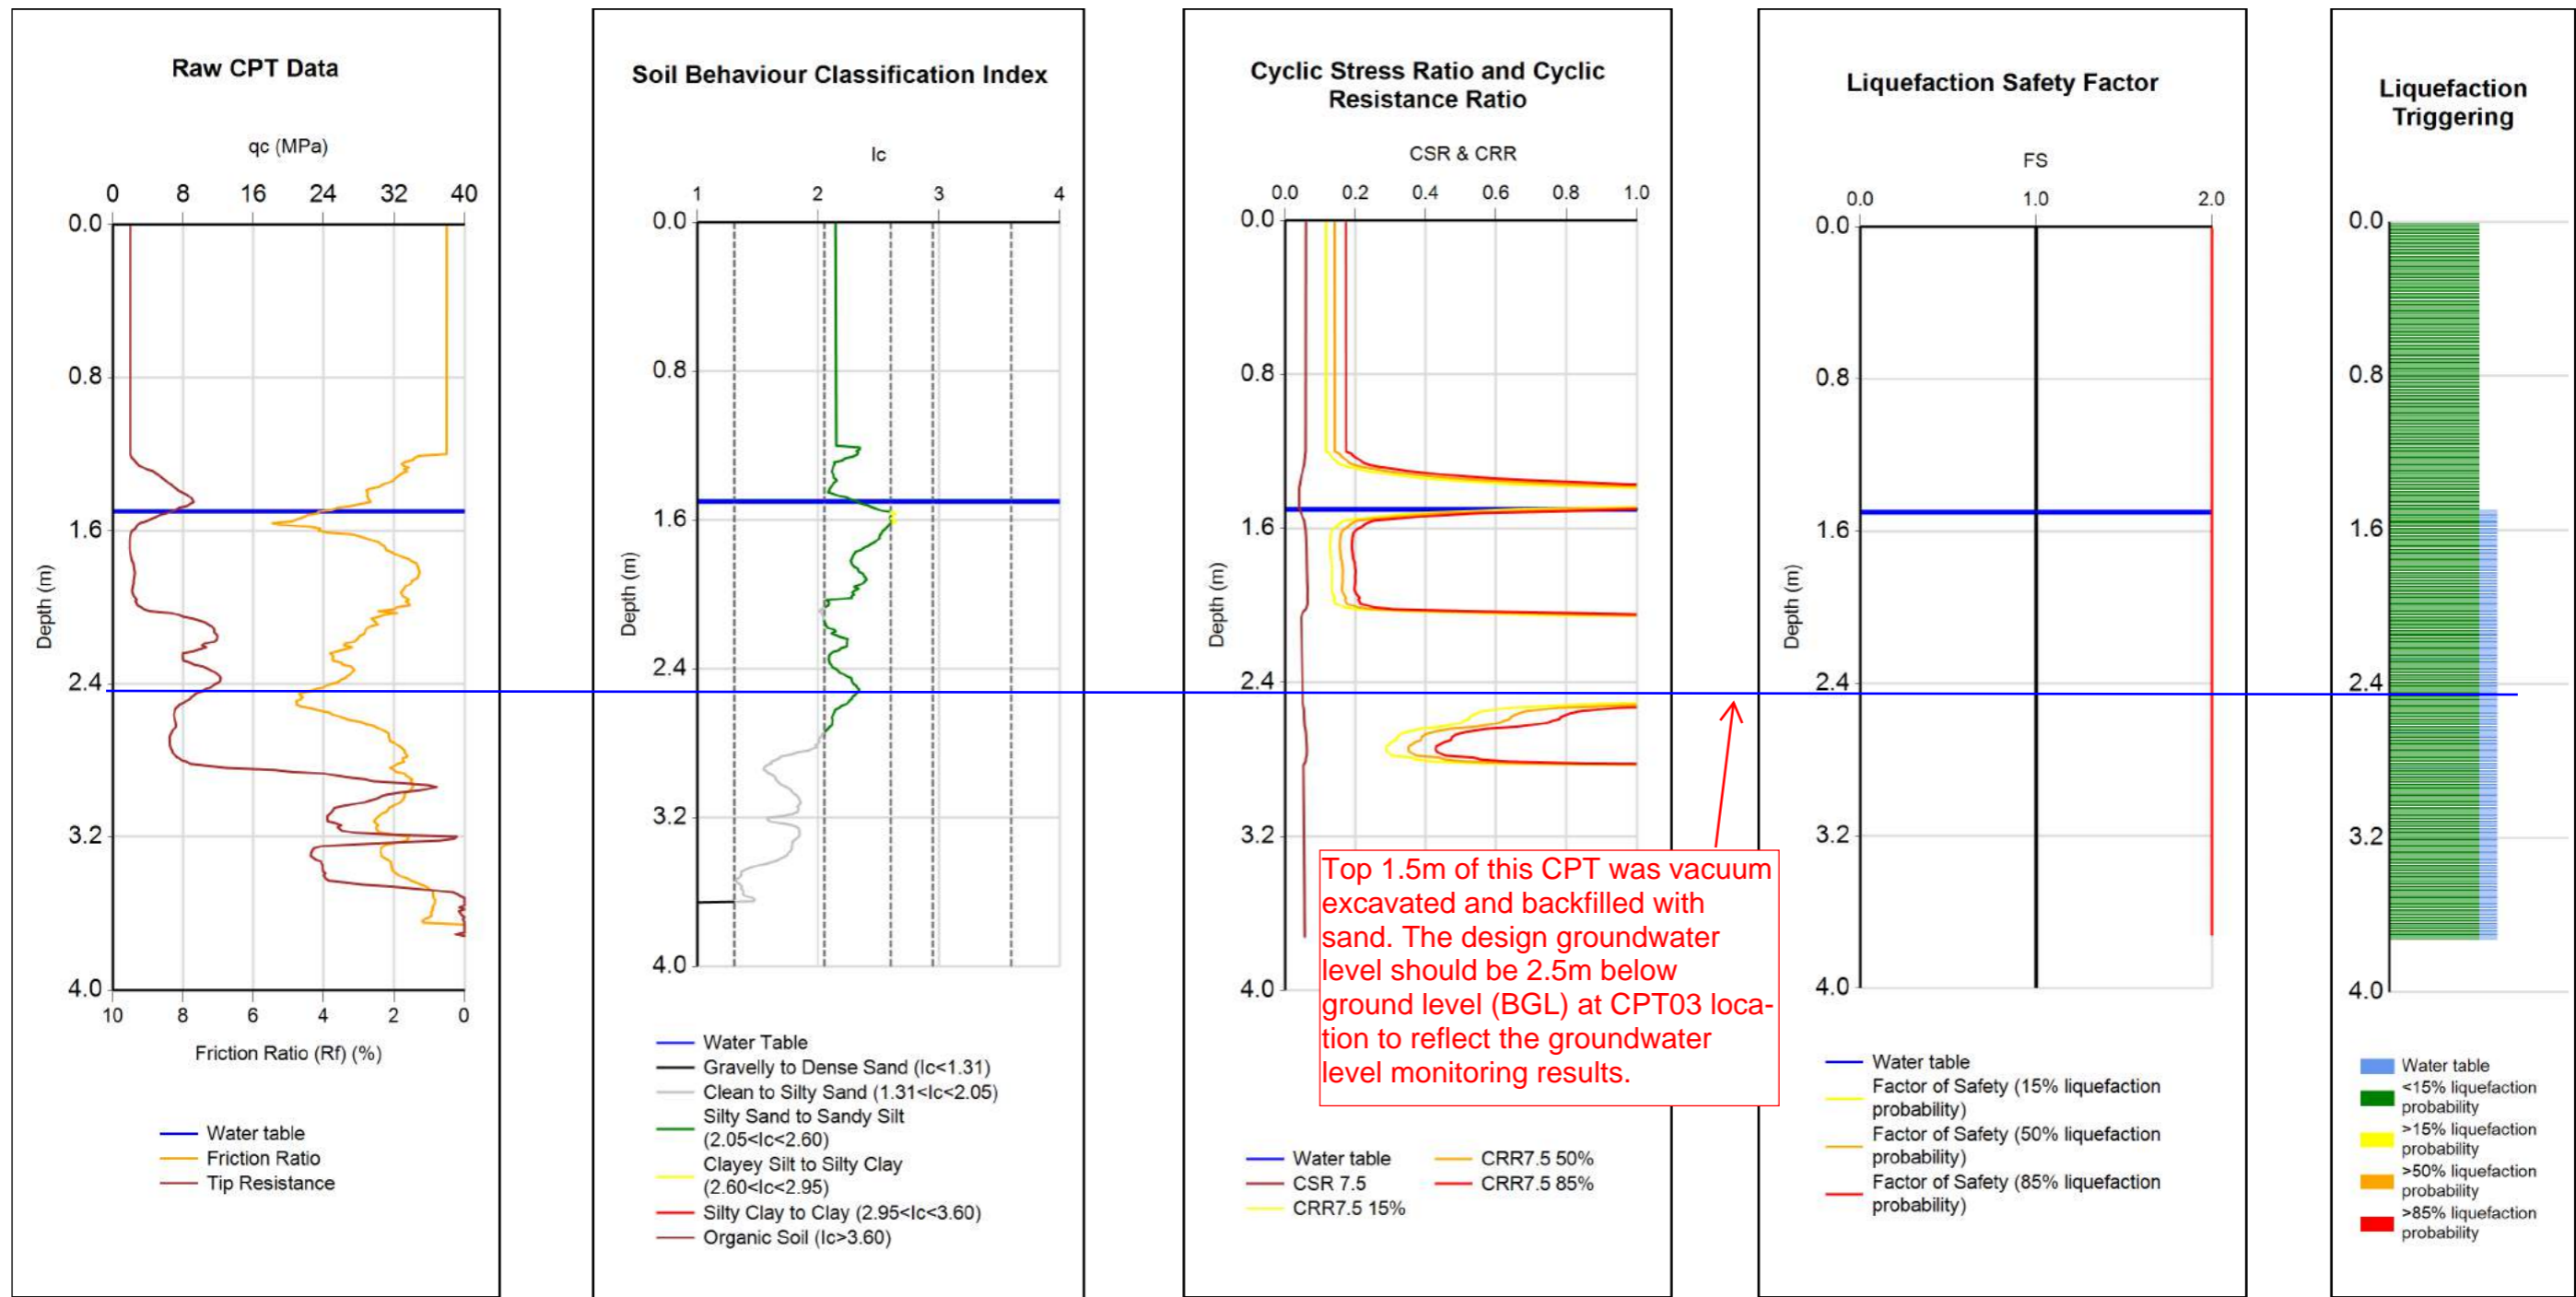
Tonkin + Taylor Exceptional thinking together V1.3	CLIENT, PROJECT Ryman Healthcare Limited Karori Prepurchase Geotechnical Assessment	LOCATION Victoria University Karori Campus	DATE 27/10/2017
	TITLE SLS CPT2, 3, 4 and 5	JOB NUMBER 30309	ANALYSED tzhl

Top 1.5m of this CPT was vacuum excavated and backfilled with sand. The design groundwater level should be 2.5m below ground level (BGL) at CPT03 location to reflect the groundwater level monitoring results.

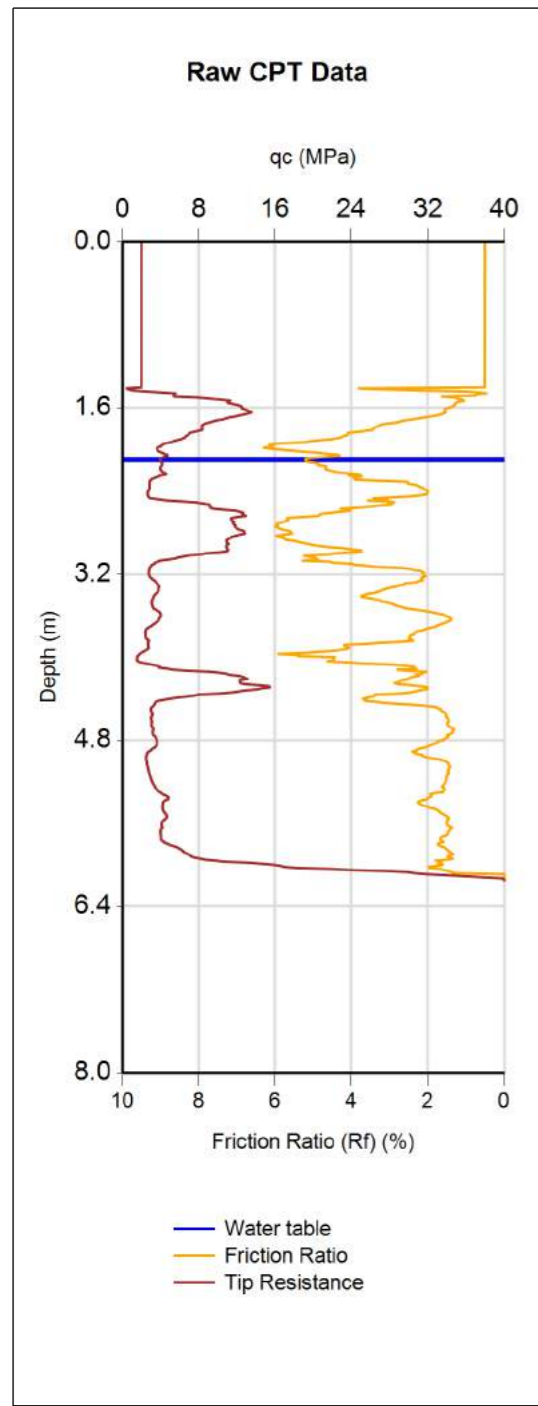
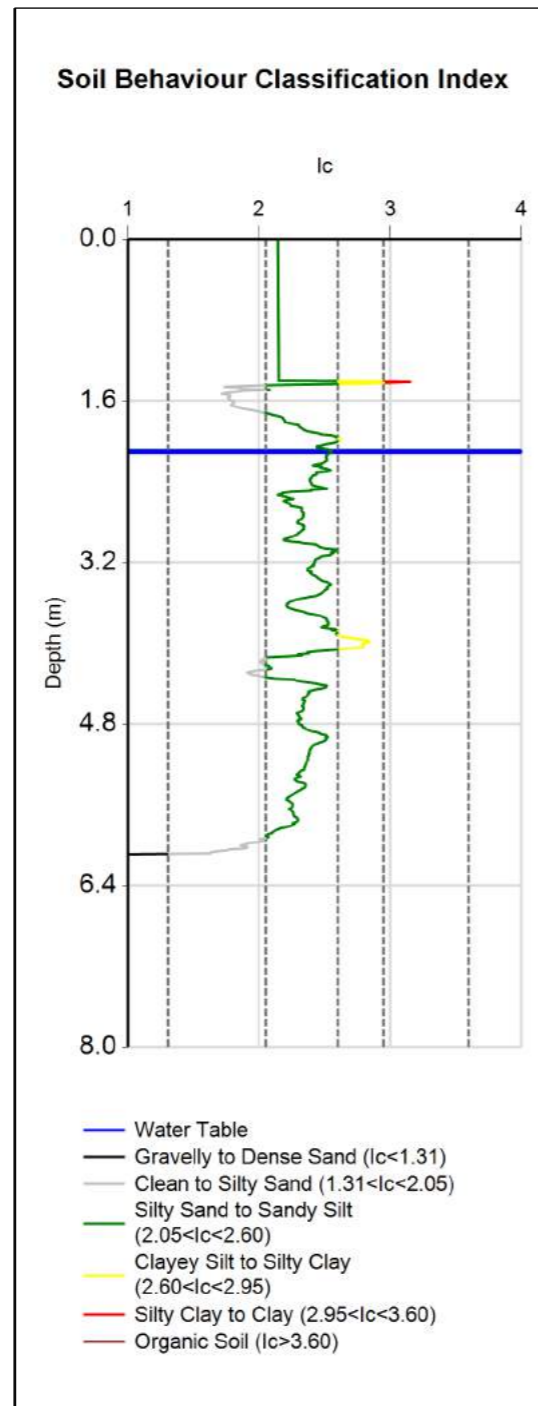
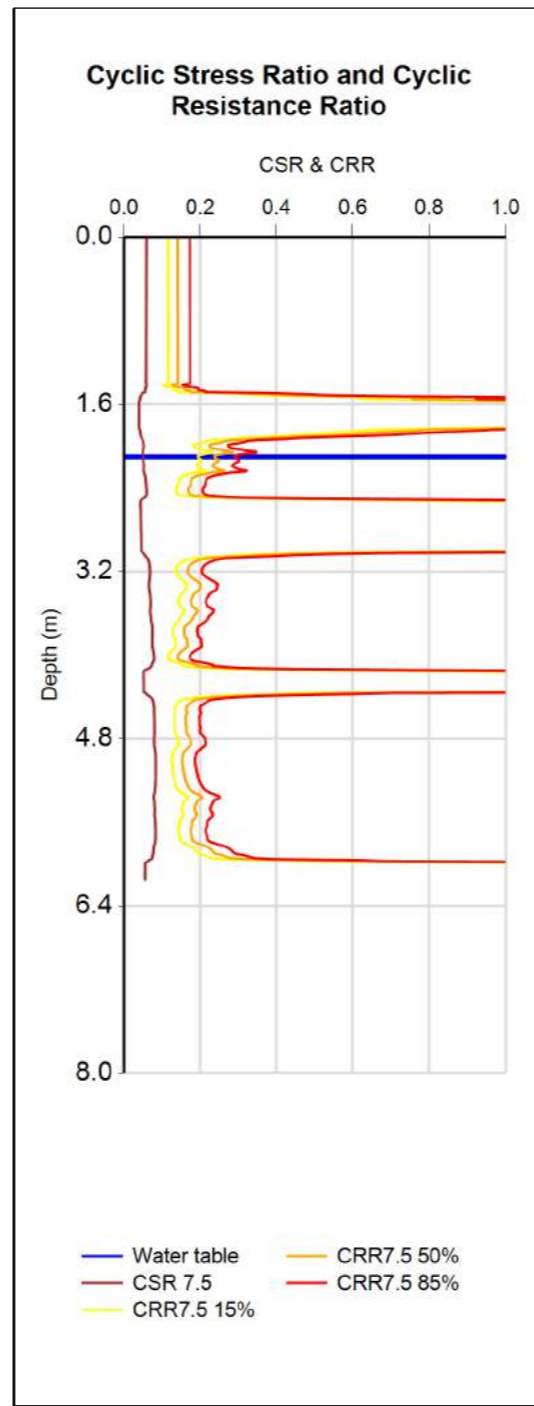
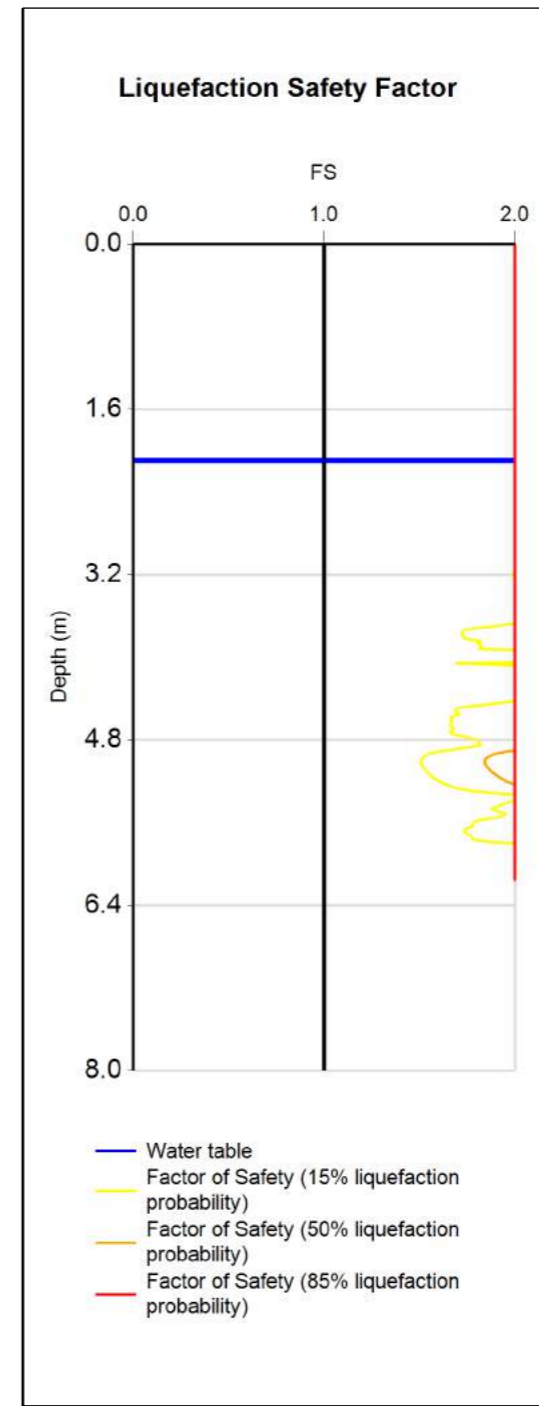
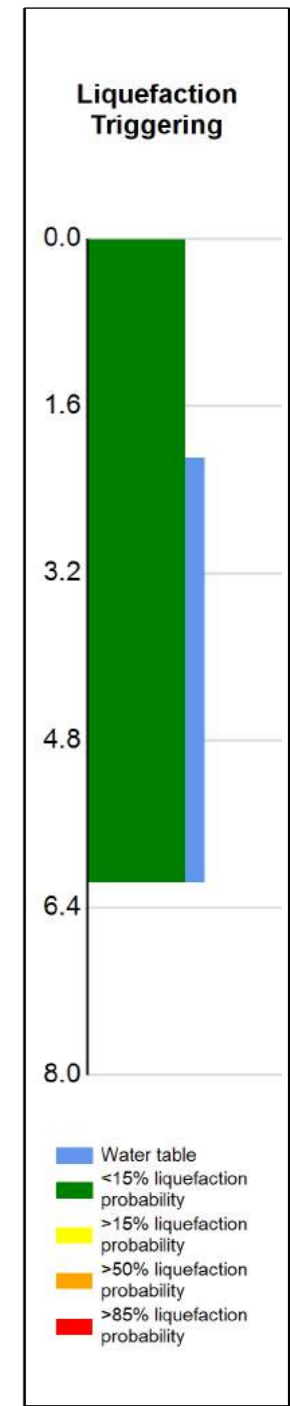
TTGD ID	103680	103681	103682	103683
CPT Name	05TT12_02	05TT12_03	05TT12_04	05TT12_05
PGA	0.11g	0.11g	0.11g	0.11g
Magnitude	6.2	6.2	6.2	6.2
Depth to groundwater	1.5m	1.5m	3.7m	2.8m
Predrill depth	1m	1.2m	1.3m	1.5m
Assumed predrill tip resistance and skin friction	qc= 2MPa & Fs= 0.01MPa	qc= 2MPa & Fs= 0.01MPa	qc= 2MPa & Fs= 0.01MPa	qc= 2MPa & Fs= 0.01MPa
Trigger method	Boulanger & Idriss (2014)	Boulanger & Idriss (2014)	Boulanger & Idriss (2014)	Boulanger & Idriss (2014)
Settlement method	Zhang, Robertson & Brachman (2002)	Zhang, Robertson & Brachman (2002)	Zhang, Robertson & Brachman (2002)	Zhang, Robertson & Brachman (2002)
CFC	0	0	0	0
Total depth of CPT	7.8m	3.72m	4.63m	5.05m
Maximum depth of analysis	7.8m	3.72m	4.63m	5.05m
RL	n/a	n/a	n/a	n/a

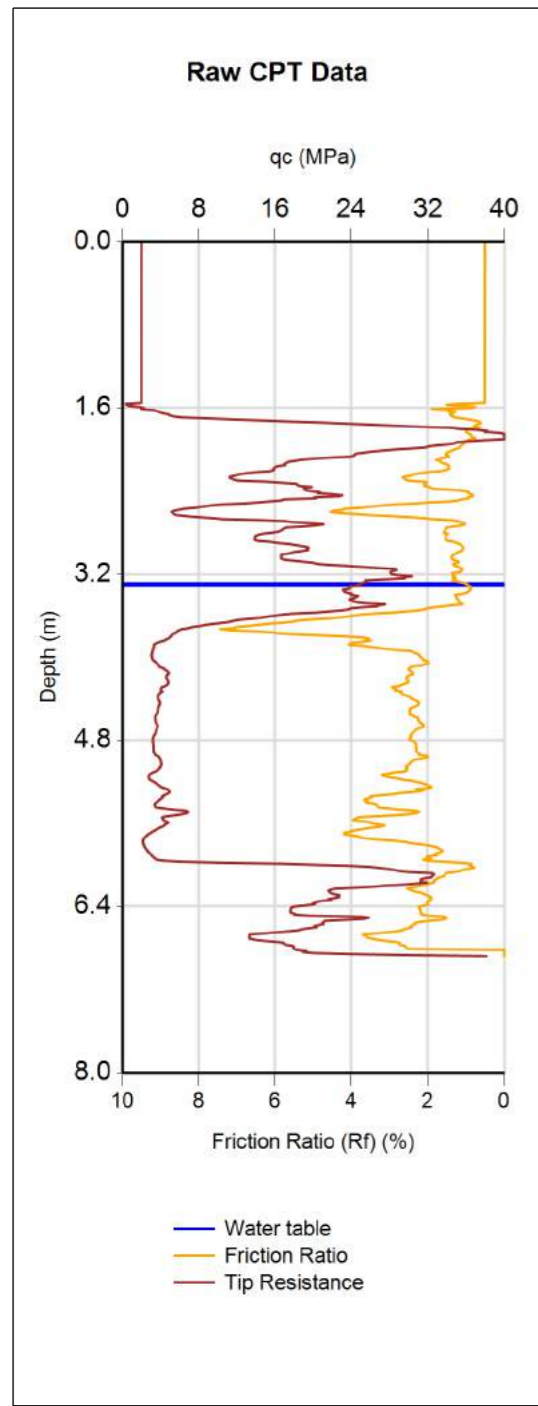
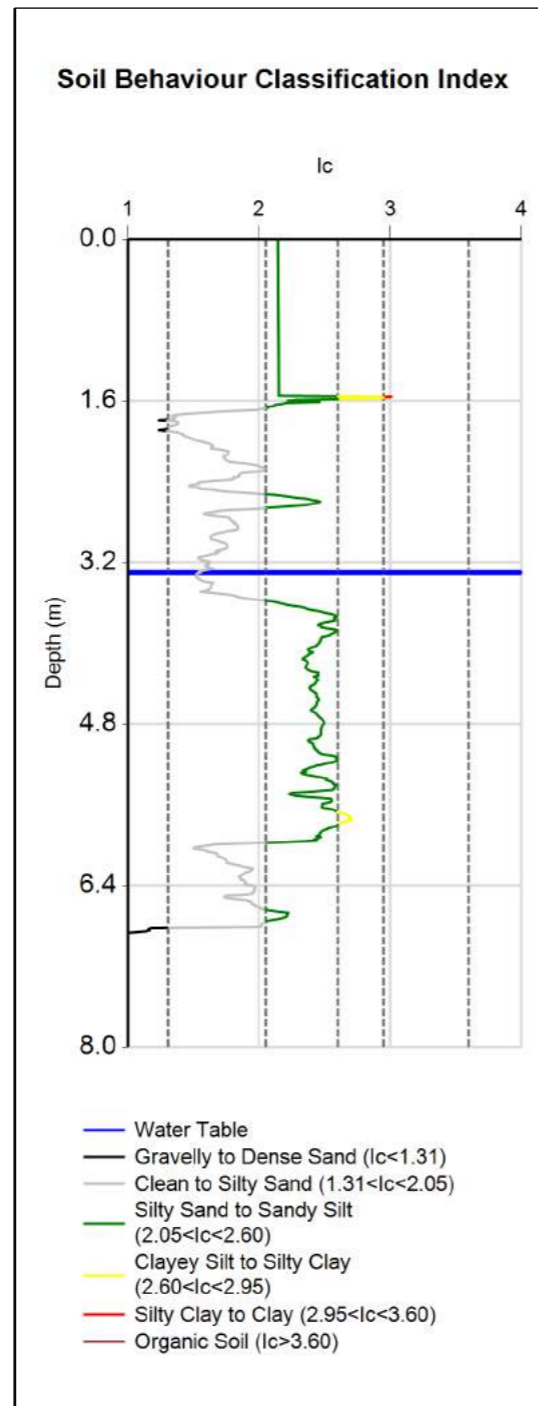
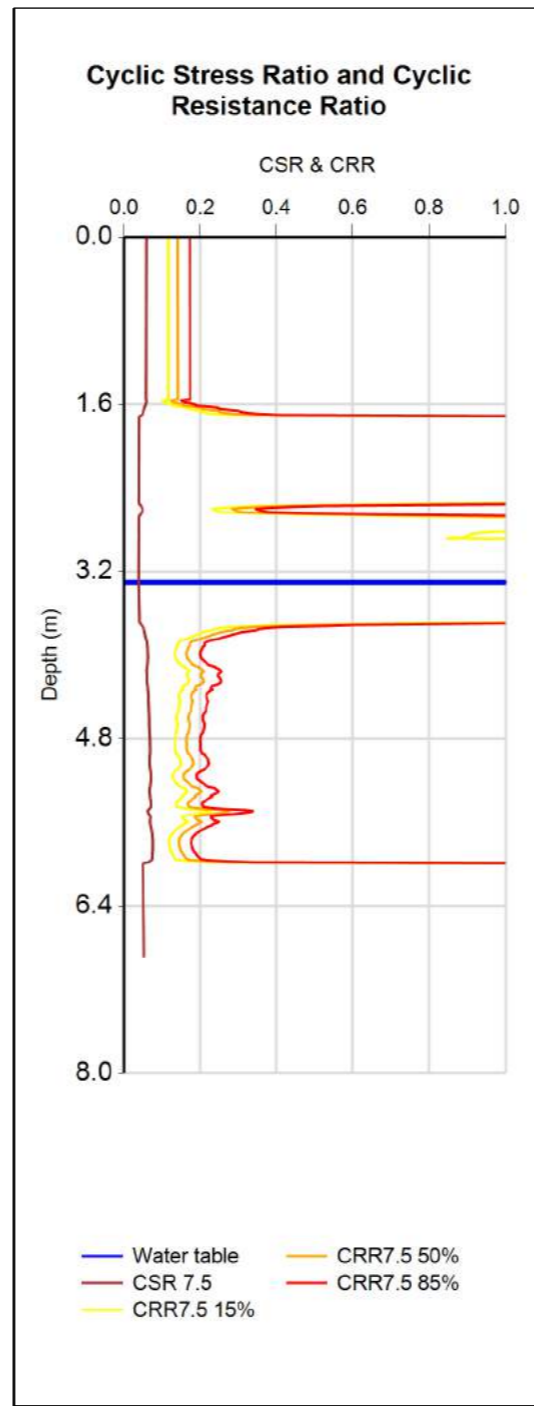
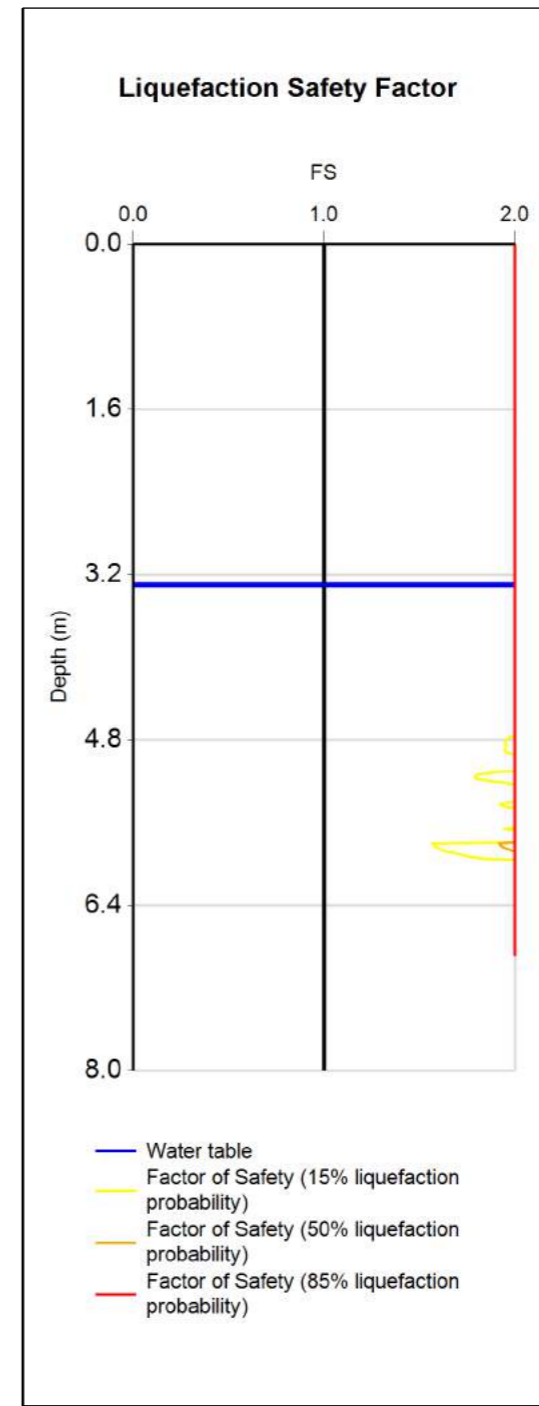
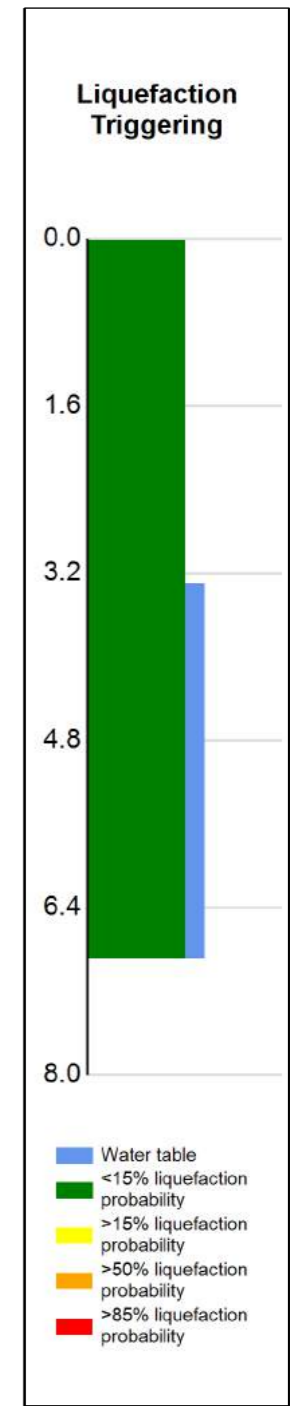
TTGD ID	103684	103685	103686	103687
CPT Name	05TT12_06a	05TT12_07	05TT12_08a	05TT12_09
PGA	0.11g	0.11g	0.11g	0.11g
Magnitude	6.2	6.2	6.2	6.2
Depth to groundwater	2.1m	1.5m	1.9m	1.5m
Predrill depth	1.4m	1.5m	1.45m	1.1m
Assumed predrill tip resistance and skin friction	qc= 2MPa & Fs= 0.01MPa	qc= 2MPa & Fs= 0.01MPa	qc= 2MPa & Fs= 0.01MPa	qc= 2MPa & Fs= 0.01MPa
Trigger method	Boulanger & Idriss (2014)	Boulanger & Idriss (2014)	Boulanger & Idriss (2014)	Boulanger & Idriss (2014)
Settlement method	Zhang, Robertson & Brachman (2002)	Zhang, Robertson & Brachman (2002)	Zhang, Robertson & Brachman (2002)	Zhang, Robertson & Brachman (2002)
CFC	0	0	0	0
Total depth of CPT	6.15m	5.63m	3.12m	6.22m
Maximum depth of analysis	6.15m	5.63m	3.12m	6.22m
RL	n/a	n/a	n/a	n/a

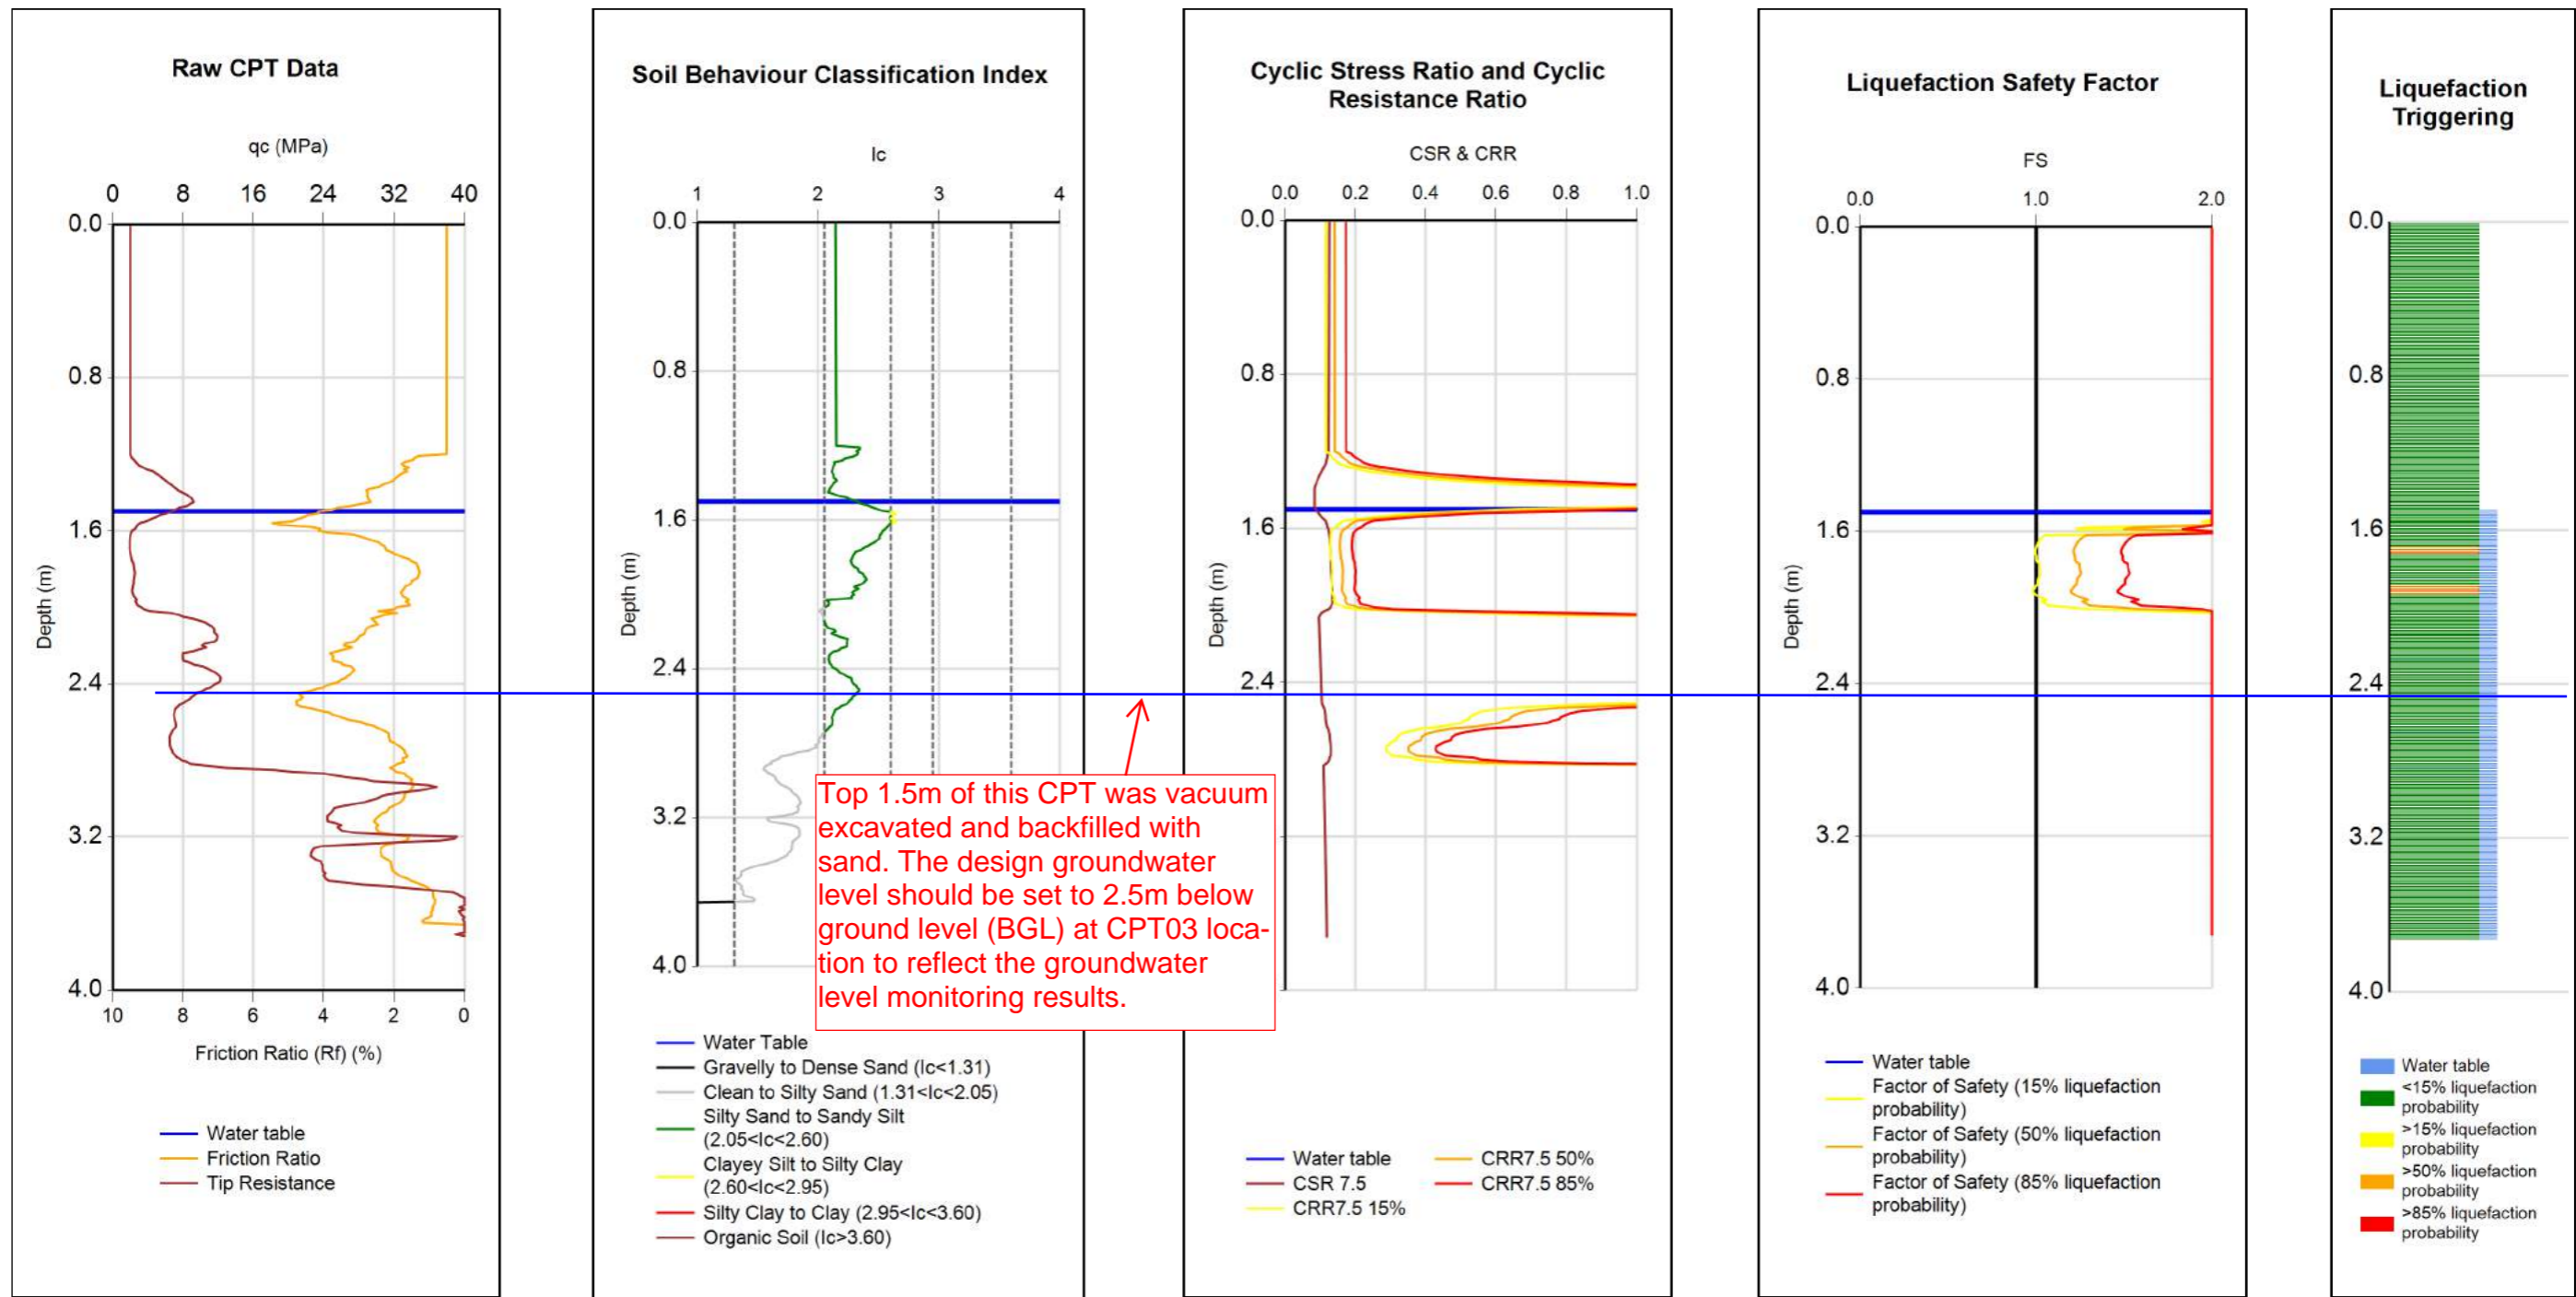
Top 1.5m of this CPT was vacuum excavated and backfilled with sand. The design groundwater level should be set to 2.5m below ground level (BGL) at CPT03 location to reflect the groundwater level monitoring results.

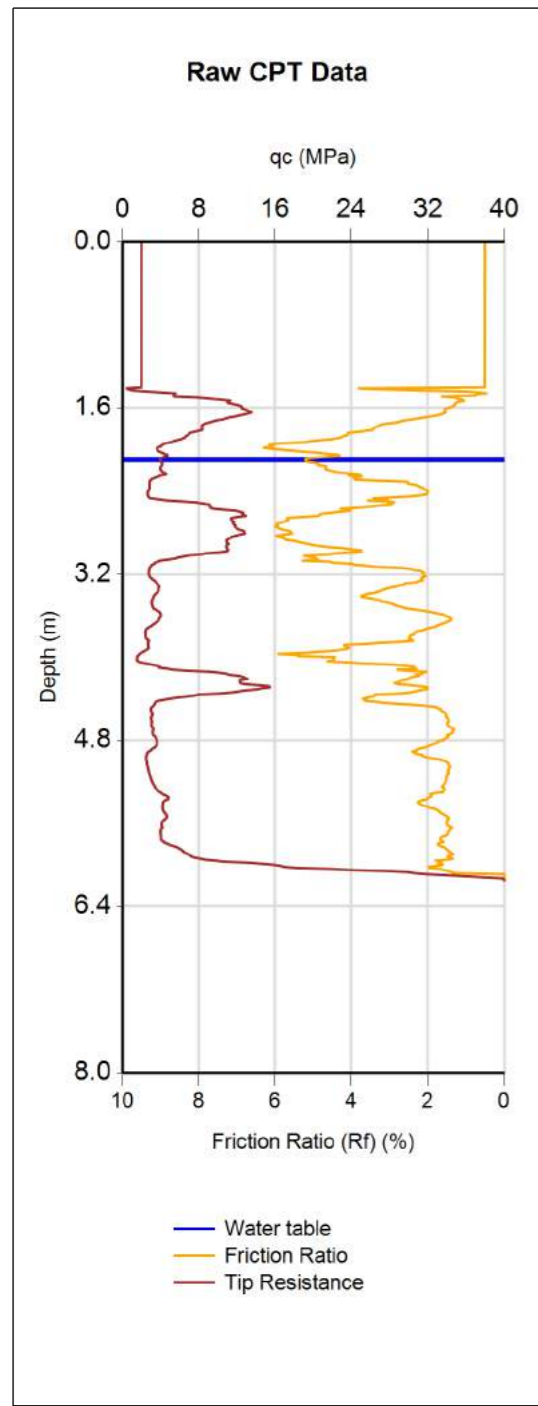
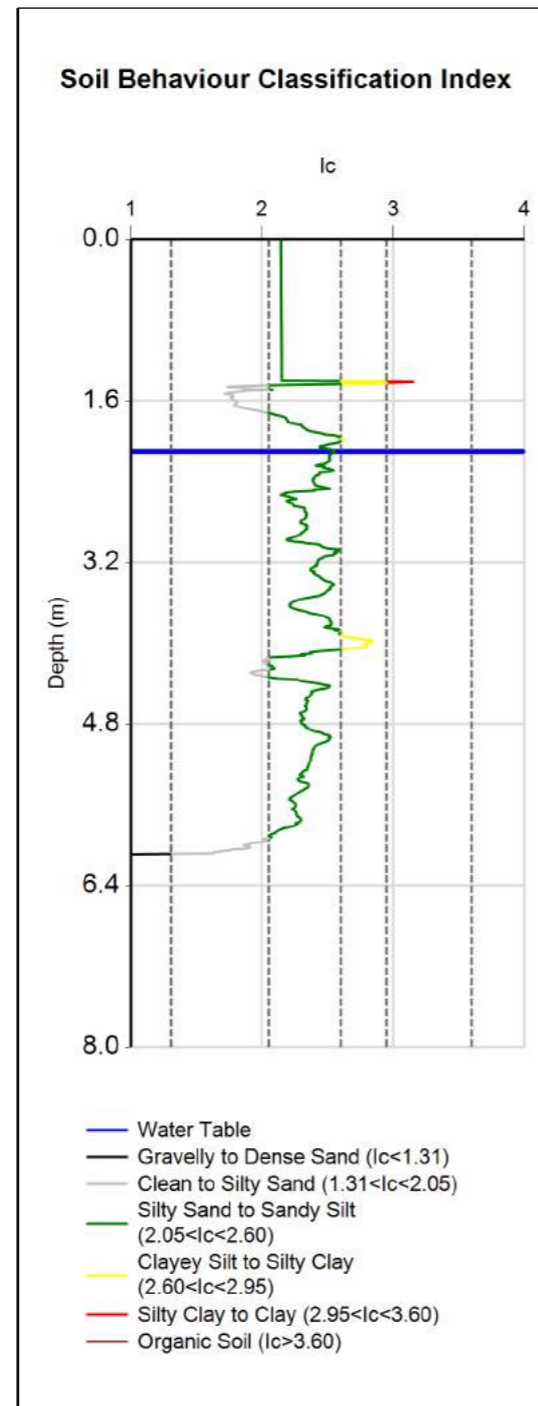
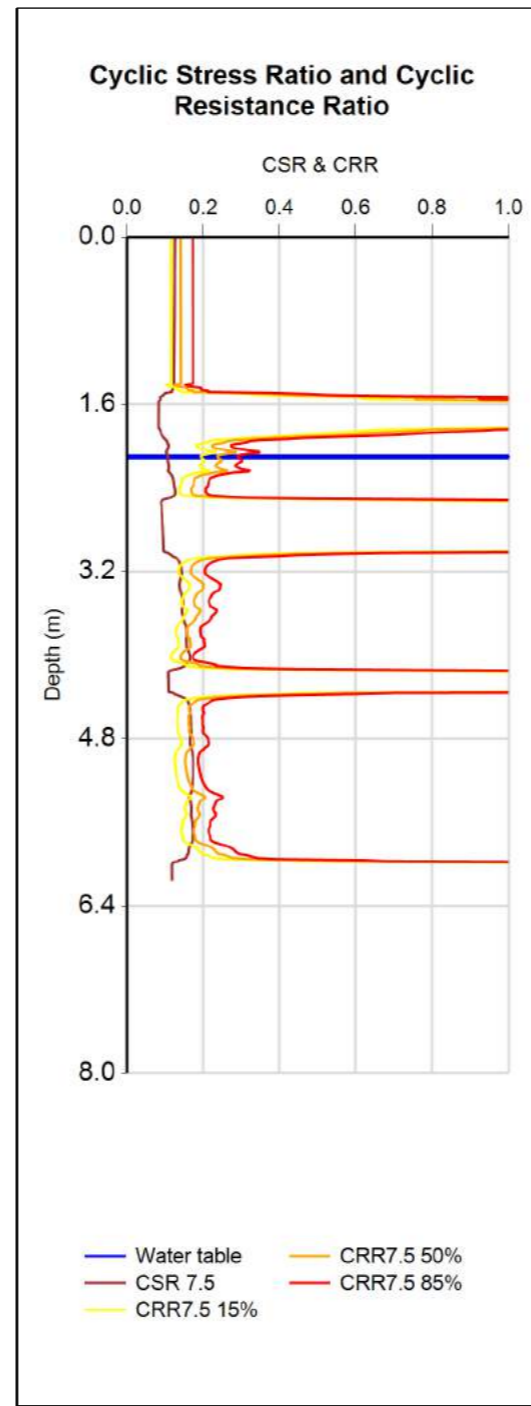
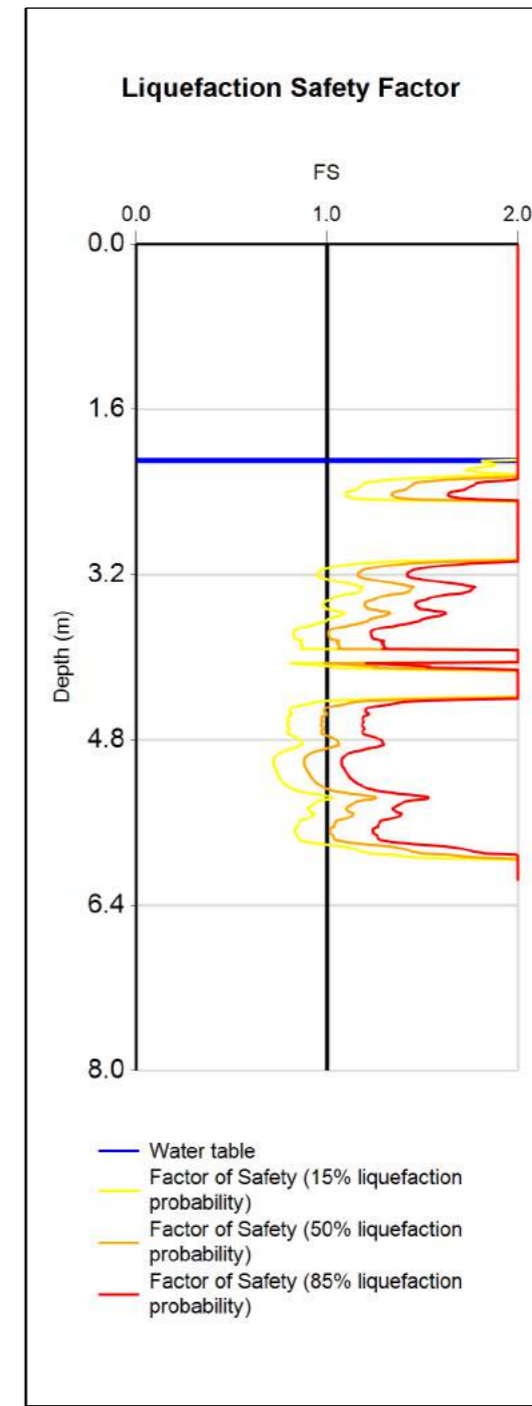
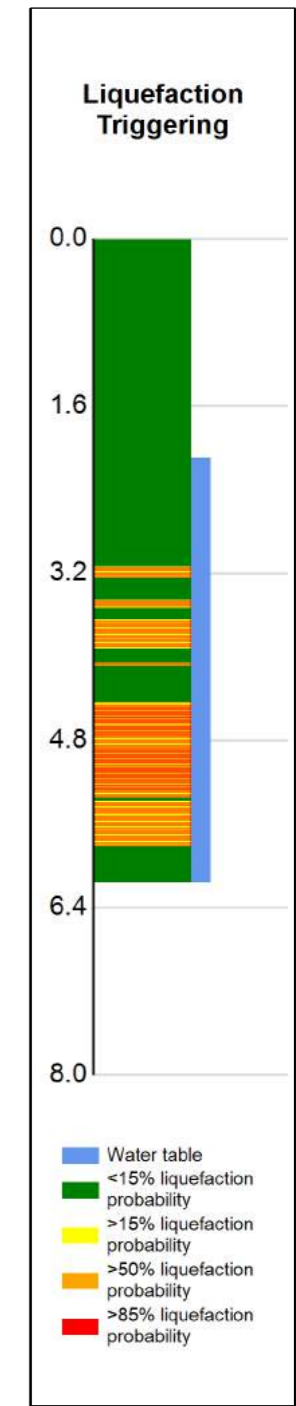
TTGD ID	103680	103681	103682	103683
CPT Name	05TT12_02	05TT12_03	05TT12_04	05TT12_05
PGA	0.23g	0.23g	0.23g	0.23g
Magnitude	6.2	6.2	6.2	6.2
Depth to groundwater	1.5m	1.5m	3.7m	2.8m
Predrill depth	1m	1.2m	1.3m	1.5m
Assumed predrill tip resistance and skin friction	qc= 2MPa & Fs= 0.01MPa	qc= 2MPa & Fs= 0.01MPa	qc= 2MPa & Fs= 0.01MPa	qc= 2MPa & Fs= 0.01MPa
Trigger method	Boulanger & Idriss (2014)	Boulanger & Idriss (2014)	Boulanger & Idriss (2014)	Boulanger & Idriss (2014)
Settlement method	Zhang, Robertson & Brachman (2002)	Zhang, Robertson & Brachman (2002)	Zhang, Robertson & Brachman (2002)	Zhang, Robertson & Brachman (2002)
CFC	0	0	0	0
Total depth of CPT	7.8m	3.72m	4.63m	5.05m
Maximum depth of analysis	7.8m	3.72m	4.63m	5.05m
RL	n/a	n/a	n/a	n/a

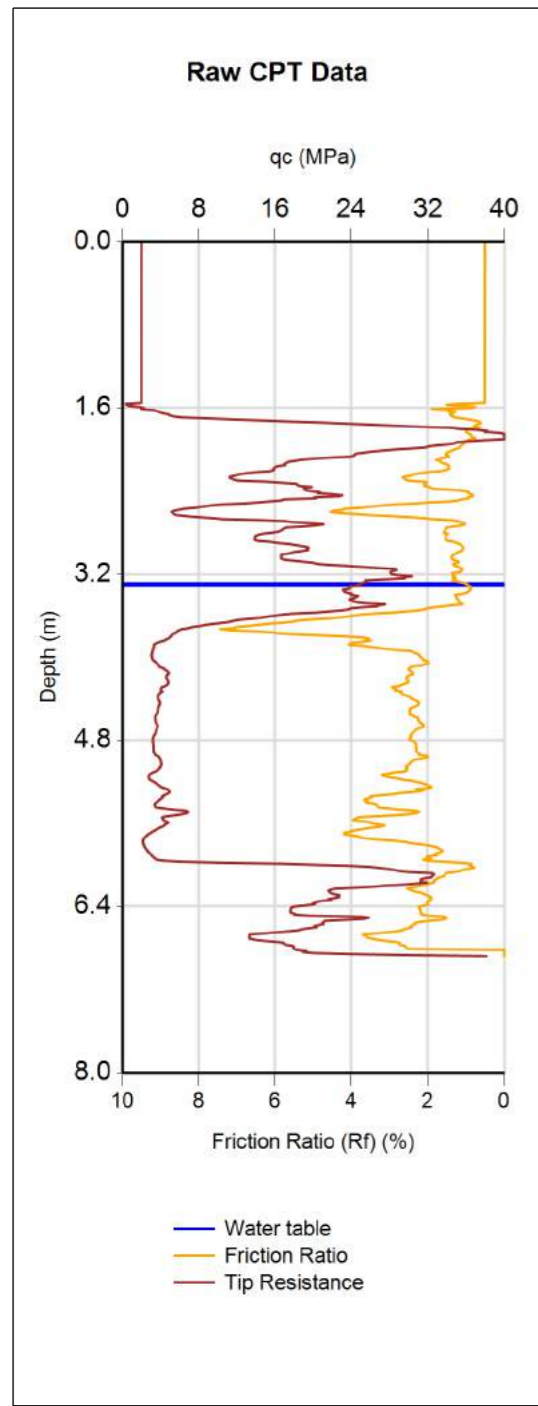
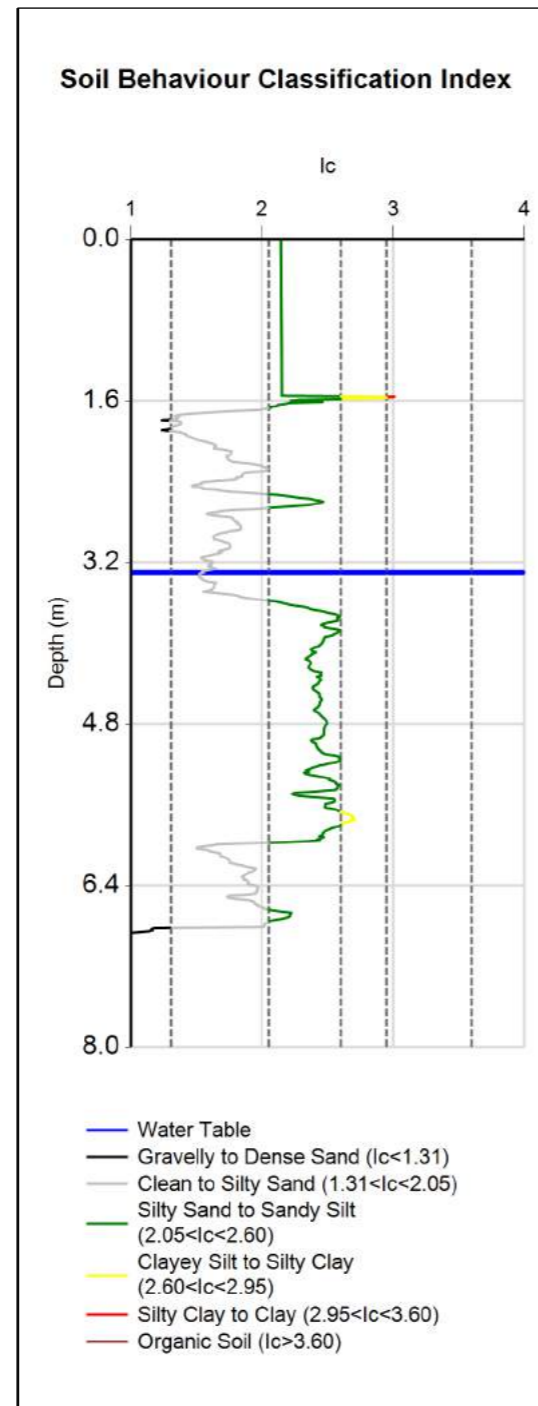
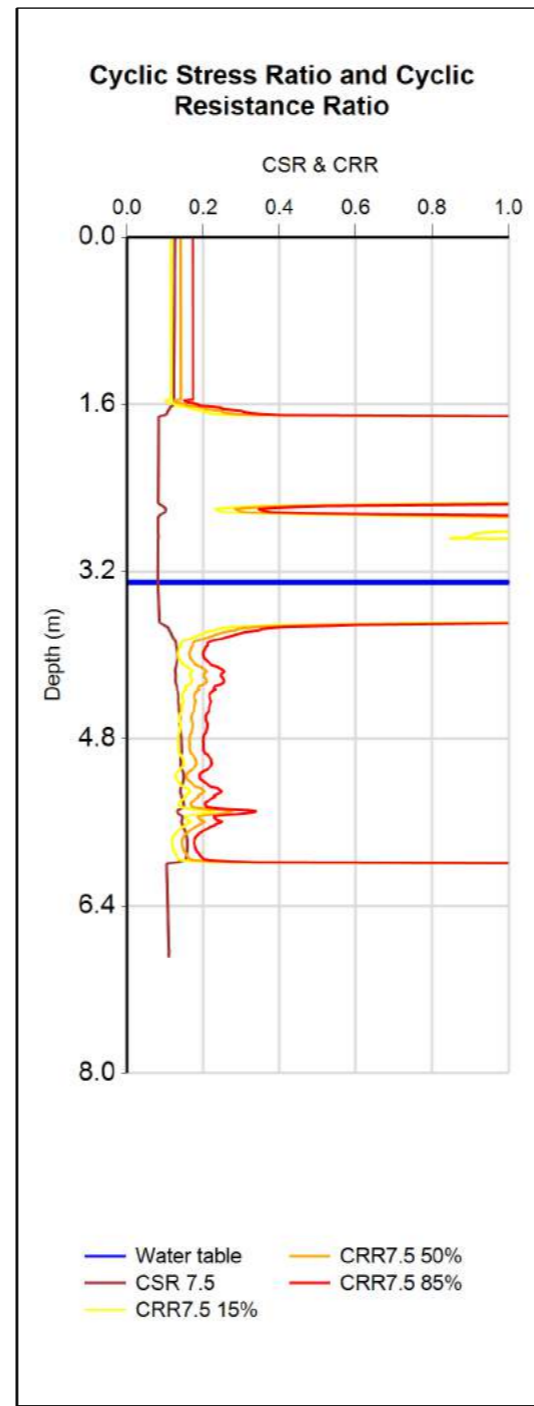
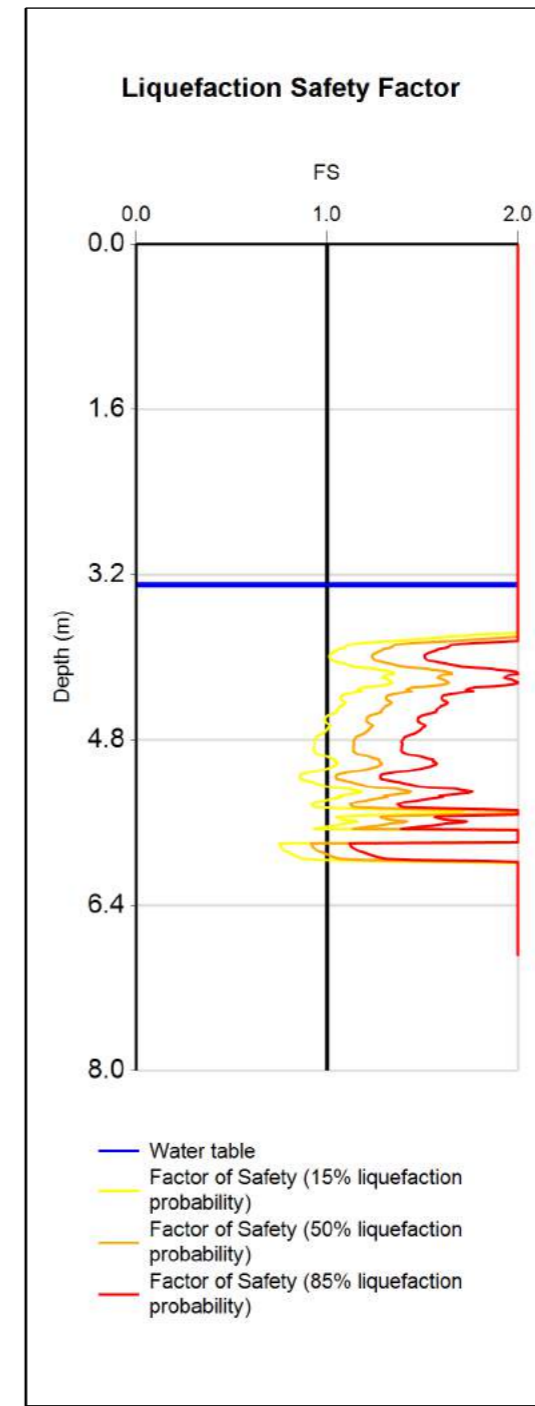
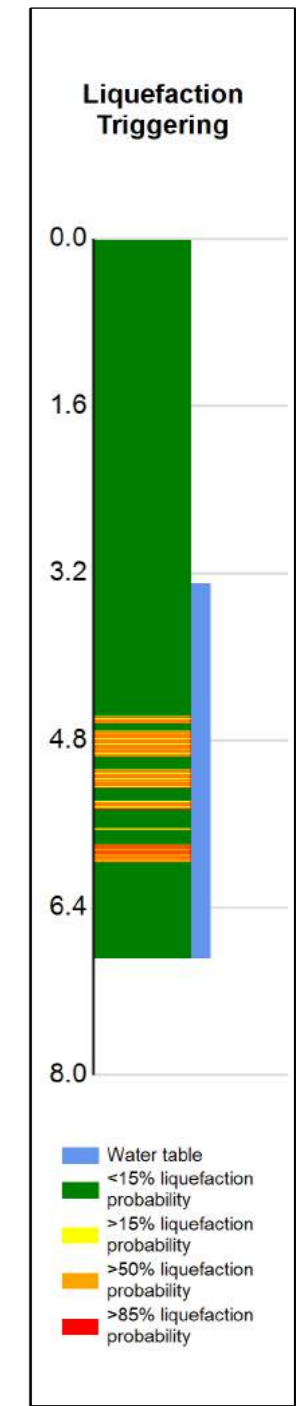
TTGD ID	103684	103685	103686	103687
CPT Name	05TT12_06a	05TT12_07	05TT12_08a	05TT12_09
PGA	0.23g	0.23g	0.23g	0.23g
Magnitude	6.2	6.2	6.2	6.2
Depth to groundwater	2.1m	1.5m	1.9m	1.5m
Predrill depth	1.4m	1.5m	1.45m	1.1m
Assumed predrill tip resistance and skin friction	qc= 2MPa & Fs= 0.01MPa	qc= 2MPa & Fs= 0.01MPa	qc= 2MPa & Fs= 0.01MPa	qc= 2MPa & Fs= 0.01MPa
Trigger method	Boulanger & Idriss (2014)	Boulanger & Idriss (2014)	Boulanger & Idriss (2014)	Boulanger & Idriss (2014)
Settlement method	Zhang, Robertson & Brachman (2002)	Zhang, Robertson & Brachman (2002)	Zhang, Robertson & Brachman (2002)	Zhang, Robertson & Brachman (2002)
CFC	0	0	0	0
Total depth of CPT	6.15m	5.63m	3.12m	6.22m
Maximum depth of analysis	6.15m	5.63m	3.12m	6.22m
RL	n/a	n/a	n/a	n/a
