APPENDIX B

Responses to Further Information
Request – Tonkin & Taylor

**Responses to Further Information Request by Wellington City Council
Service Request Number 471670, WGN 210104
Redevelopment of 26 Donald Street and 37 Campbell Street, Karori, Wellington**

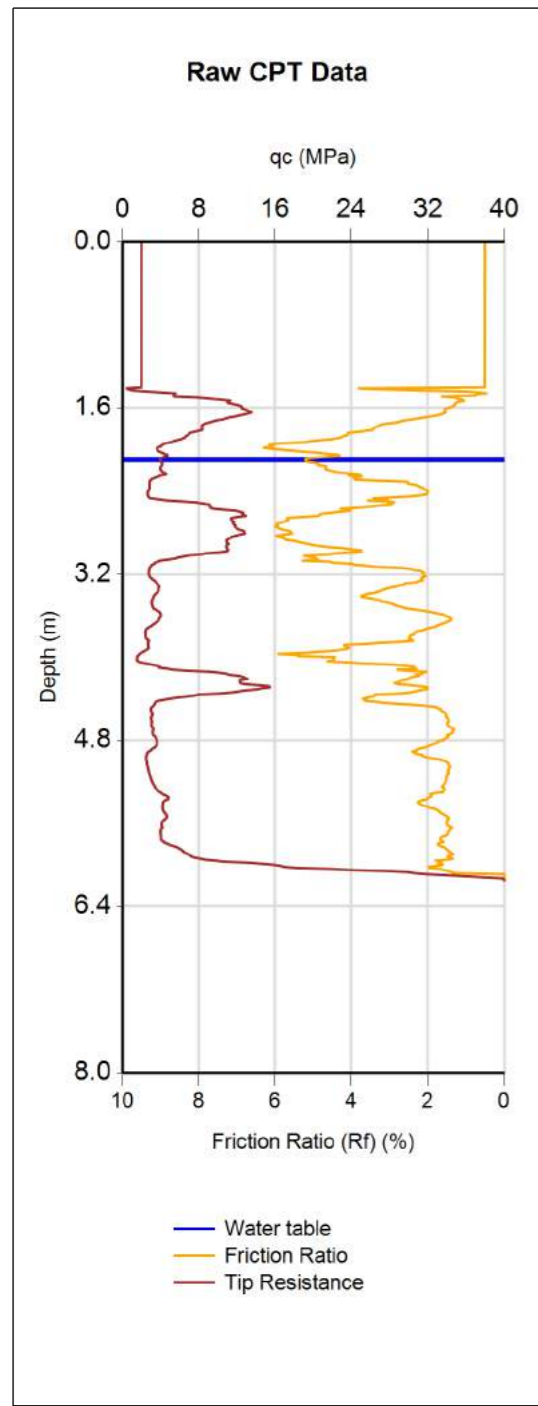
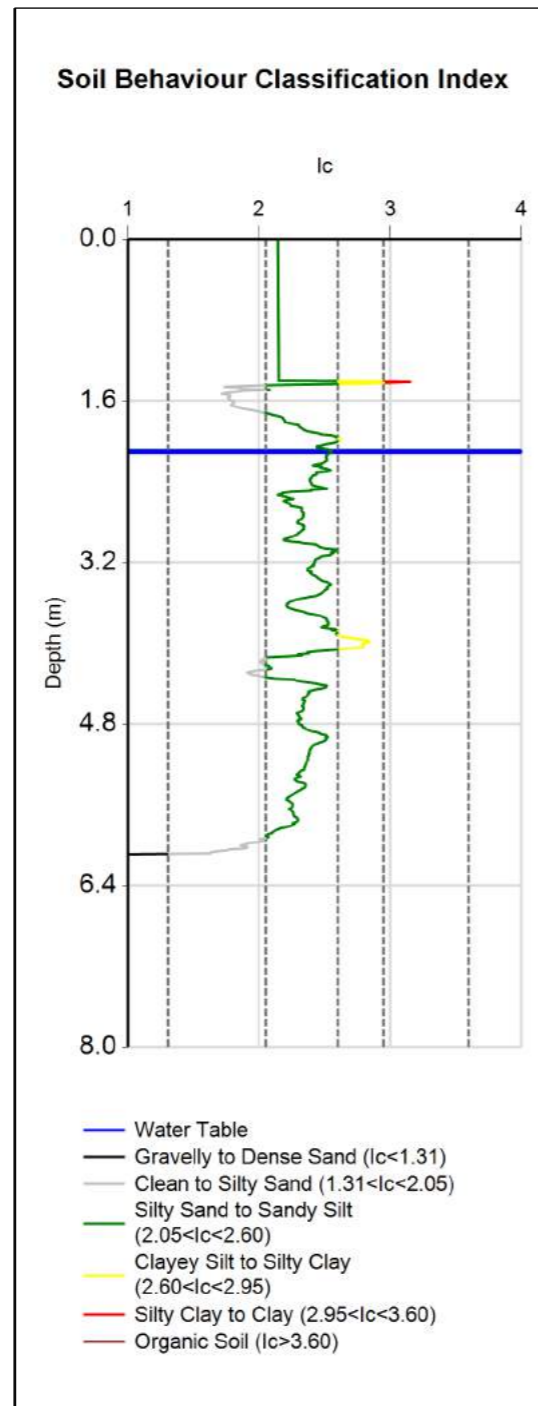
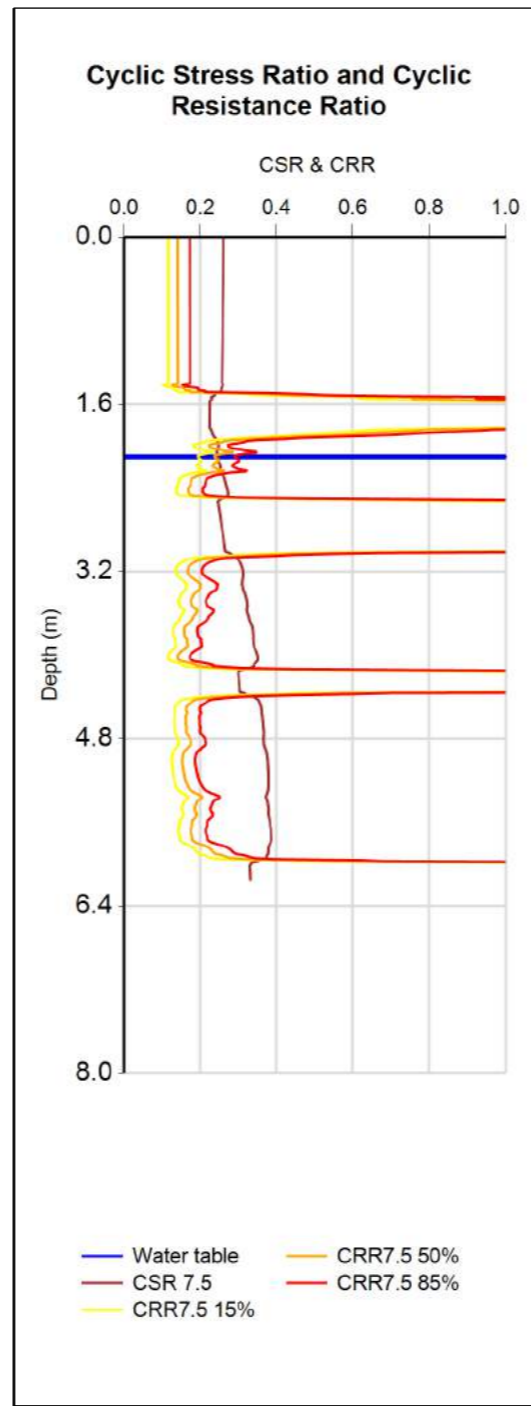
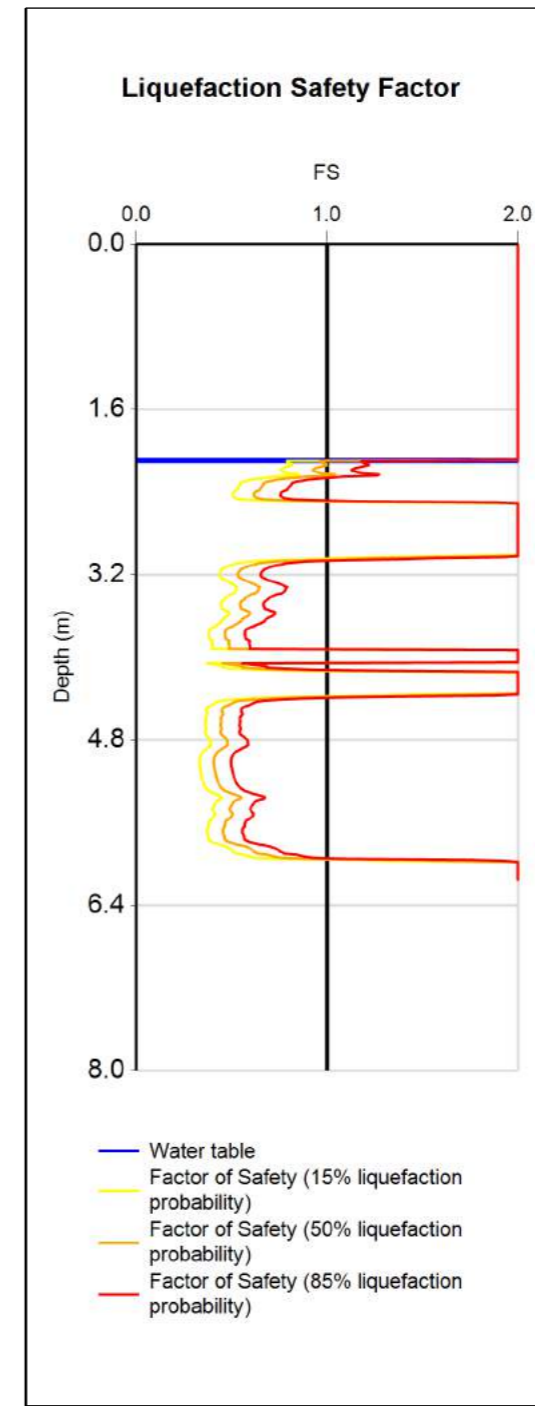
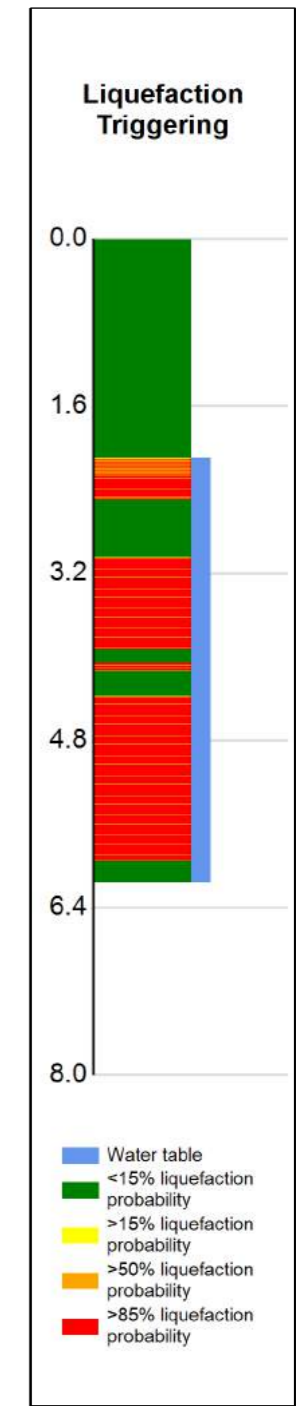
TTGD ID	103680	103681	103682	103683
CPT Name	05TT12_02	05TT12_03	05TT12_04	05TT12_05
PGA	0.45g	0.45g	0.45g	0.45g
Magnitude	7.1	7.1	7.1	7.1
Depth to groundwater	1.5m	1.5m	3.7m	2.8m
Predrill depth	1m	1.2m	1.3m	1.5m
Assumed predrill tip resistance and skin friction	qc= 2MPa & Fs= 0.01MPa	qc= 2MPa & Fs= 0.01MPa	qc= 2MPa & Fs= 0.01MPa	qc= 2MPa & Fs= 0.01MPa
Trigger method	Boulanger & Idriss (2014)	Boulanger & Idriss (2014)	Boulanger & Idriss (2014)	Boulanger & Idriss (2014)
Settlement method	Zhang, Robertson & Brachman (2002)	Zhang, Robertson & Brachman (2002)	Zhang, Robertson & Brachman (2002)	Zhang, Robertson & Brachman (2002)
CFC	0	0	0	0
Total depth of CPT	7.8m	3.72m	4.63m	5.05m
Maximum depth of analysis	7.8m	3.72m	4.63m	5.05m
RL	n/a	n/a	n/a	n/a

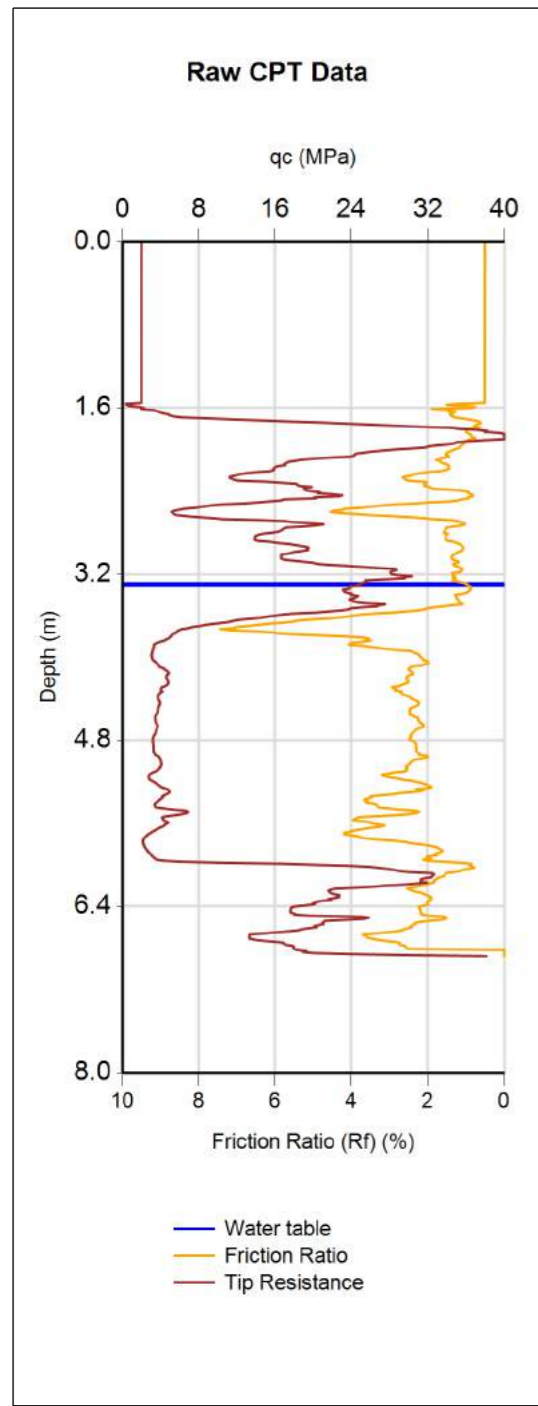
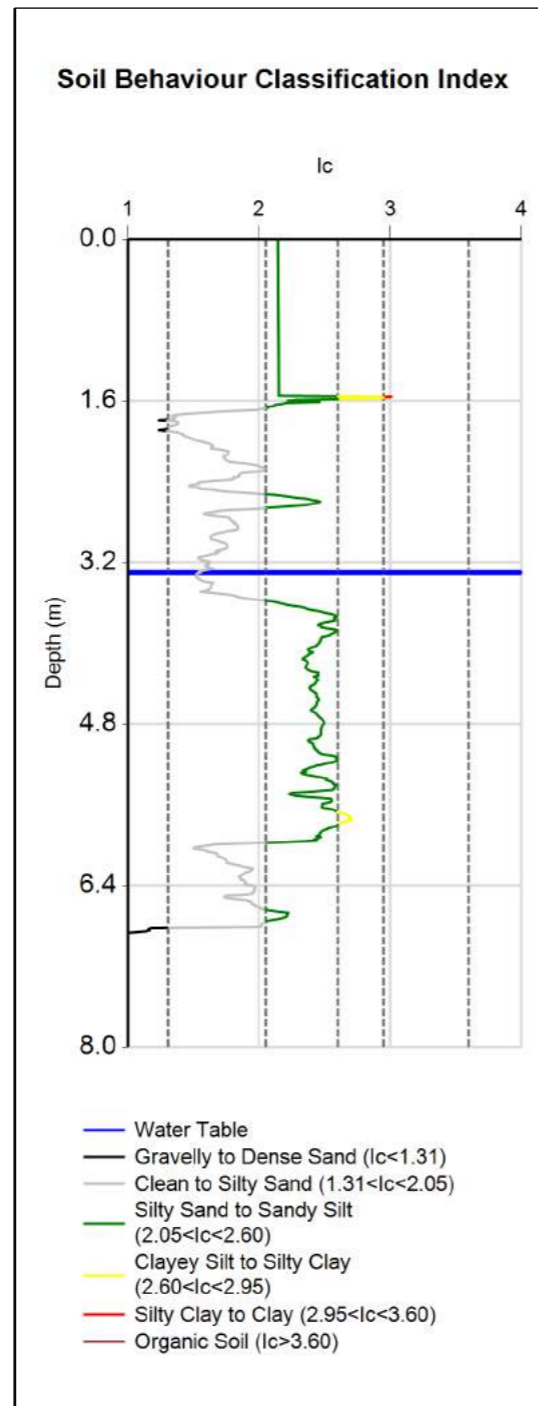
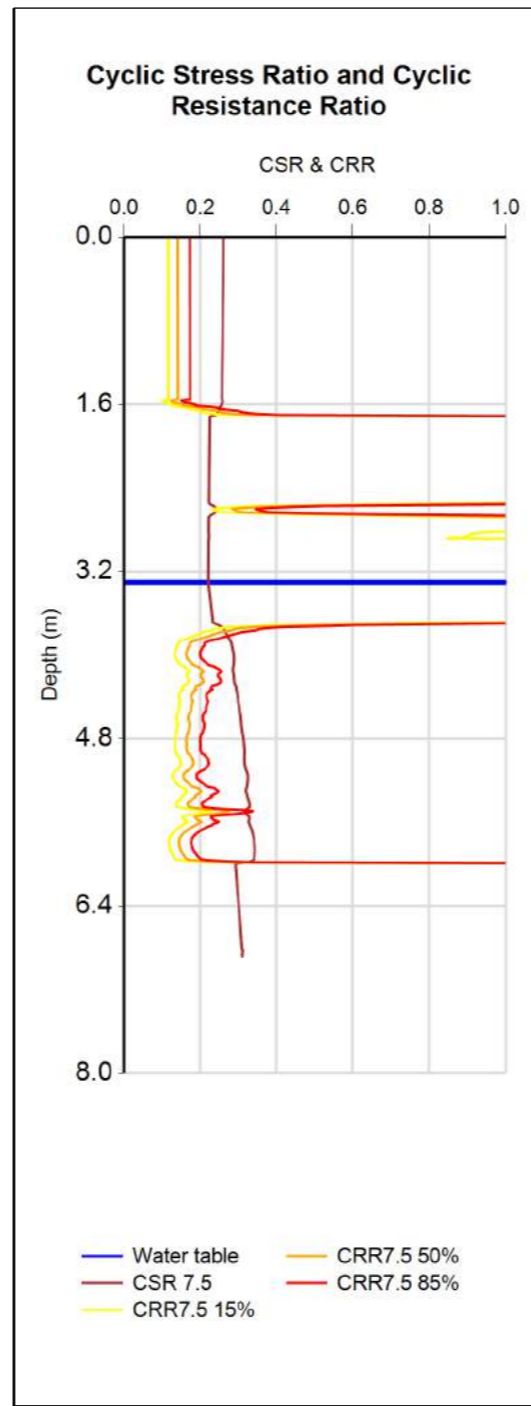
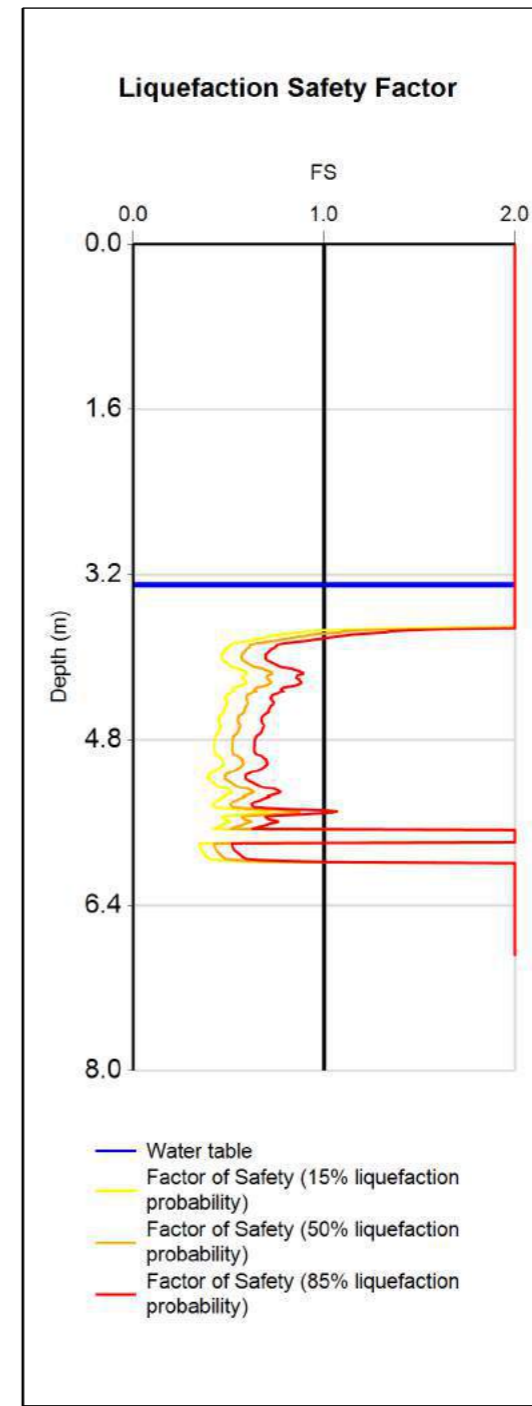
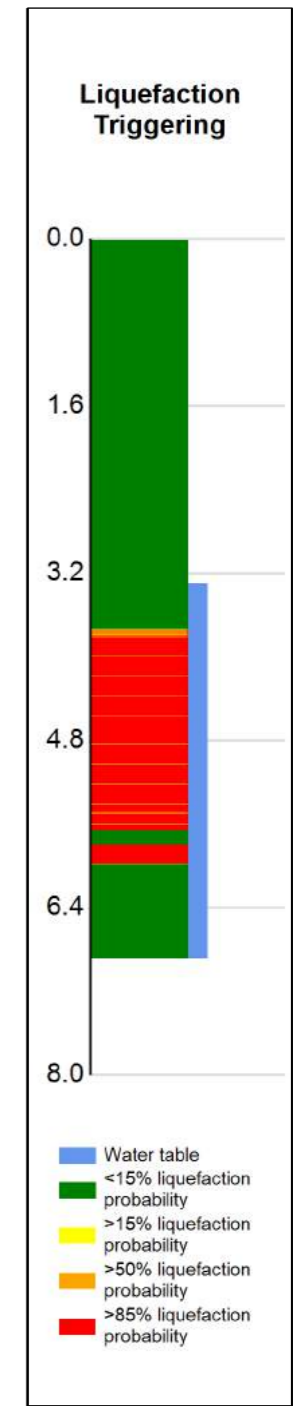
TTGD ID	103684	103685	103686	103687
CPT Name	05TT12_06a	05TT12_07	05TT12_08a	05TT12_09
PGA	0.45g	0.45g	0.45g	0.45g
Magnitude	7.1	7.1	7.1	7.1
Depth to groundwater	2.1m	1.5m	1.9m	1.5m
Predrill depth	1.4m	1.5m	1.45m	1.1m
Assumed predrill tip resistance and skin friction	qc= 2MPa & Fs= 0.01MPa	qc= 2MPa & Fs= 0.01MPa	qc= 2MPa & Fs= 0.01MPa	qc= 2MPa & Fs= 0.01MPa
Trigger method	Boulanger & Idriss (2014)	Boulanger & Idriss (2014)	Boulanger & Idriss (2014)	Boulanger & Idriss (2014)
Settlement method	Zhang, Robertson & Brachman (2002)	Zhang, Robertson & Brachman (2002)	Zhang, Robertson & Brachman (2002)	Zhang, Robertson & Brachman (2002)
CFC	0	0	0	0
Total depth of CPT	6.15m	5.63m	3.12m	6.22m
Maximum depth of analysis	6.15m	5.63m	3.12m	6.22m
RL	n/a	n/a	n/a	n/a

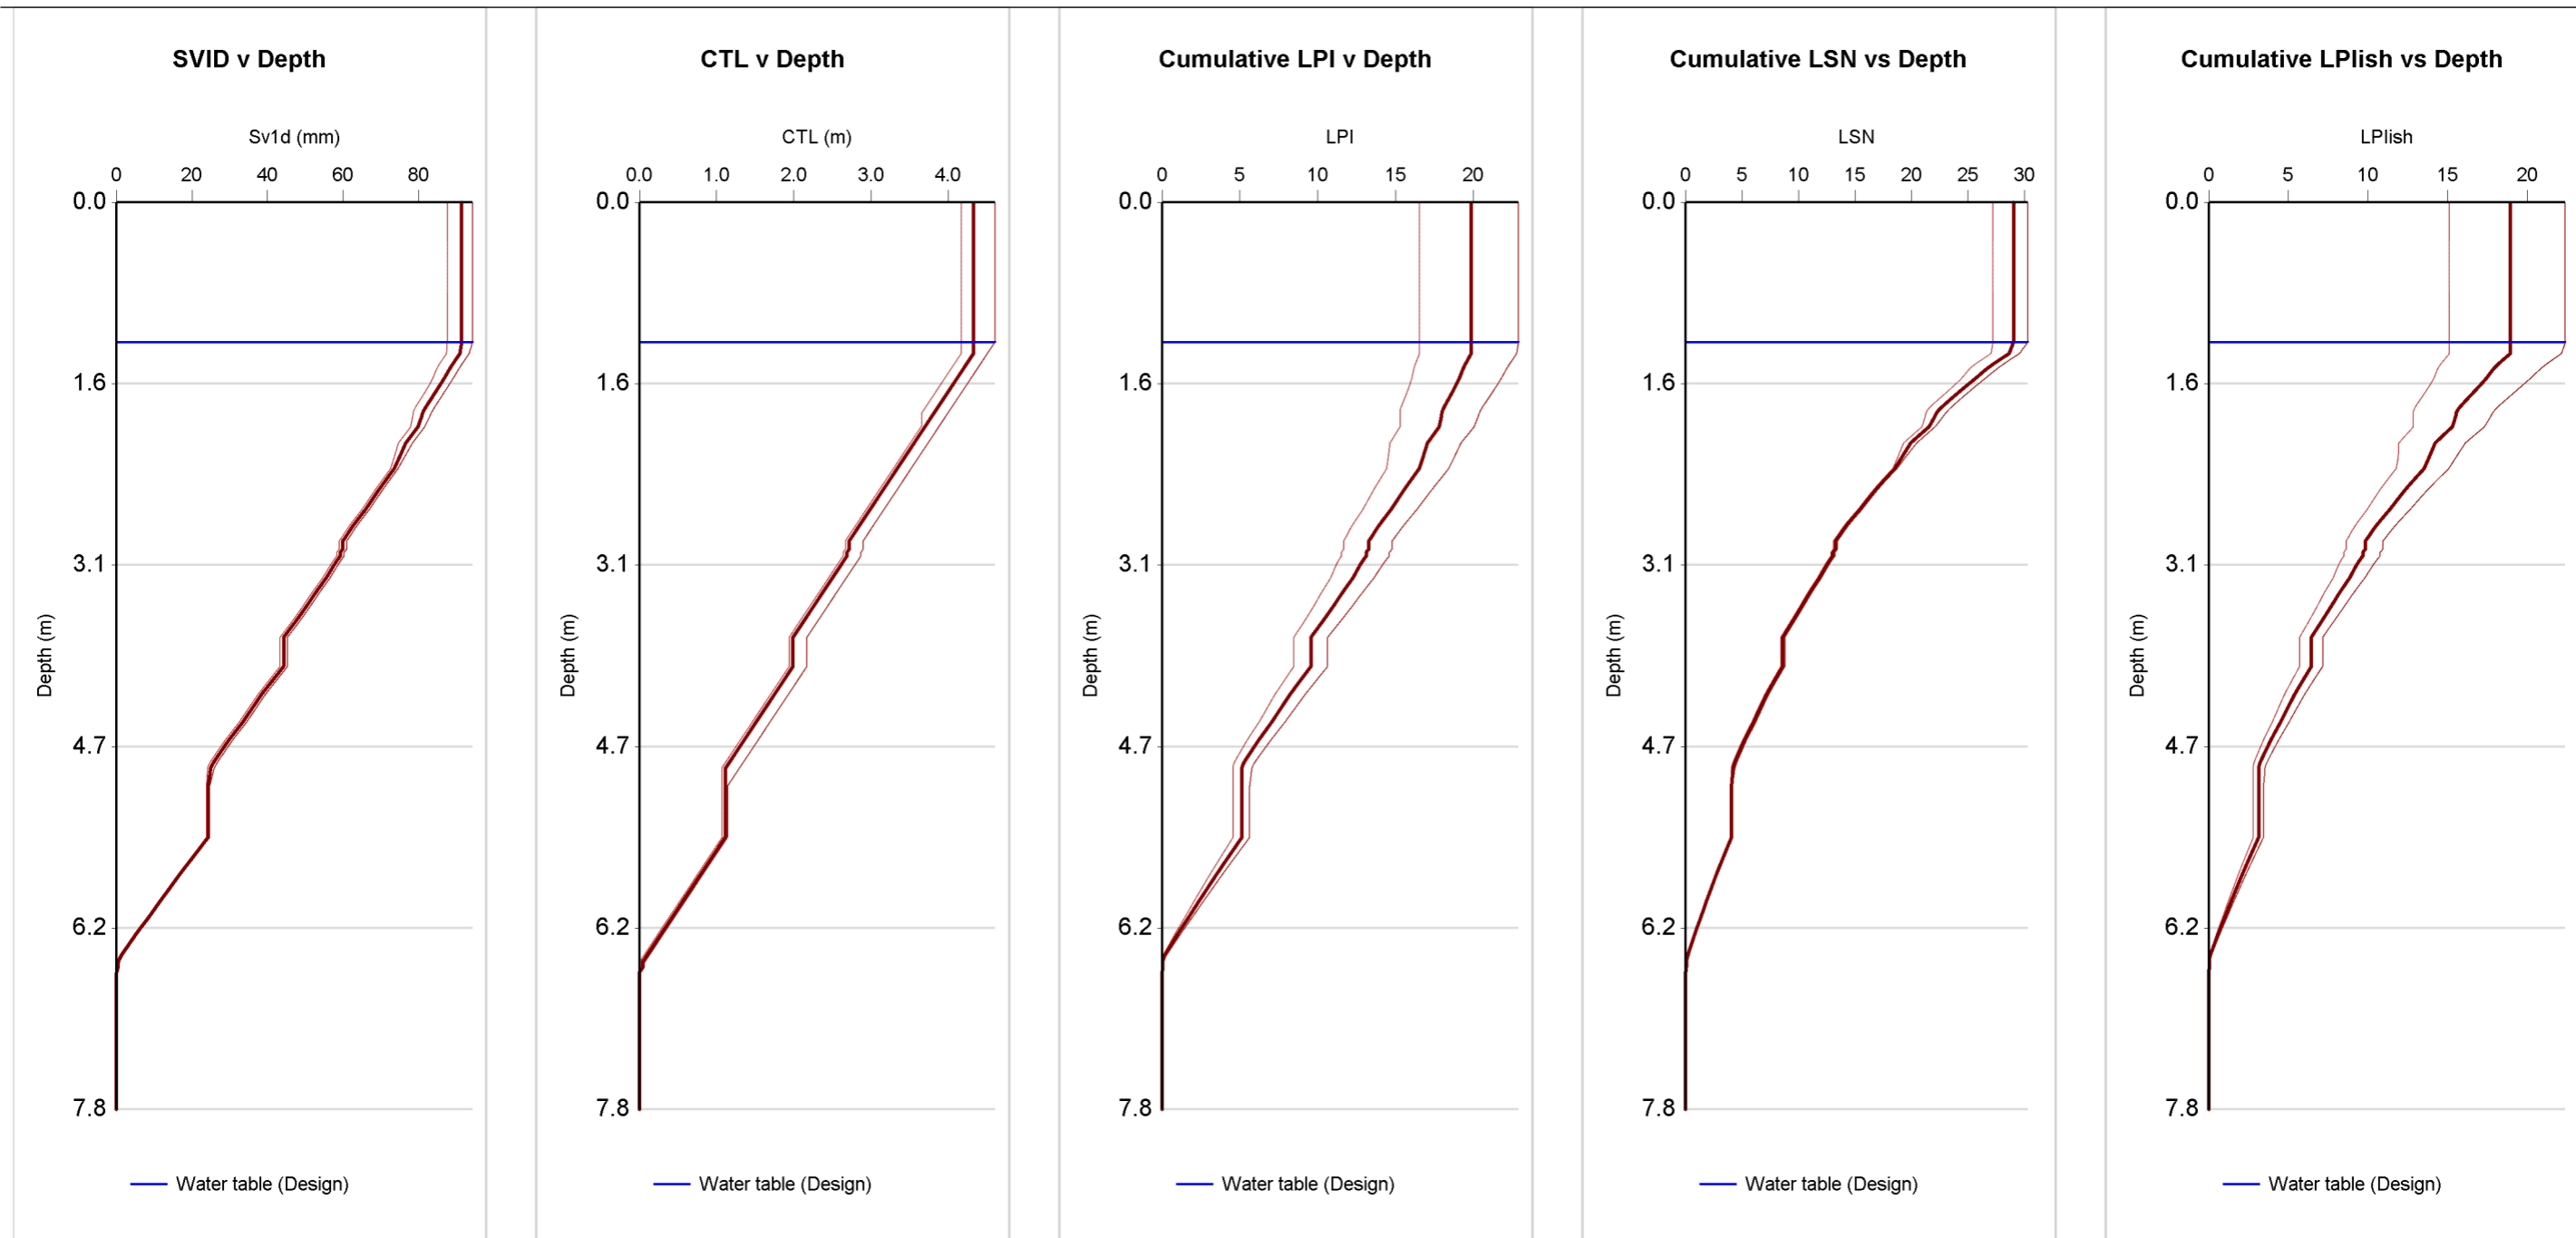
Run Description	TTGD ID	Investigation Date	Pre-drill (m)	Magnitude	PGA (g)	Trigger Method	Settlement Method	γ (kN/m ³)	Surcharge/Cut/Fill	Surcharge (kPa)	Cut/Fill Height (m)
INPUT IM3 CPT2	103680	12/10/2017	1	7.1	0.59	BI-2014	ZRB-2002	18		0

See response to Item 3 below. The 2020 liquefaction analysis output is enclosed in Attachment B. The results of the 2020 liquefaction analysis conclude that the calculated 'free field' liquefaction induced settlement range for a 1-in-1000 year event is up to 100 mm.

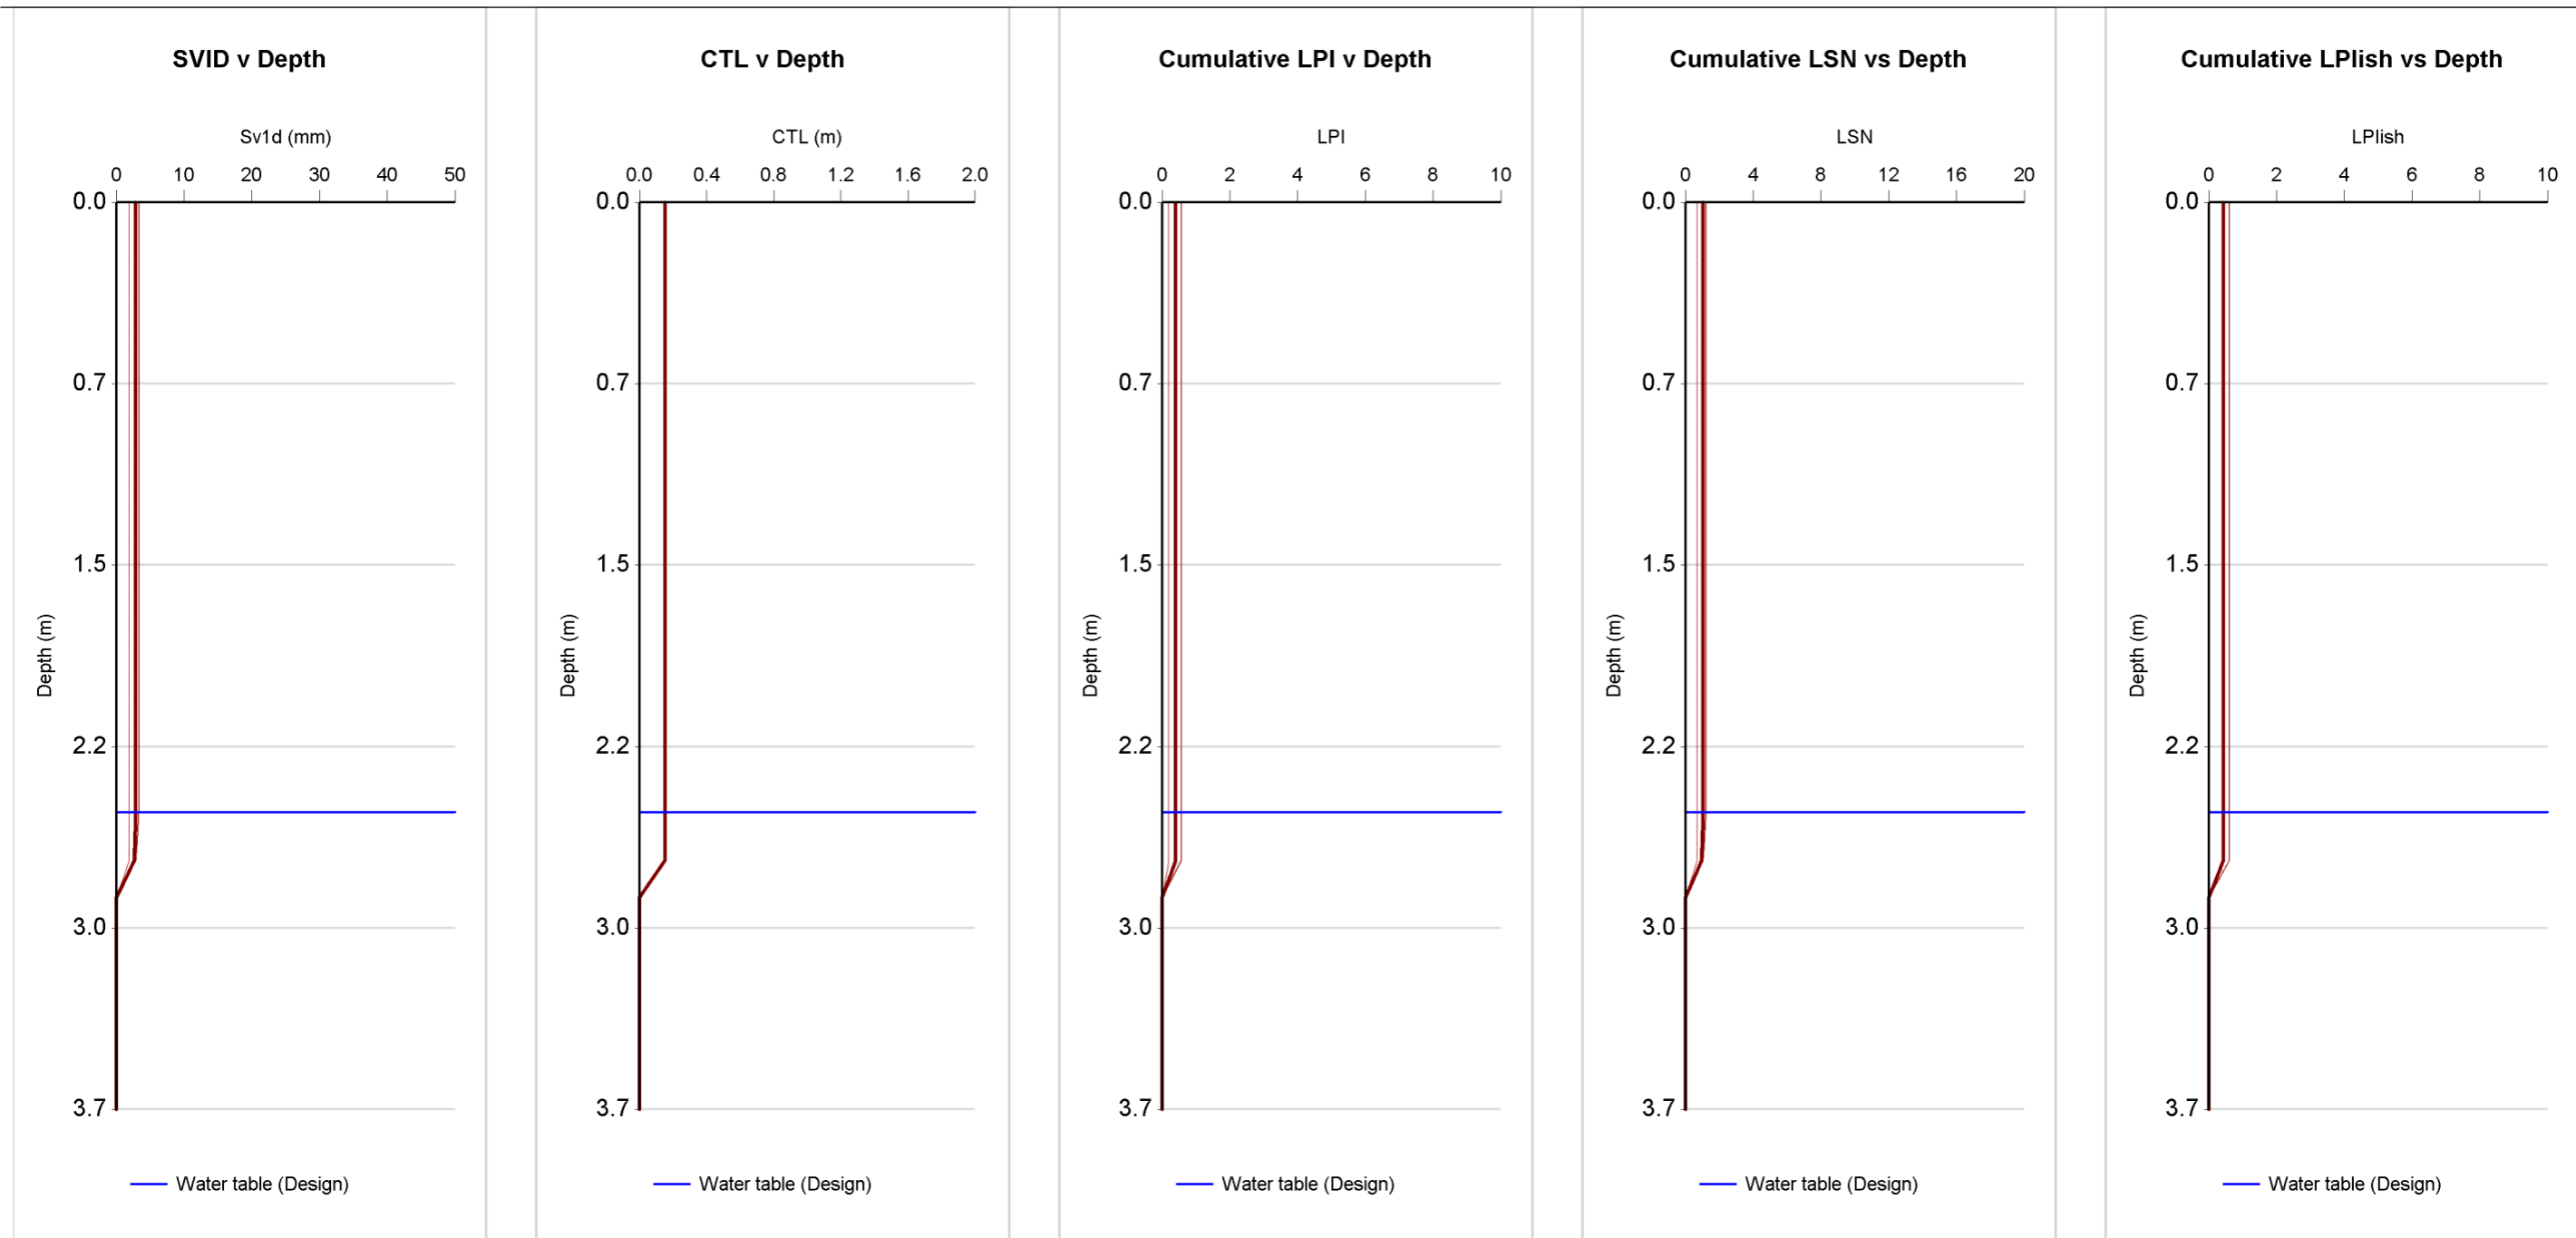
Run Description	TTGD ID	Investigation Date	Pre-drill (m)	Magnitude	PGA (g)	Trigger Method	Settlement Method	γ (kN/m ³)	Surcharge/Cut/Fill	Surcharge (kPa)	Cut/Fill Height (m)
INPUT IM3 CPT3	103681	12/10/2017	1.2	7.1	0.59	BI-2014	ZRB-2002	18		0

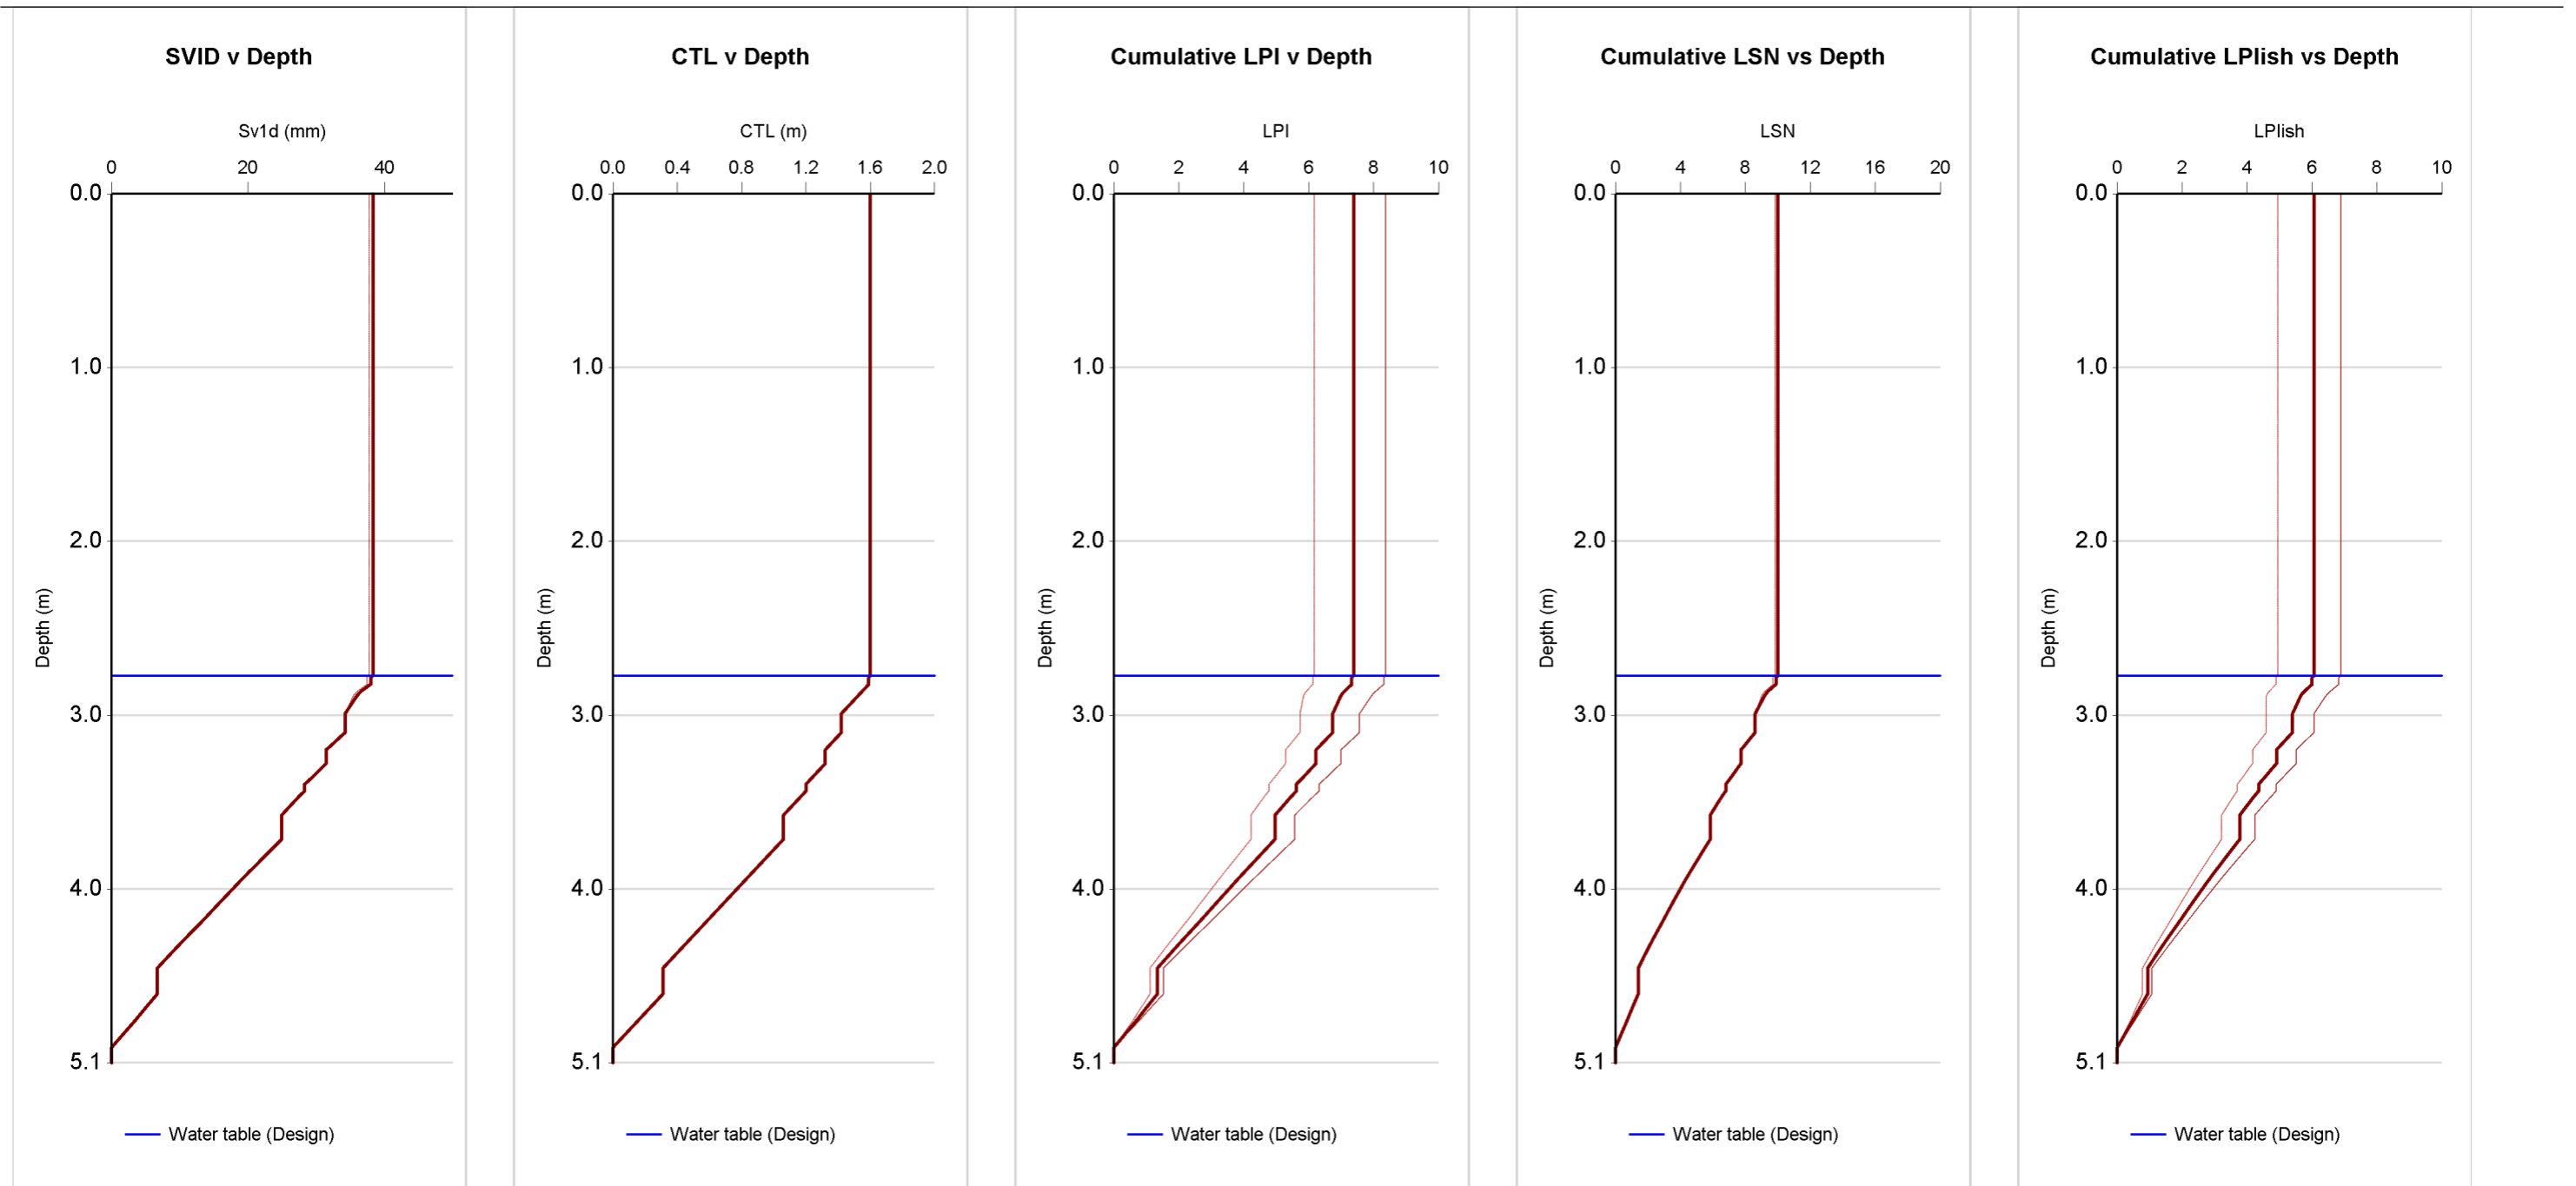
Run Description	TTGD ID	Investigation Date	Pre-drill (m)	Magnitude	PGA (g)	Trigger Method	Settlement Method	γ (kN/m ³)	Surcharge/Cut/Fill	Surcharge (kPa)	Cut/Fill Height (m)
INPUT IM3 CPT5	103683	12/10/2017	1.5	7.1	0.59	BI-2014	ZRB-2002	18		0

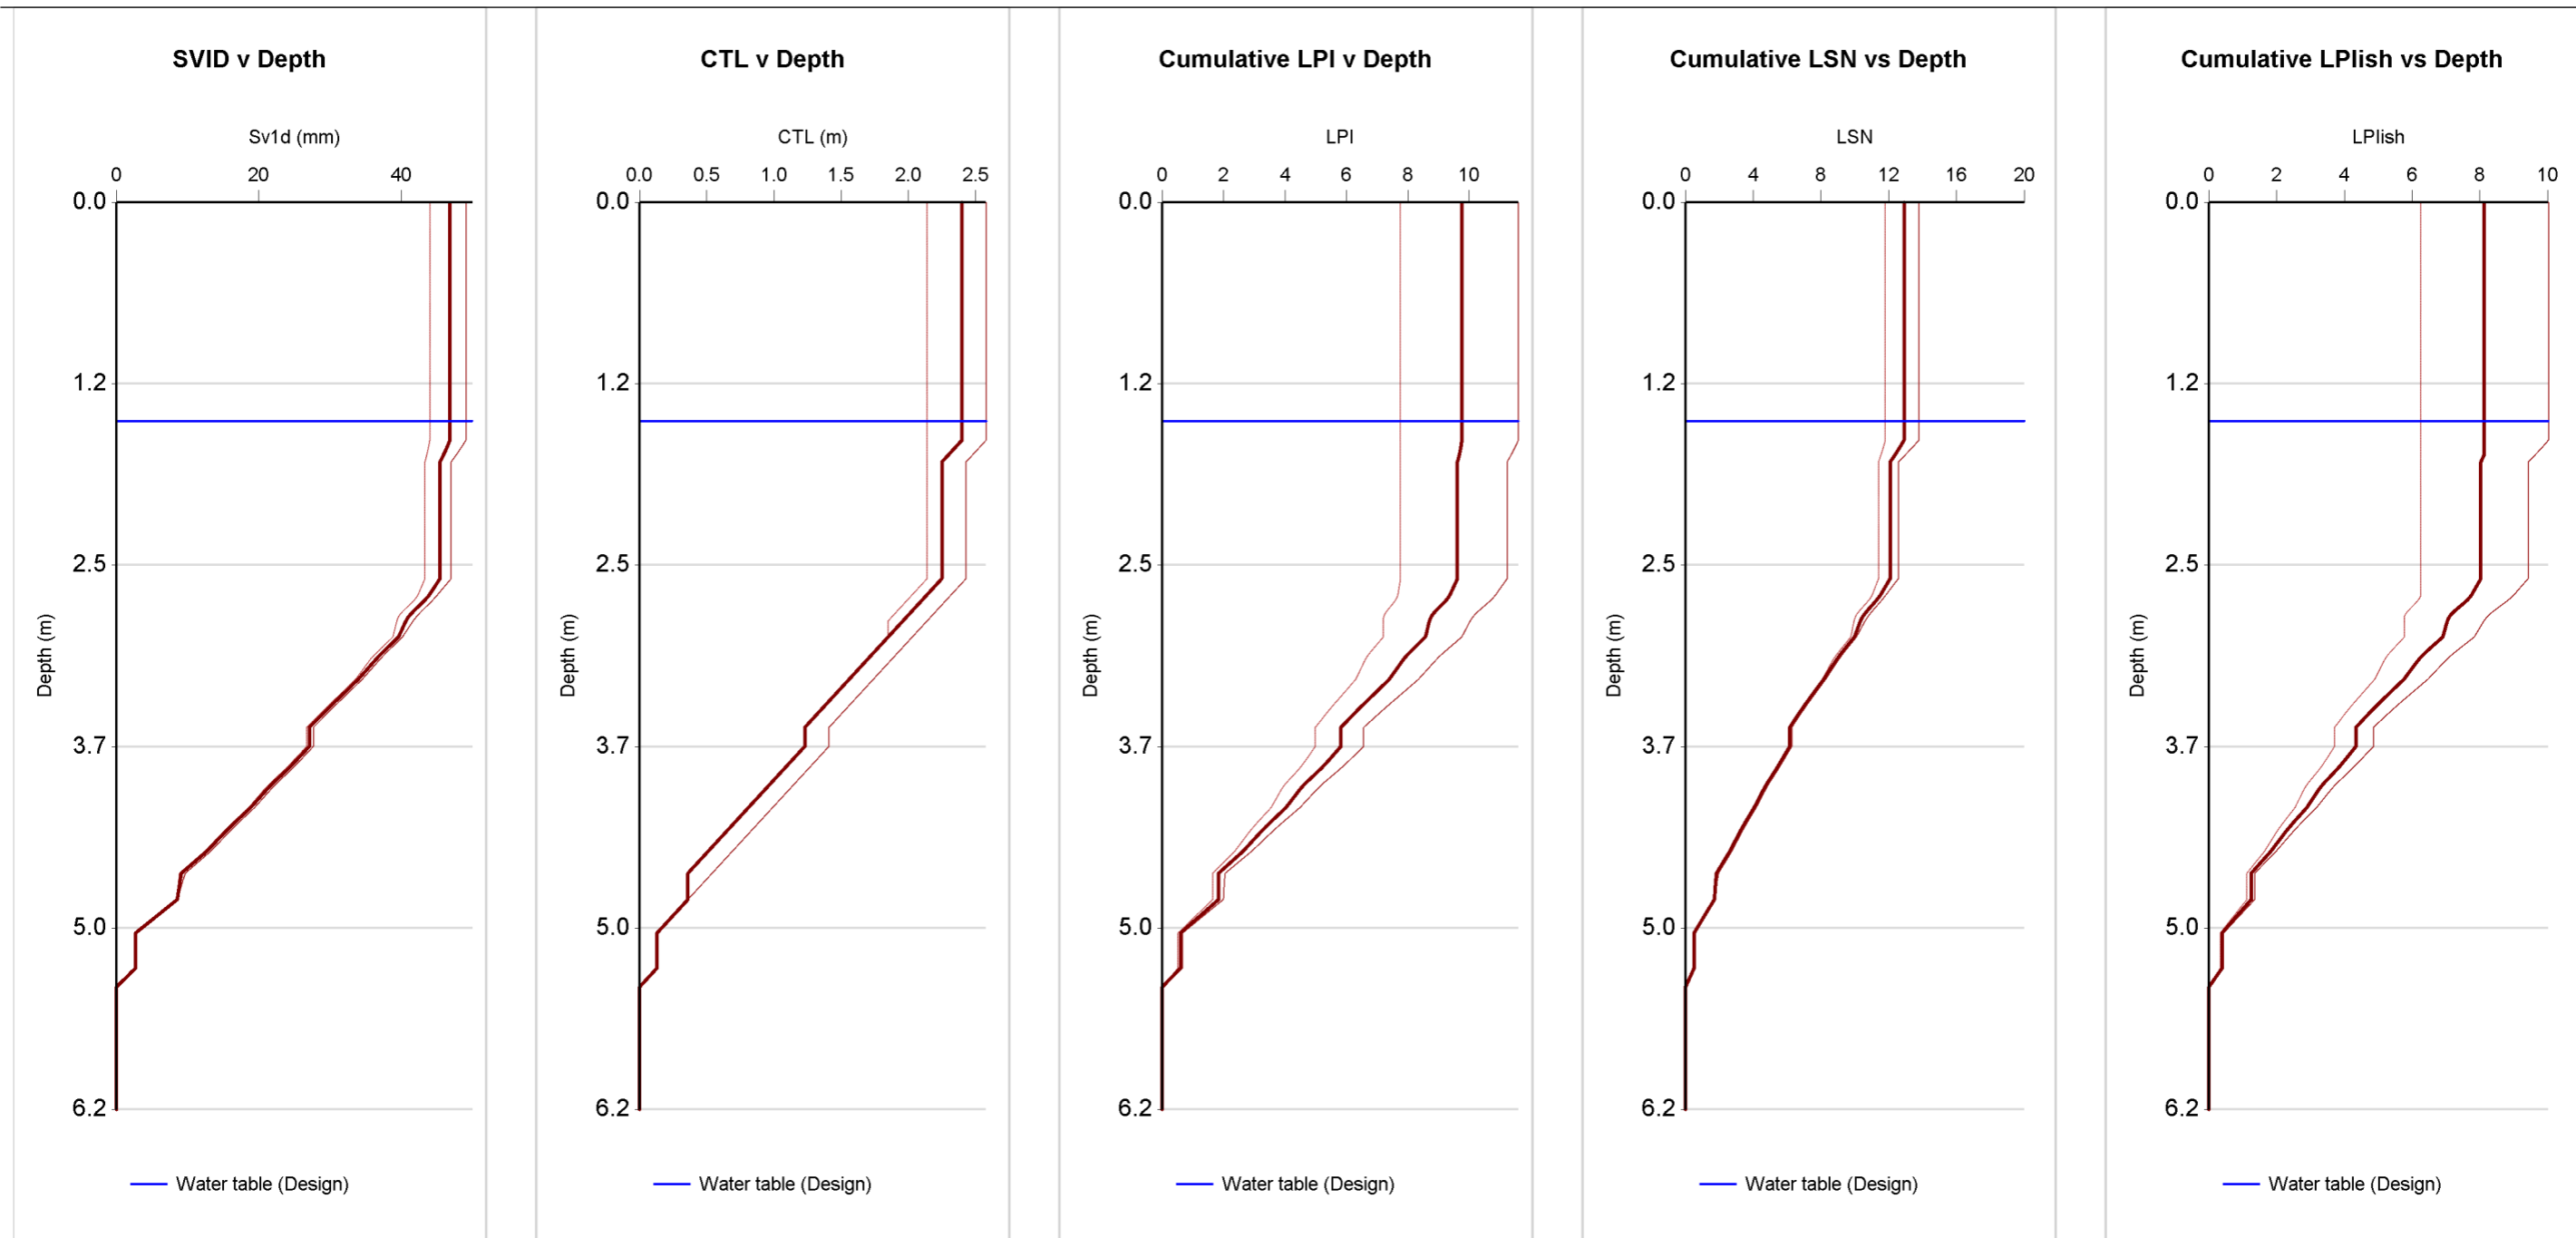
Run Description	TTGD ID	Investigation Date	Pre-drill (m)	Magnitude	PGA (g)	Trigger Method	Settlement Method	γ (kN/m ³)	Surcharge/Cut/Fill	Surcharge (kPa)	Cut/Fill Height (m)
INPUT IM3 CPT9	103687	11/10/2017	1.1	7.1	0.59	BI-2014	ZRB-2002	18		0
