APPENDIX B

Responses to Further Information
Request – Tonkin & Taylor

**Responses to Further Information Request by Wellington City Council
Service Request Number 471670, WGN 210104
Redevelopment of 26 Donald Street and 37 Campbell Street, Karori, Wellington**

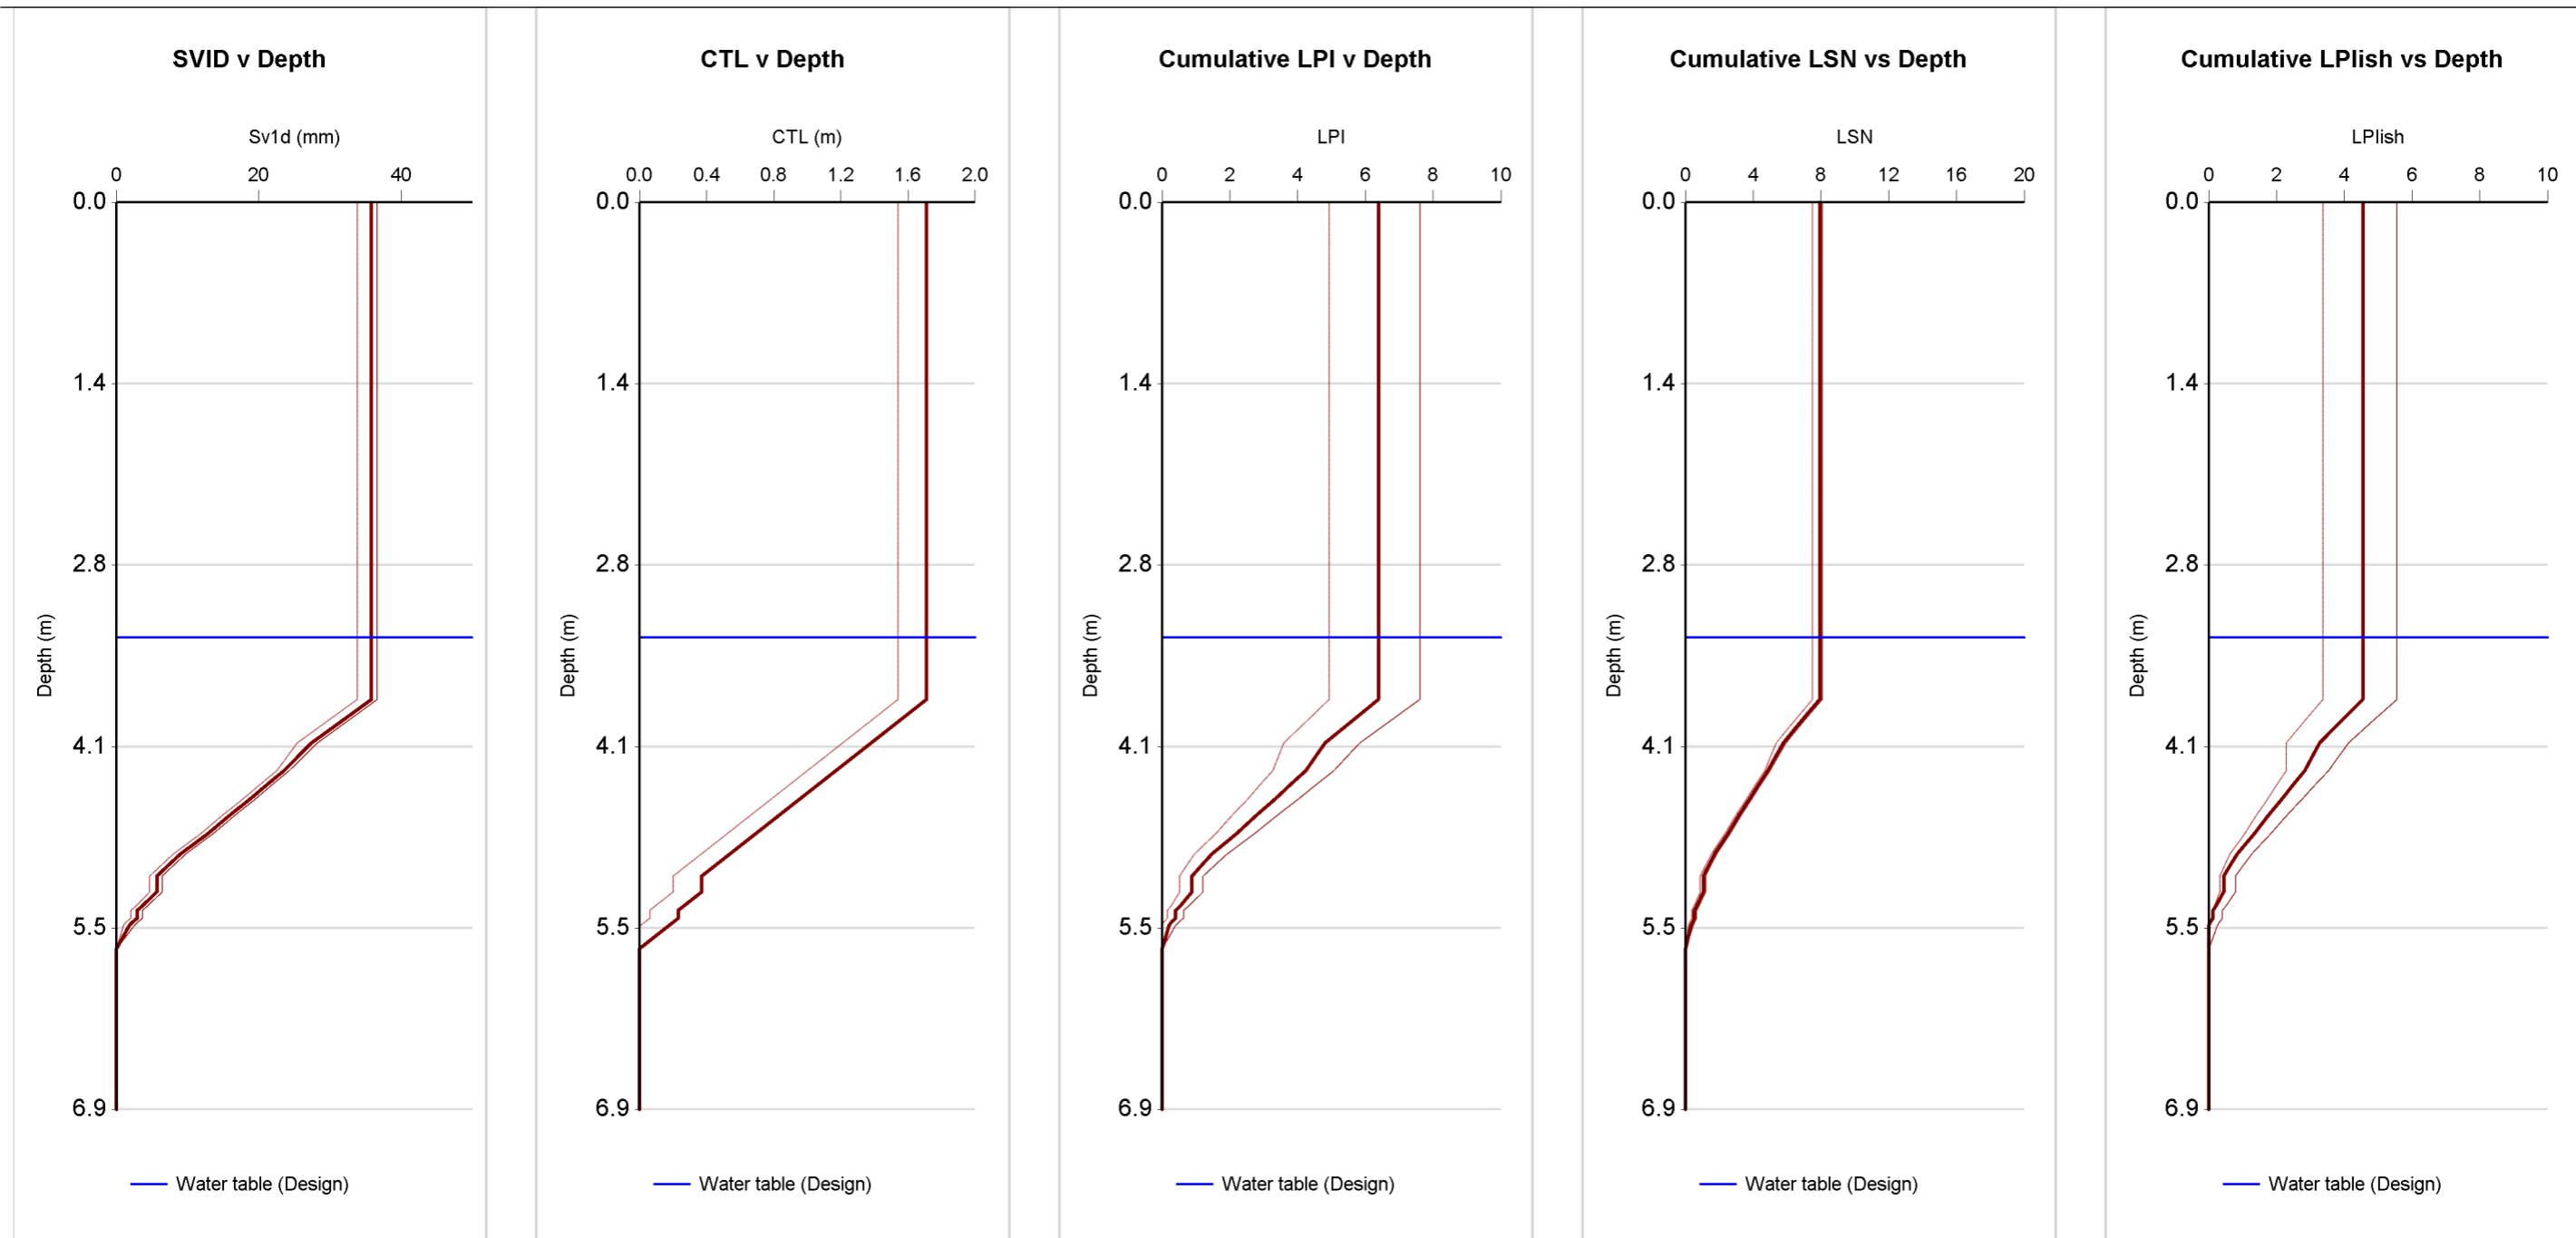
Run Description	TTGD ID	Investigation Date	Pre-drill (m)	Magnitude	PGA (g)	Trigger Method	Settlement Method	γ (kN/m ³)	Surcharge/Cut/Fill	Surcharge (kPa)	Cut/Fill Height (m)
INPUT IM3 CPT10	103688	12/10/2017	1.55	7.1	0.59	BI-2014	ZRB-2002	18		0

See response to Item 3 below. The 2020 liquefaction analysis output is enclosed in Attachment B. The results of the 2020 liquefaction analysis conclude that the calculated 'free field' liquefaction induced settlement range for a 1-in-1000 year event is up to 100 mm.
