**Ground Contamination  
Assessment of  
Environmental Effects**

**Ryman Village, Karori, Wellington**

**Prepared for**  
Ryman Healthcare Ltd

**Prepared by**  
Tonkin & Taylor Ltd

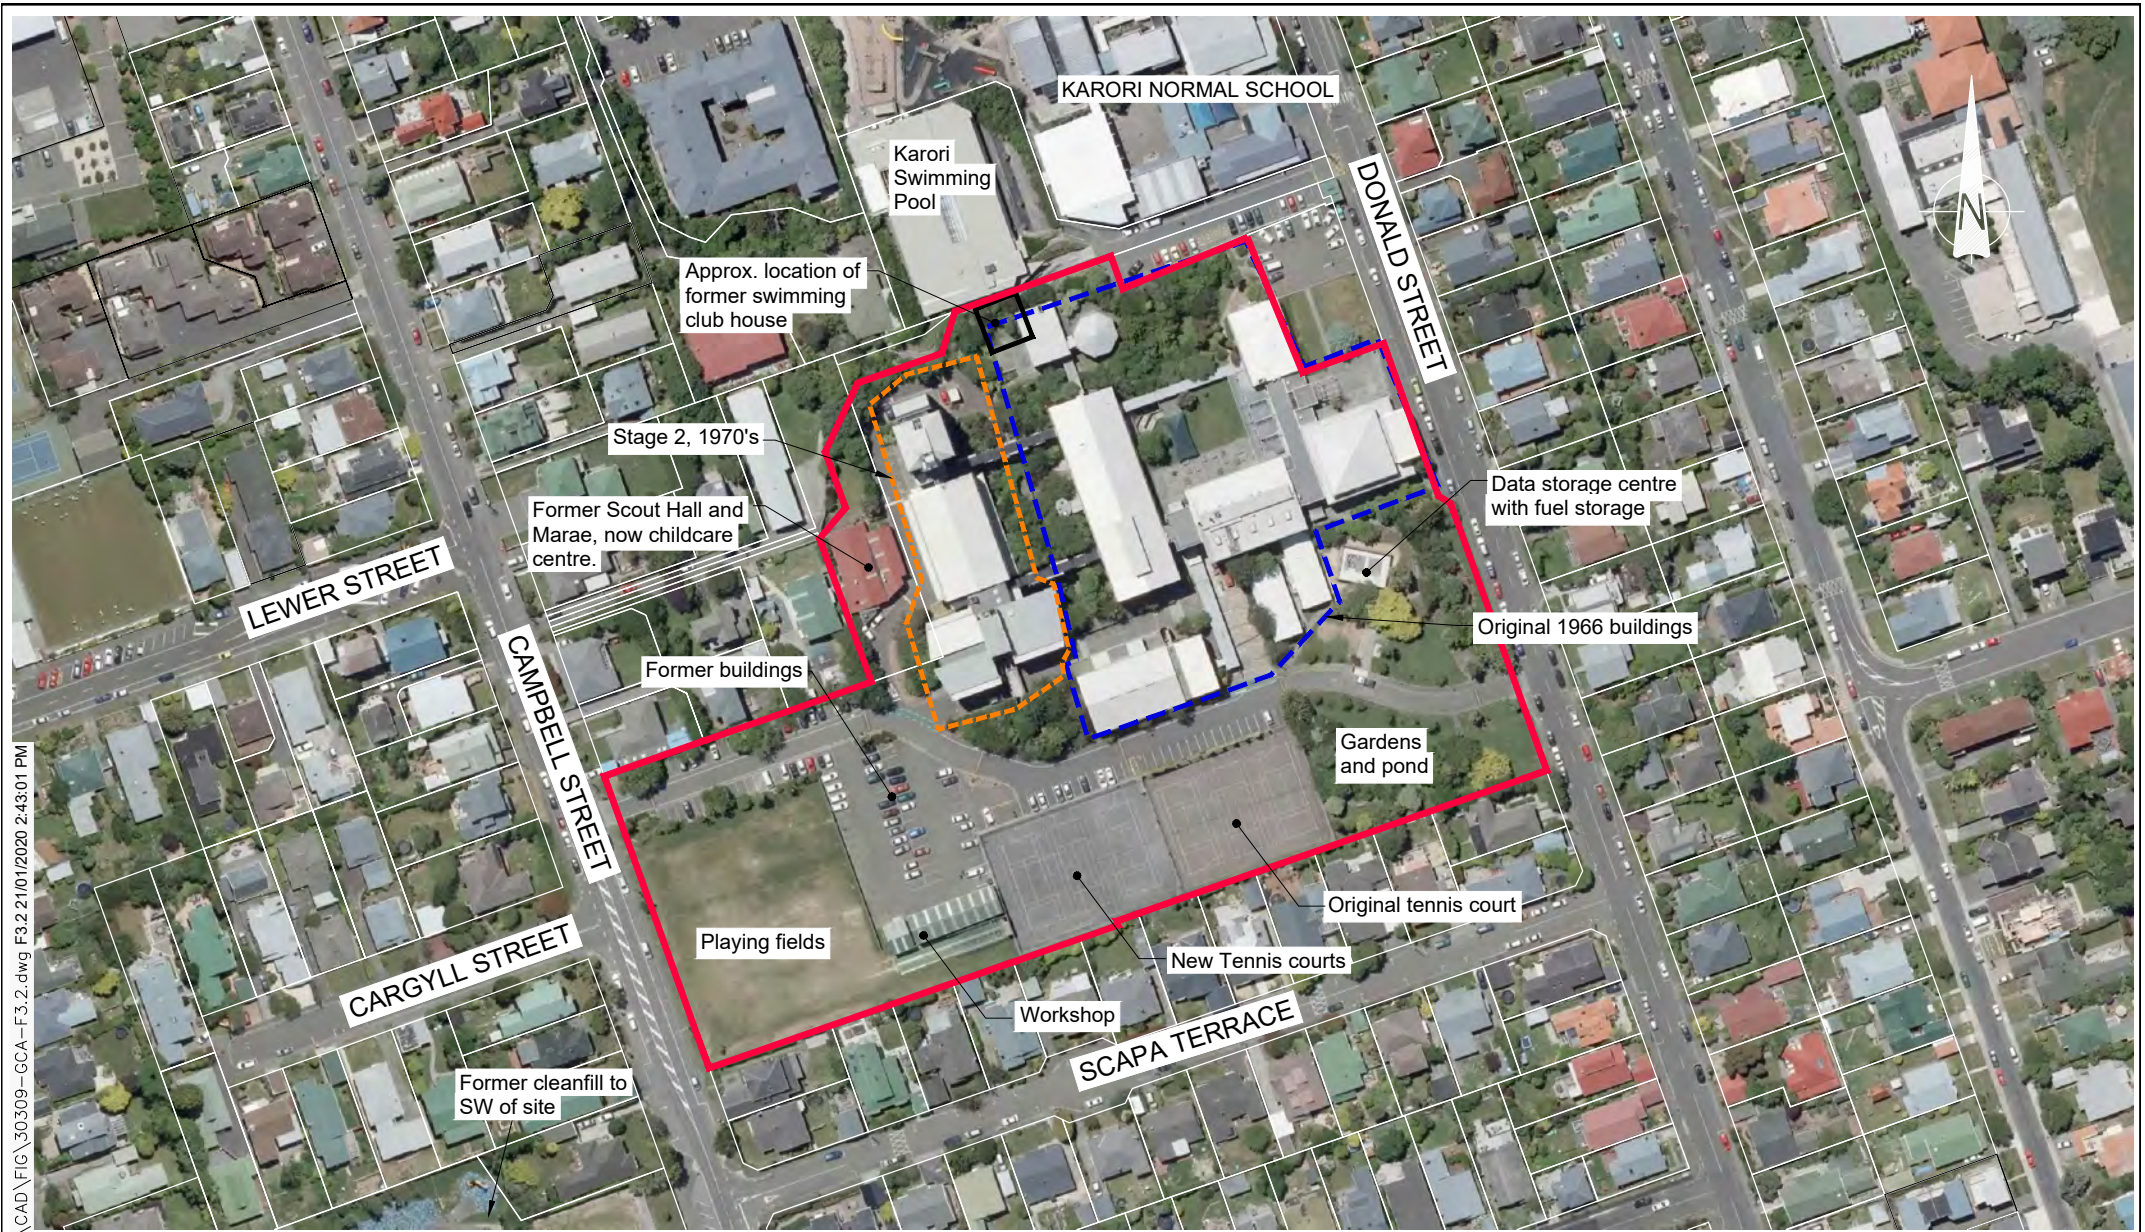
L: \30309\WorkingMaterial\CAD\FIG\30309-GCA-F3.2.dwg F3.2 11/01/2020 2:43:01 PM

The buildings observed at the Site during the October 2017 Site walkover are shown in Figure 3.2 and comprised:

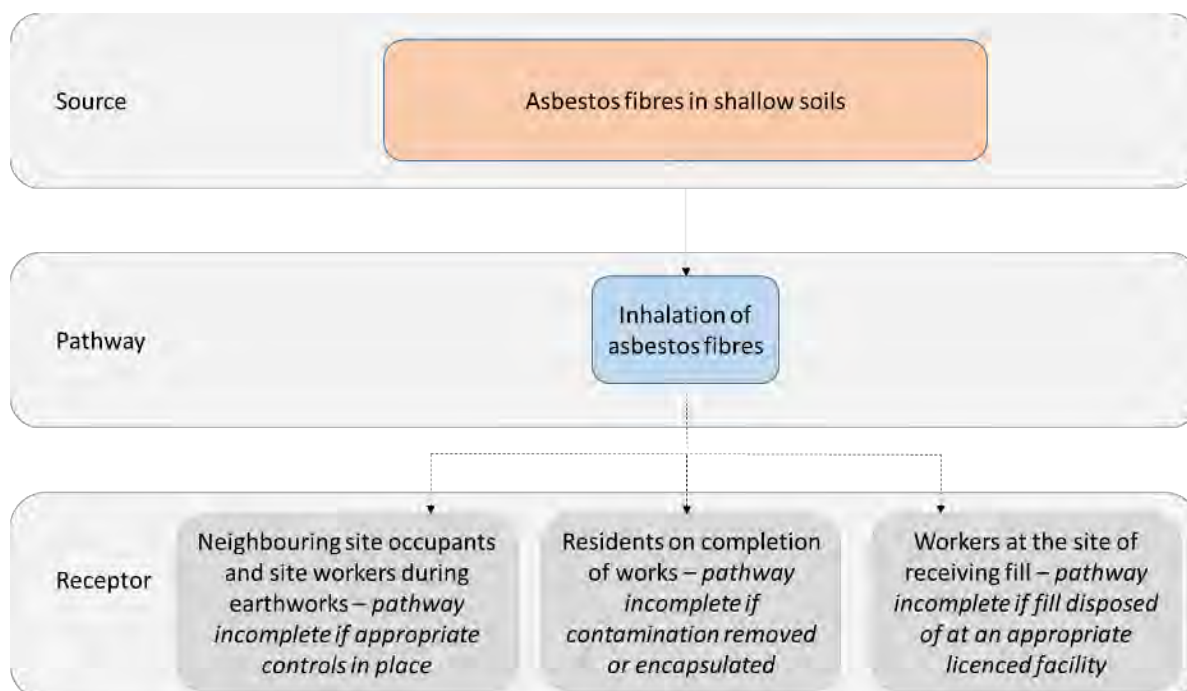
Figure 6.2: Final conceptual site model. Note the dashed lines and grey boxes indicate pathways that are expected to be incomplete based on the recommendations presented in this report.

The preliminary conceptual site model provided in Section 5.2 has been revised to reflect the sampling results, which only found asbestos contamination above human health guidelines. The revised model is presented in Figure 6.2 below.

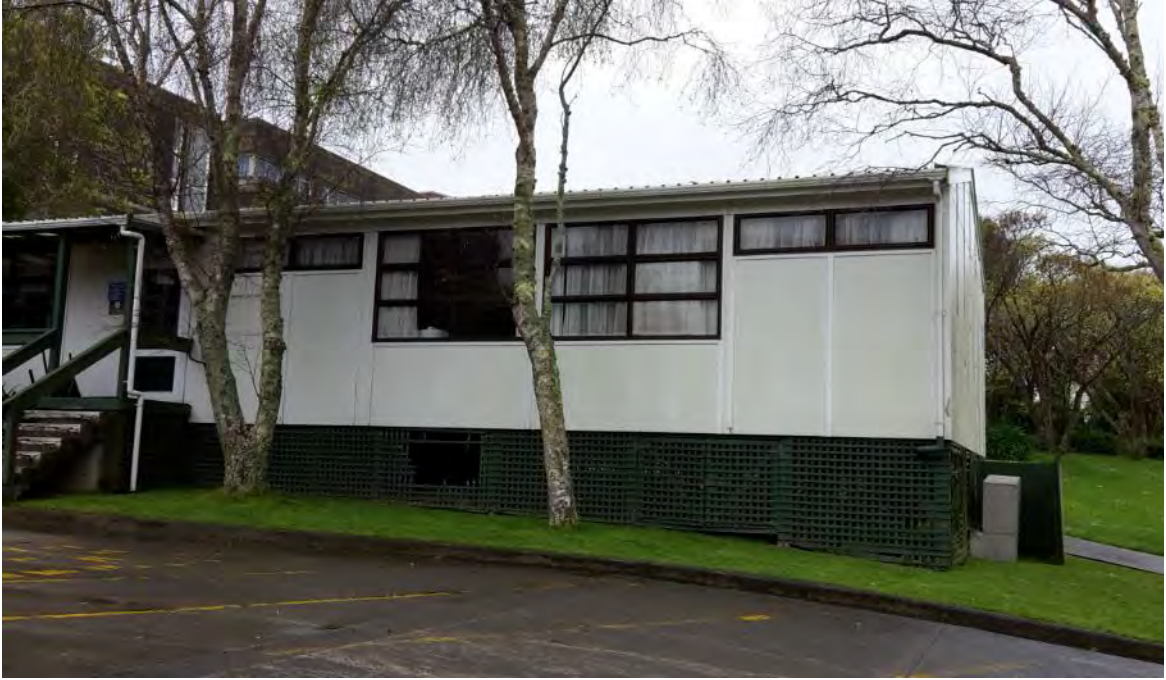
*Photograph 3: A typical pre-fabricated building.*

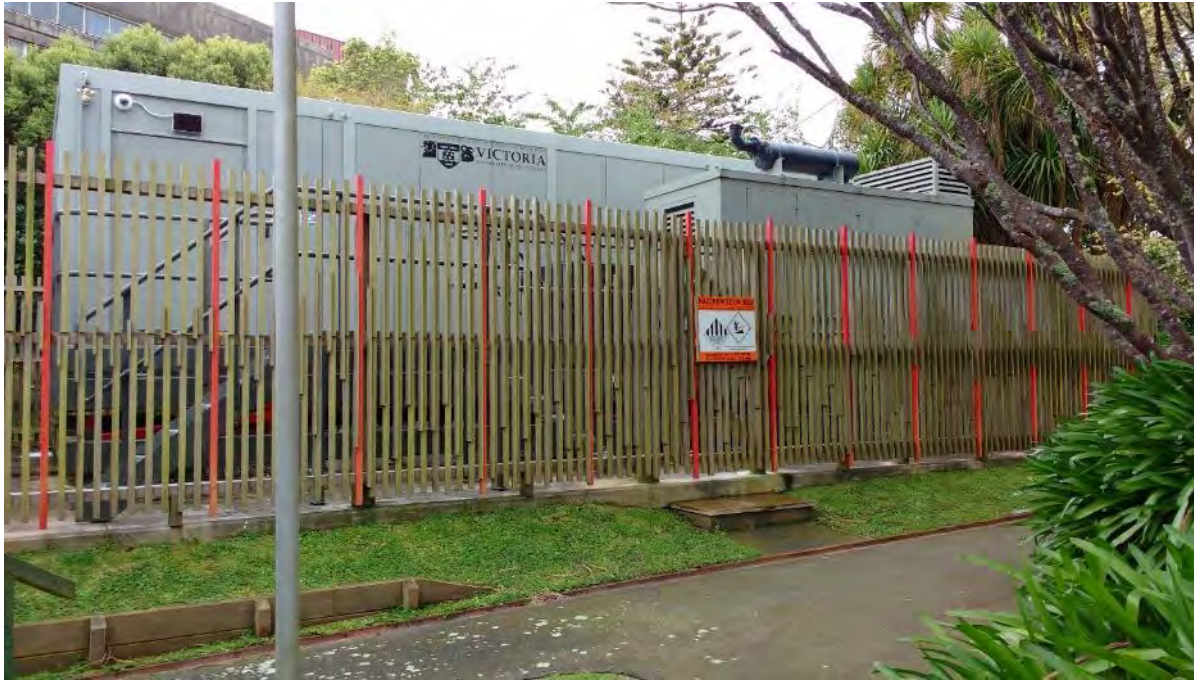
*Photograph 5: View of the data centre with the independent generator and fuel storage.*

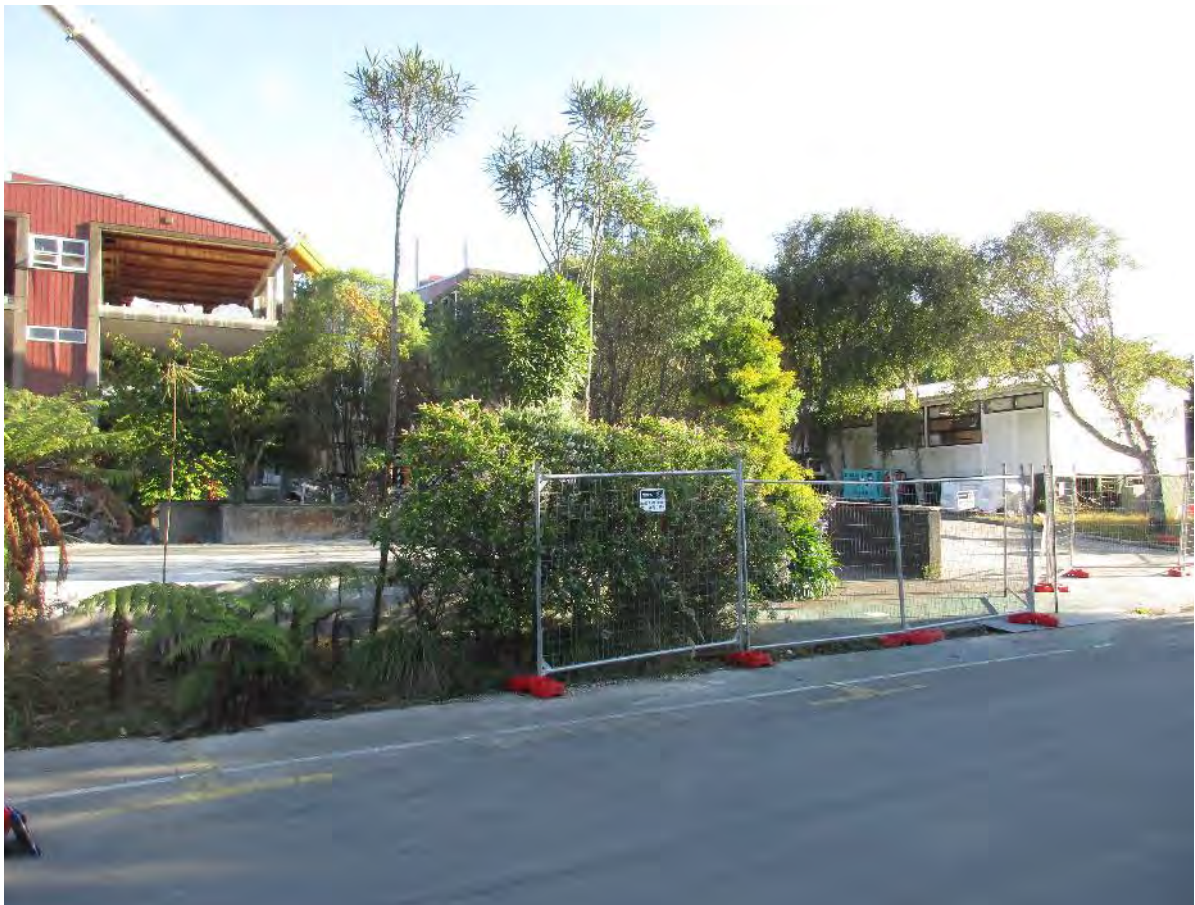
*Photograph 6: View of footprint of Mackie Gym building following removal.*

Building deconstruction is now completed. During a site visit by T+T on 26 February 2020, it was noted that the Mackie Gym and Ako Pai Marae building had been removed (Photographs 6 and 7, respectively), and deconstruction of the Malcom Block and Panckhurst Block was underway. The above ground storage tank and data centre generator was removed in October 2018 by RCP Limited on behalf of Victoria University.

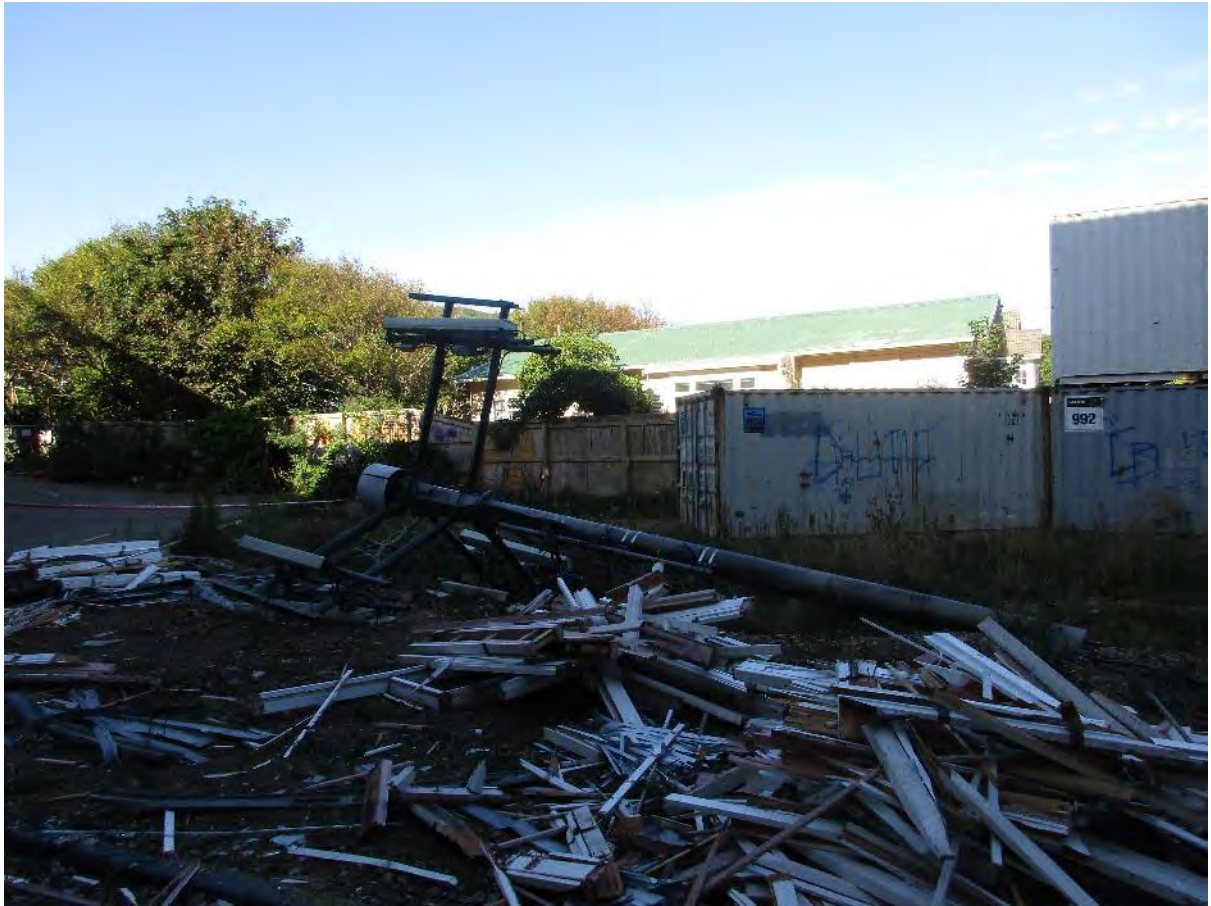
*Photograph 7: Area formerly occupied by Marae building, now temporarily containing demolition materials.*
