# Arboricultural Report

Job No. 35419

**Prepared by:** David Spencer – Consultant Arborist

**Re:** Application to relocate the Museum St Oak Tree

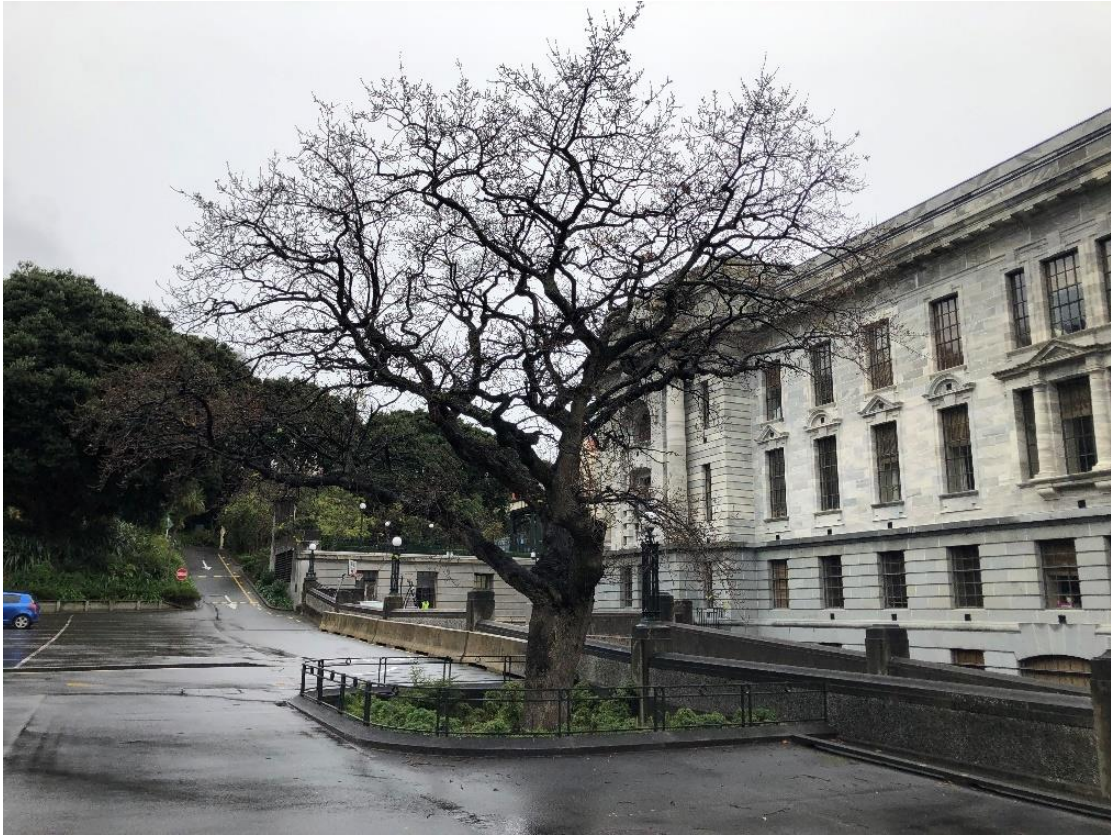
**Photograph 2: Museum Street Oak Tree in June 2021.**

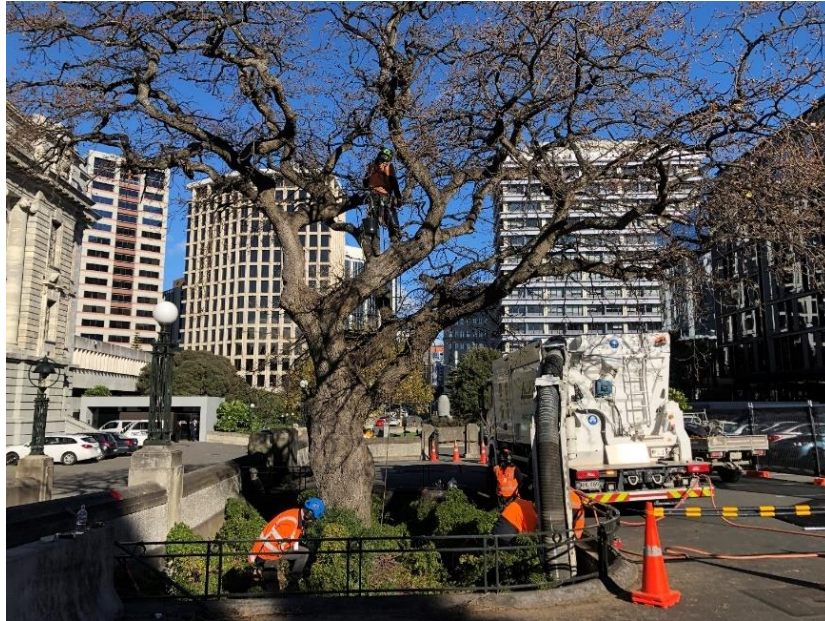
- 6.1 The air excavations determined that there is extensive root development around the entire circumference of the tree. The soil was excavated to a depth of 1.5m on the southeast corner which showed considerable root development down to this depth. <sup>2</sup> Air Excavation Around Trees
- 6.2 The excavation on the northern side of the planter bed was limited by a hard compacted soil layer, which could not be penetrated by air excavation. The final excavation depth was approximately 500mm. There was good root development to this depth.
- 6.3 The eastern side was excavated to between 1.2m and 1.4m with considerable root development discovered.
- 6.4 Appendix 1 shows the locations of any excavations, their depths and notes on what was discovered. The following photograph 1 shows the air excavation in progress.

**Photograph 1. Air excavation with an air vac.**
