# Arboricultural Completion Memorandum

Job No. 35419

**Date:** August 2022

**Re:** Preparatory root pruning for proposed tree relocation completion memo

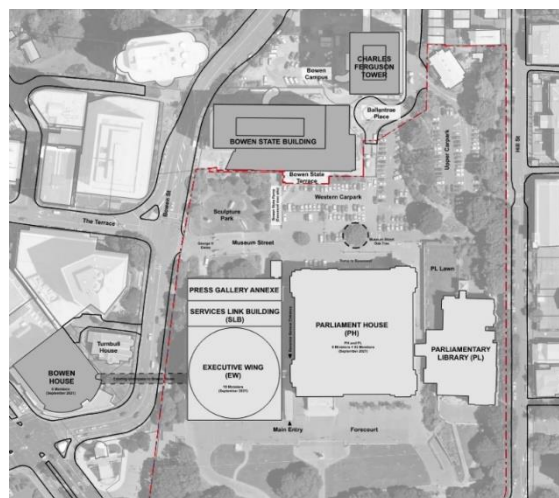
Figure 1: The site with the tree within the dashed circle.

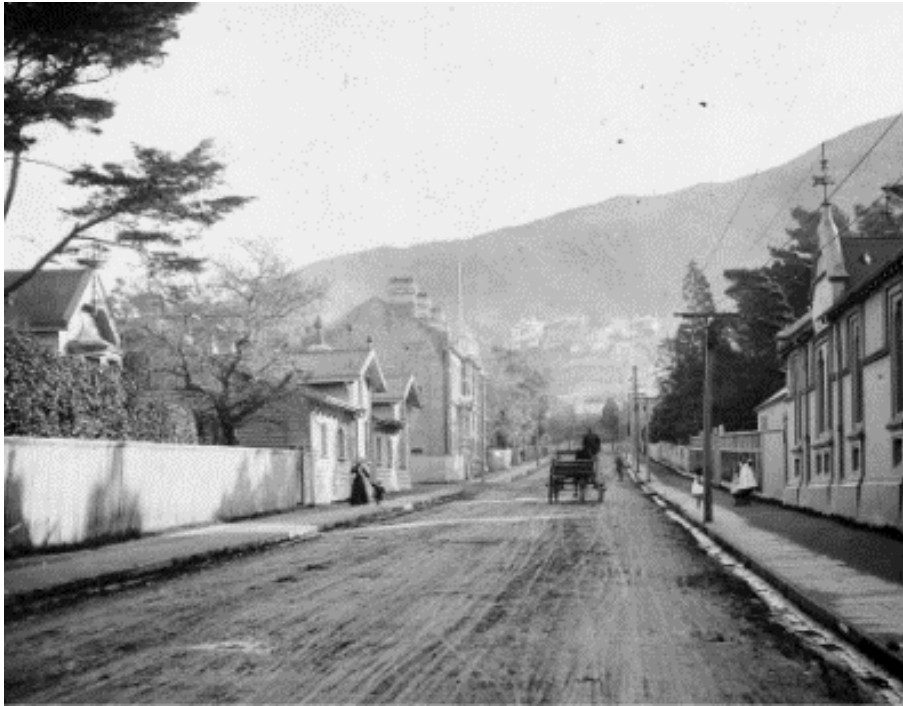
**Photograph 1: Museum Street Oak Tree (centre left) c.1900 in the grounds of the Government Gardens cottage from Museum Street.**
